# 2023 Annual Site Inspection and Monitoring Report for Uranium Mill Tailings Radiation Control Act Title I Disposal Sites

March 2024

Legacy  
Management

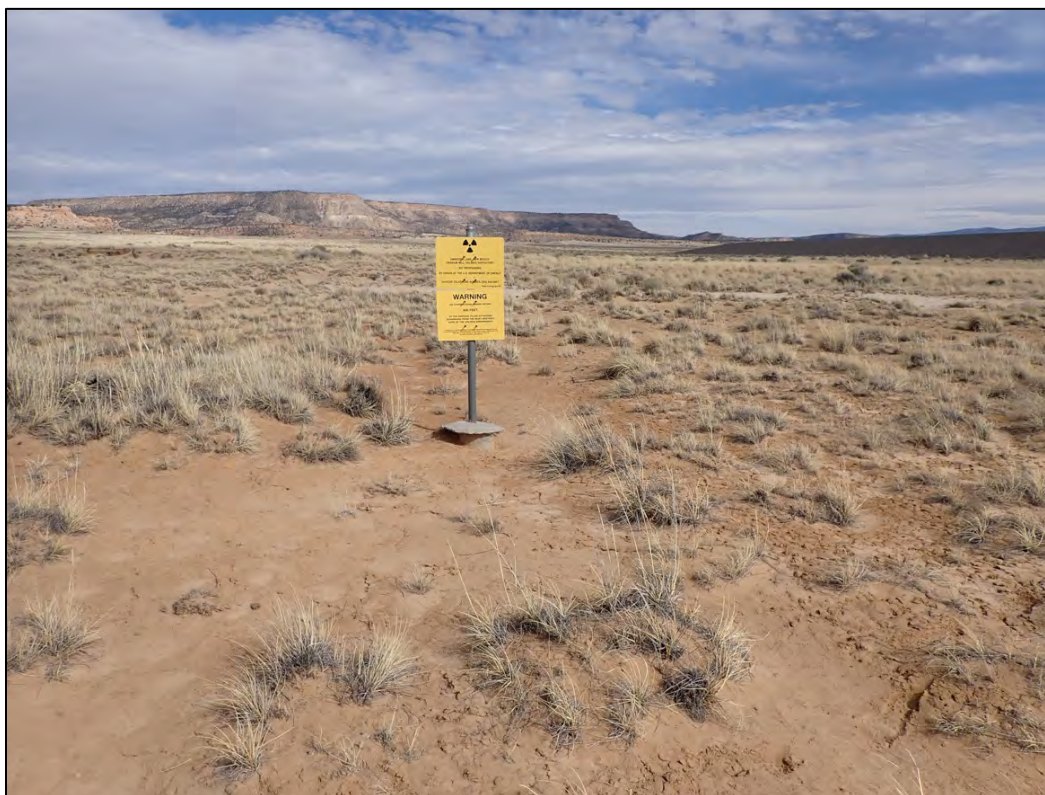
*PL-2. Erosion at Base of Perimeter Sign P12*

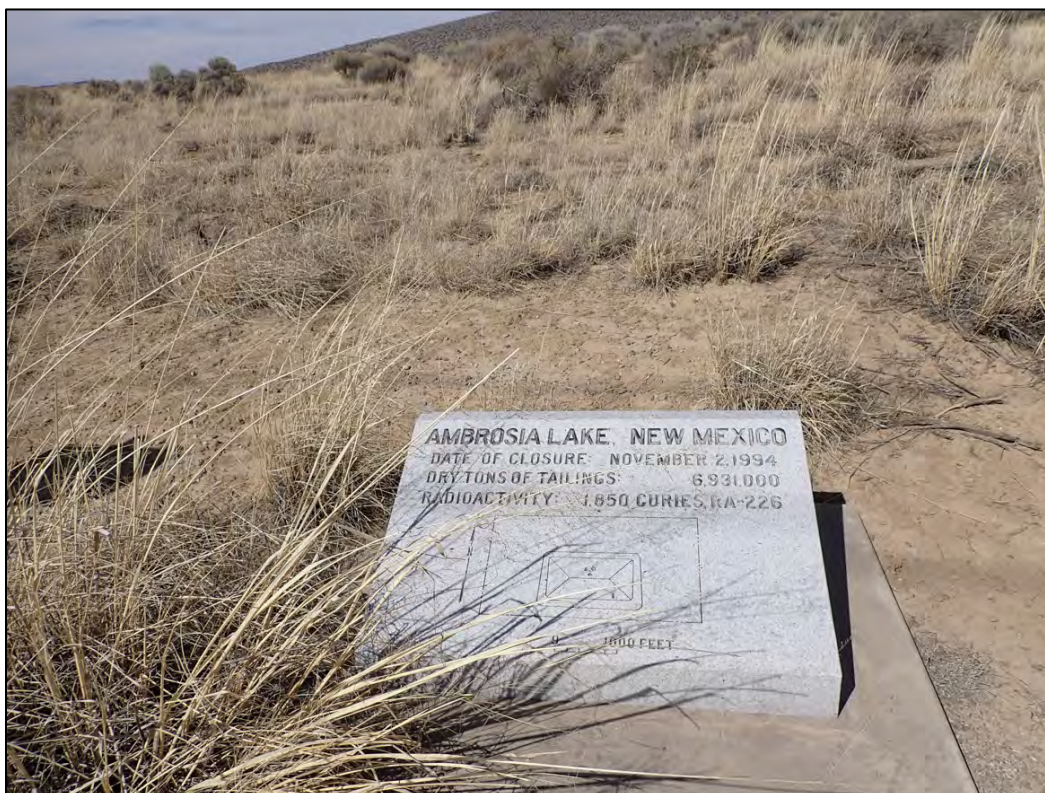
The site has two granite site markers. Site marker SMK-1 (PL-3) is just inside the site entrance, and site marker SMK-2 is on the top slope of the disposal cell. No maintenance needs were identified.

*PL-3. Site Marker SMK-1*

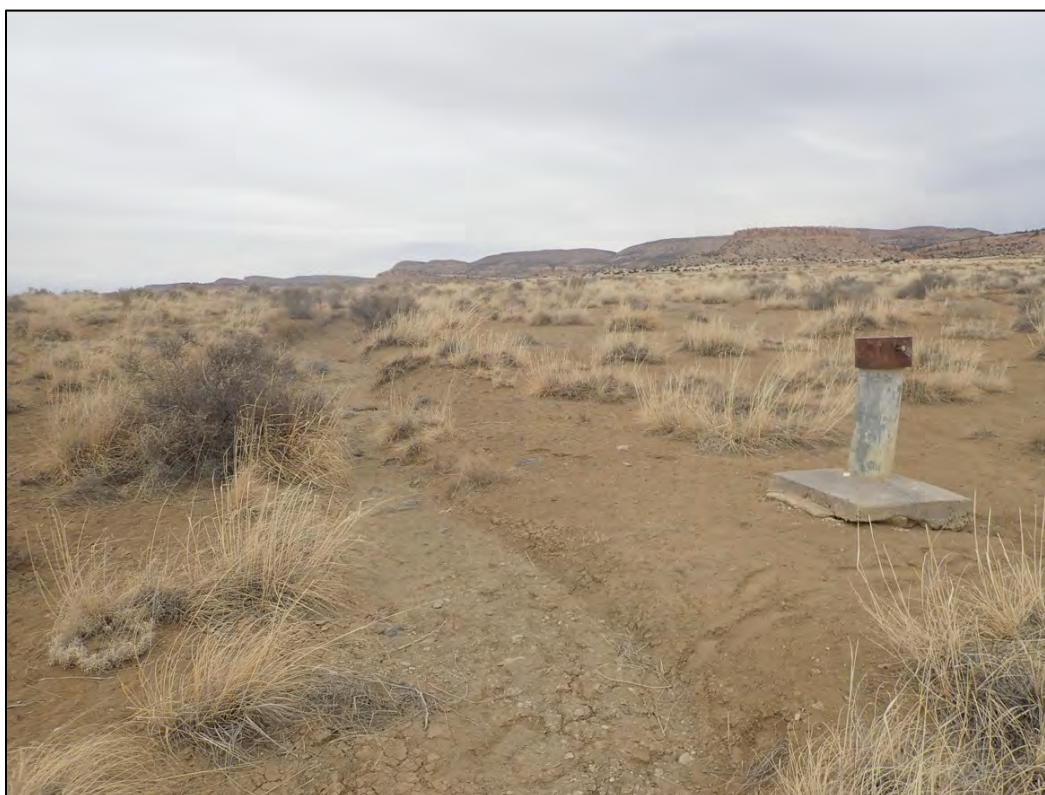
The site has three monitoring wells. A gully adjacent to well 0678 appears to be stable, and the well is not affected by the erosion (PL-4). All wellhead protectors observed during the inspection were undamaged, locked, and properly labeled. No maintenance needs were identified.

*PL-4. Monitoring Well 0678 and Adjacent Gully*

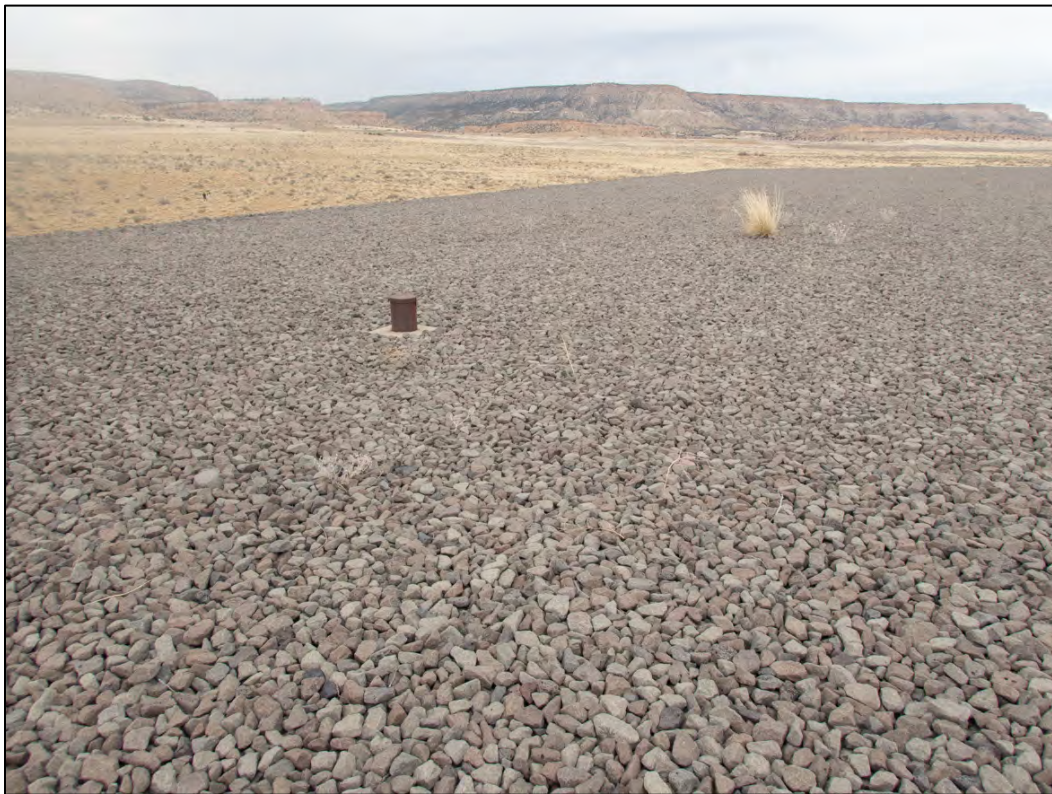
*PL-6. Depression Area near Settlement Plate 4 (Not Discernible)*

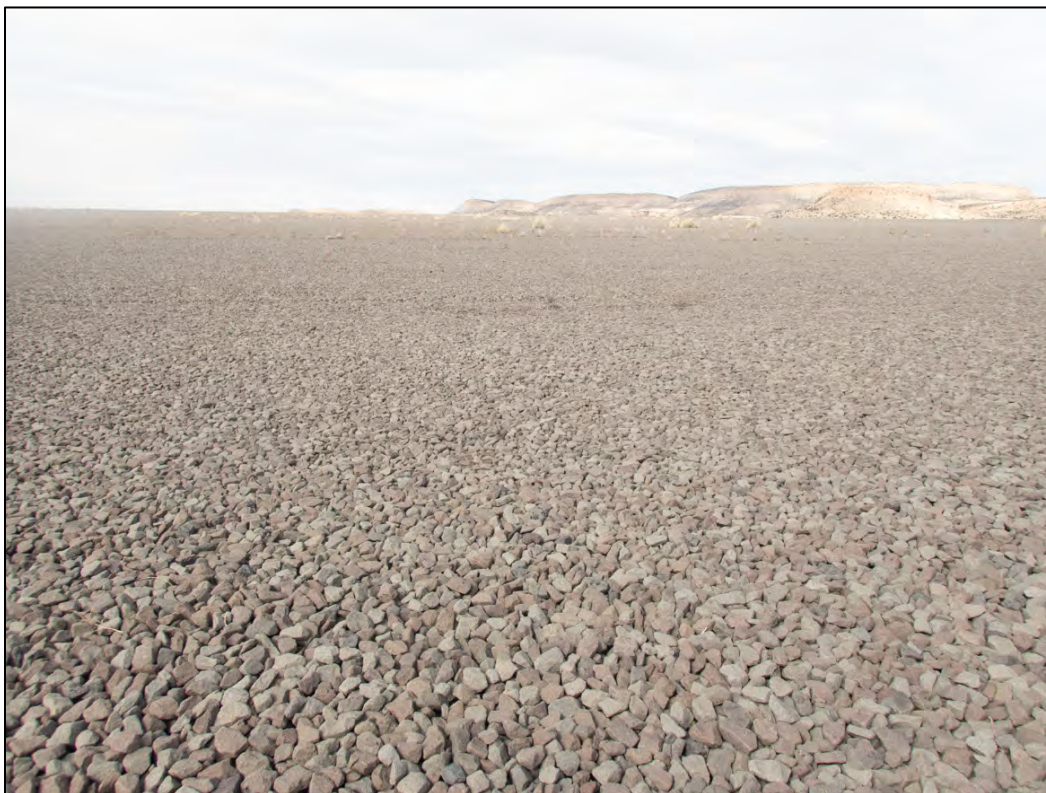
*PL-7. Weeds and Grasses on Disposal Cell Top Slope*

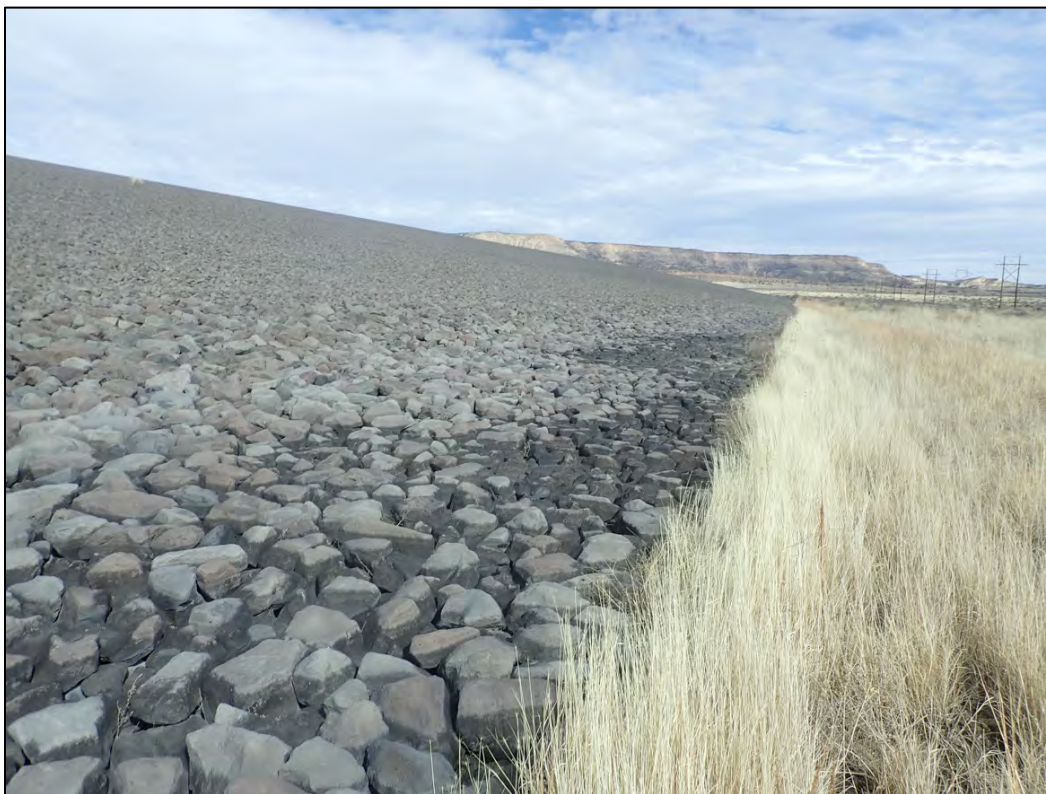
*PL-8. Evidence of Ponding Water; Evaporite Forming on Riprap of Cell Apron*

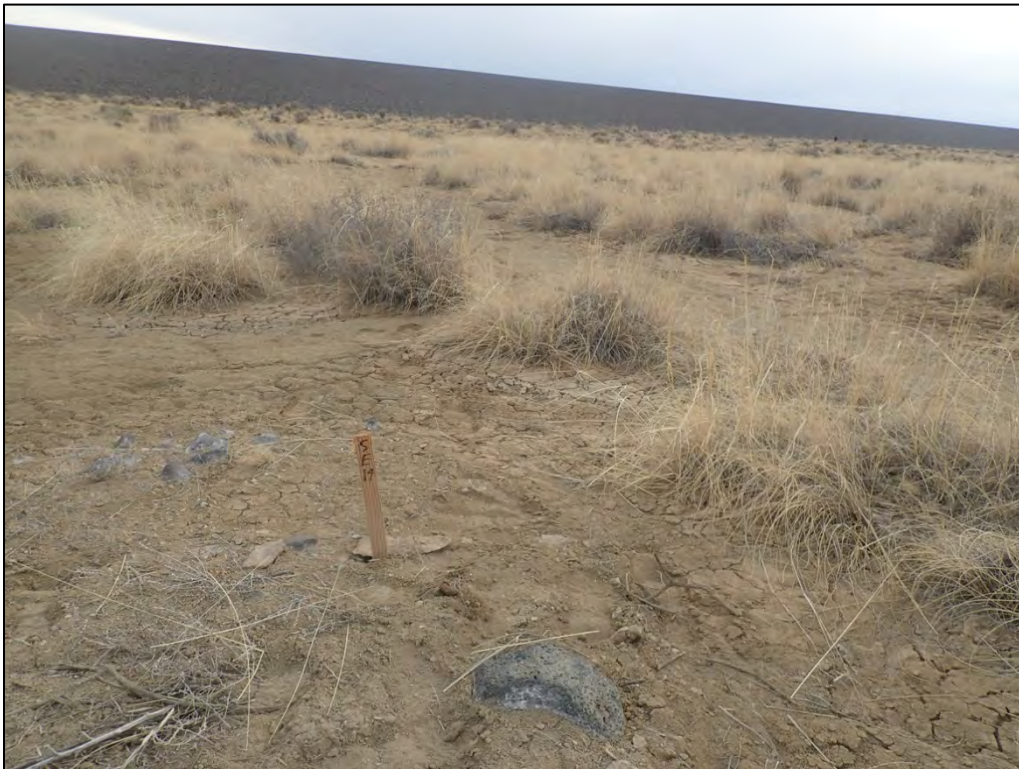
*PL-10. Gully Outlet Northeast of Disposal Cell*

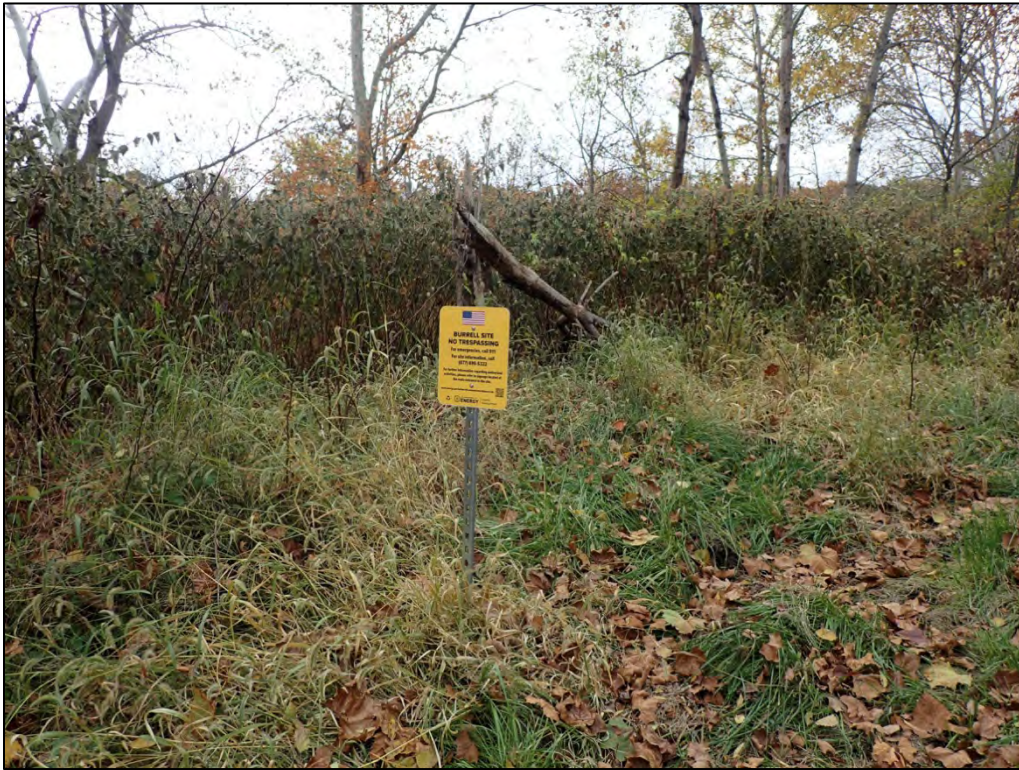
*PL-7. No-Trespassing Sign*

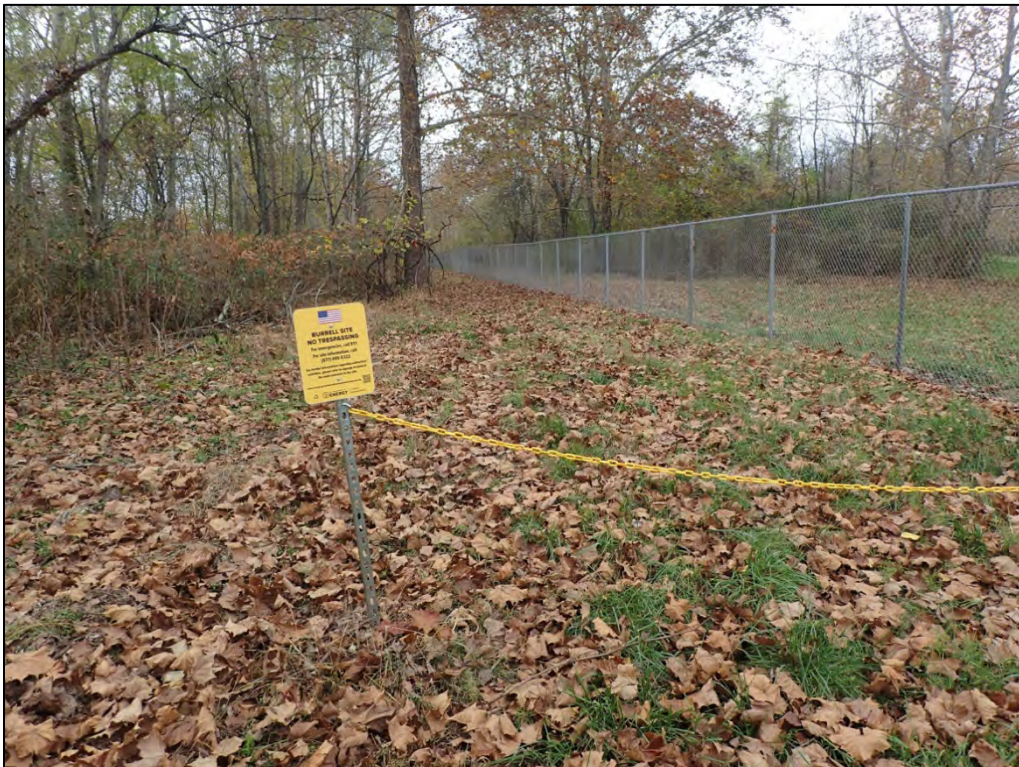
*PL-8. No-Trespassing Sign with Yellow Chain*

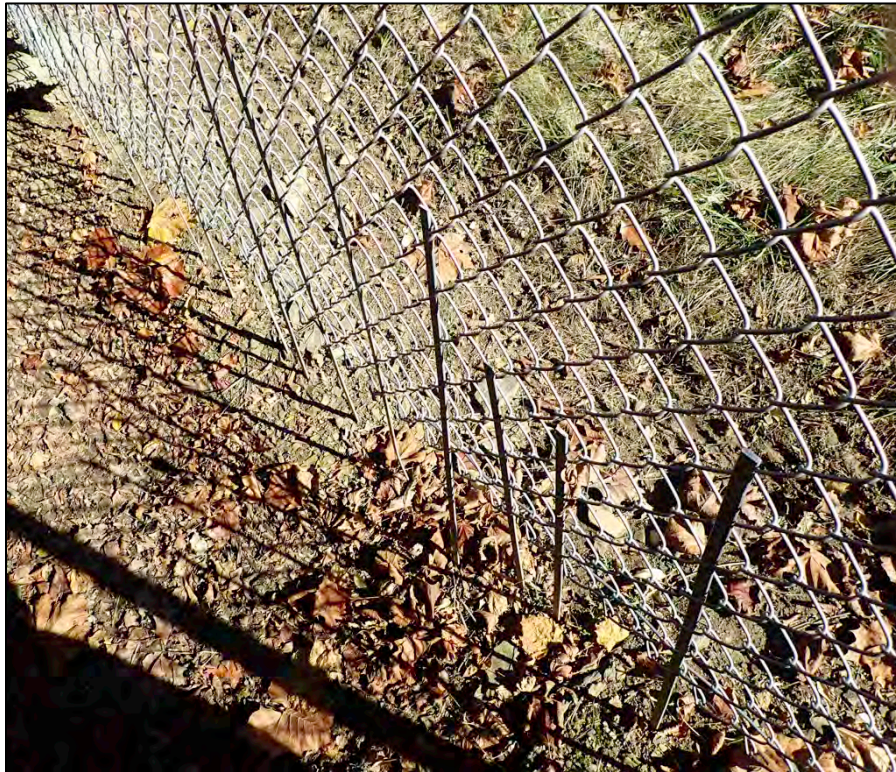
*PL-1. Base of Fence near Erosion Area*

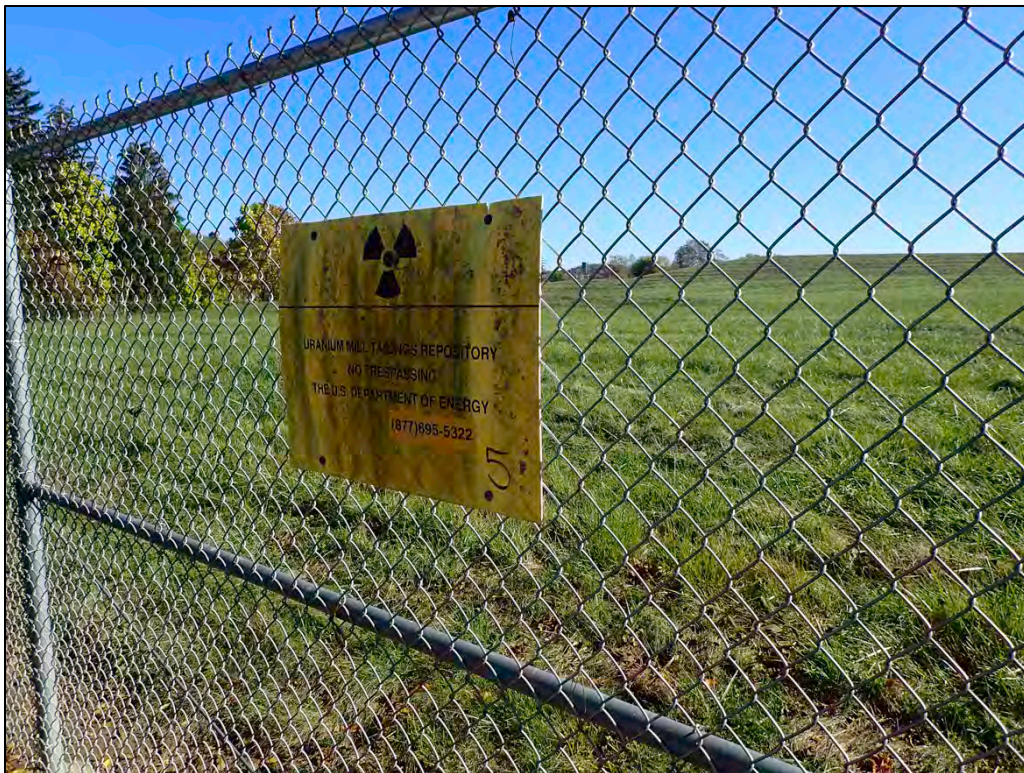
*PL-2. Perimeter Sign P5, Weathered but Still Legible*

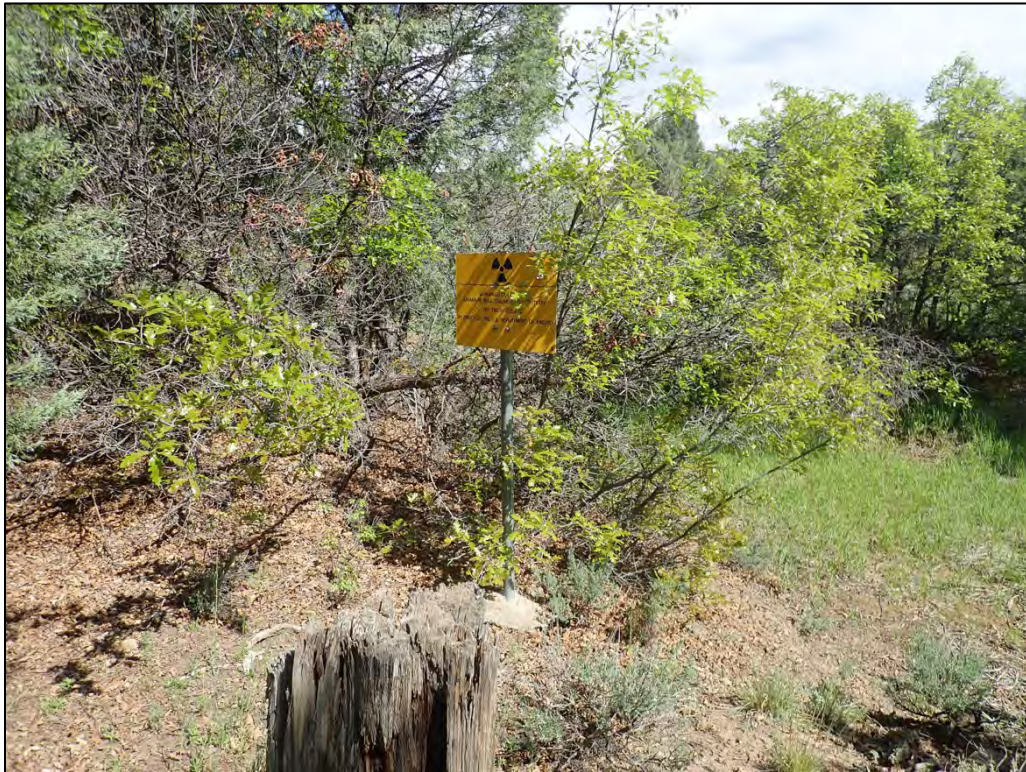
Inspectors noted that perimeter sign P5 (PL-1) was obscured by overgrown vegetation and was treated following the inspection. The concrete bases of several perimeter signs that continue to be undercut include perimeter signs P6, P8, P19, P25, P27, P28, P29, and P56 (PL-2). The undercutting at perimeter signs P57 and P58 was advanced enough that the signs were repaired following the inspection. Several perimeter signs, P17, P27, P34, P71, P74, P76, P79, P80, and P82, have bullet holes but are still legible. The sign number on perimeter sign P77 was faded but legible. No other maintenance needs were identified.

*PL-1. Heavy Vegetation Around Perimeter Sign P5*

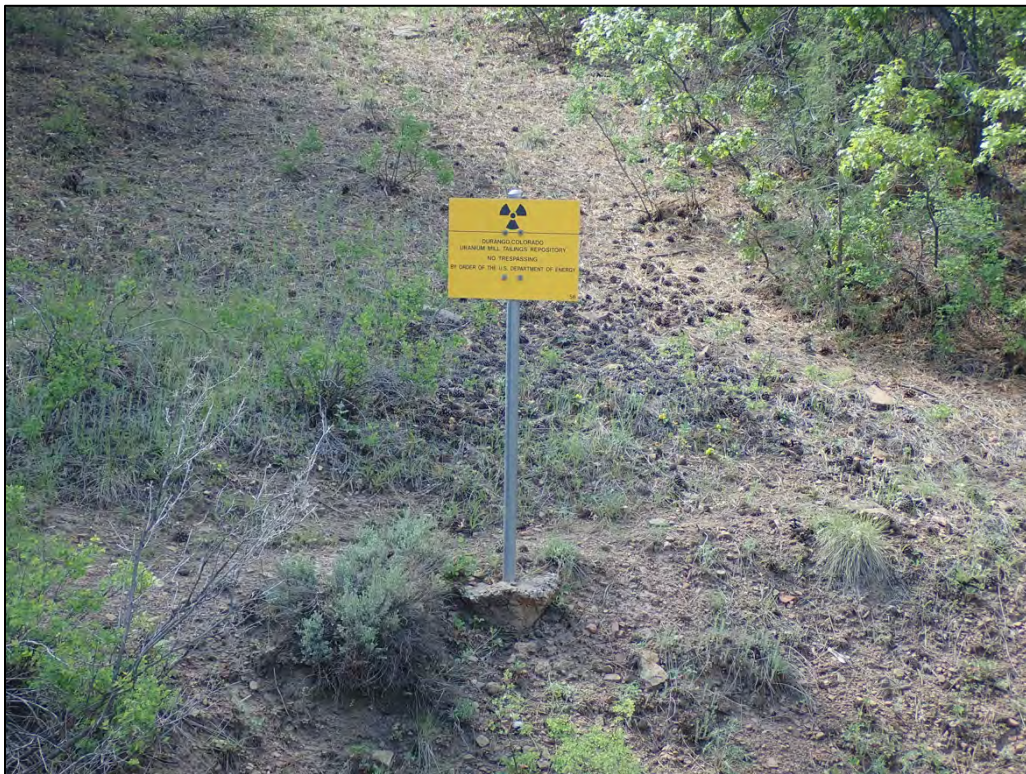
*PL-2. Undercutting Around Base of Perimeter Sign P56*

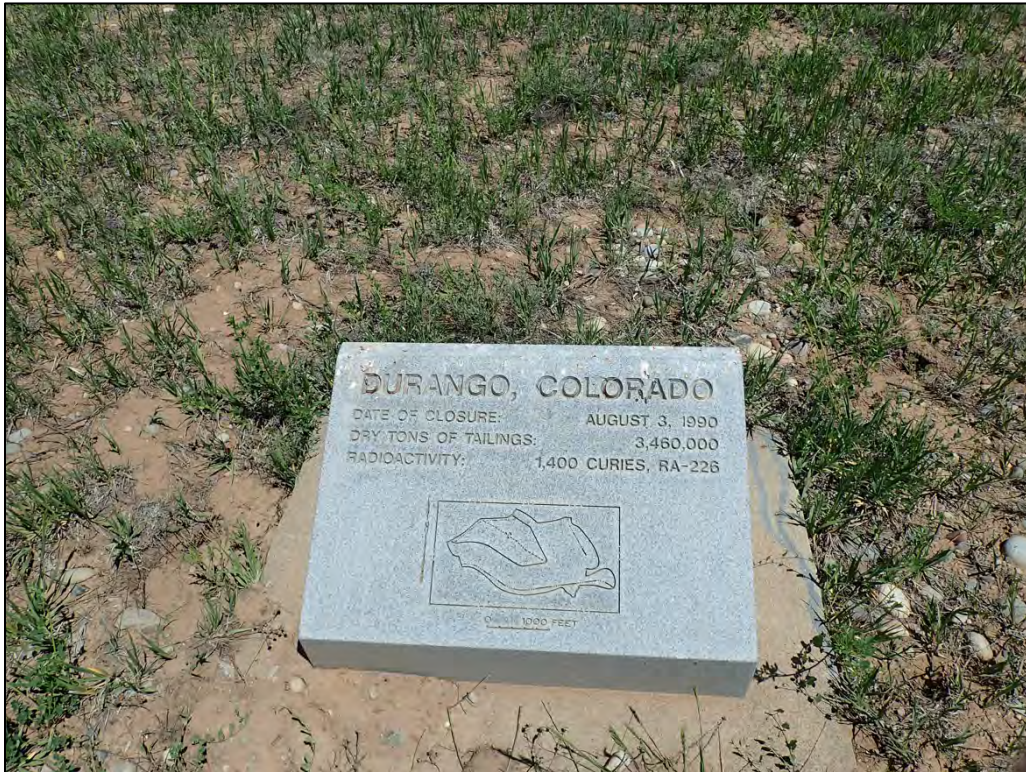
The site has two site markers. Site marker SMK-1 is just inside the original entrance gate and was in good condition. Site marker SMK-2 (PL-3) is on the top slope of the disposal cell and was also in good condition. No maintenance needs were identified.

*PL-3. Site Marker SMK-2*

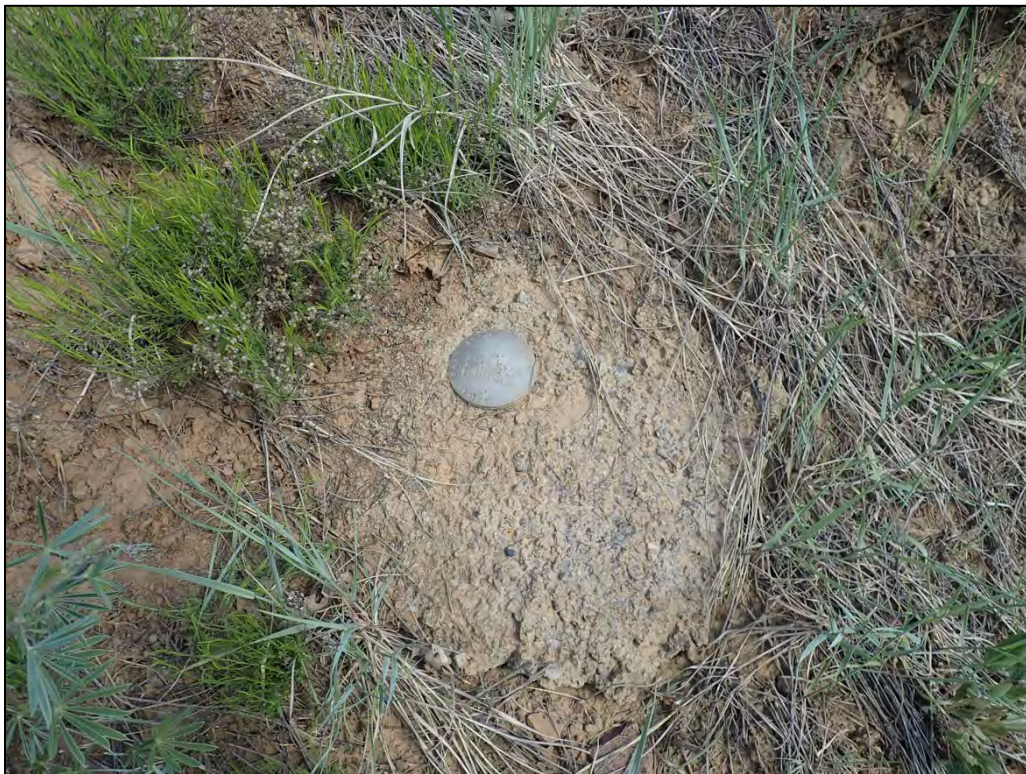
Four survey monuments and six boundary monuments (each with two witness corners) delineate the property boundary. Boundary monument BM-6 was listed as missing in previous inspection reports but was observed intact and in place during the 2023 inspection, along with both adjacent witness corners. Boundary monument BM-4 was visible during the 2023 inspection (PL-4). No other maintenance needs were identified.

*PL-4. Boundary Monument BM-4*

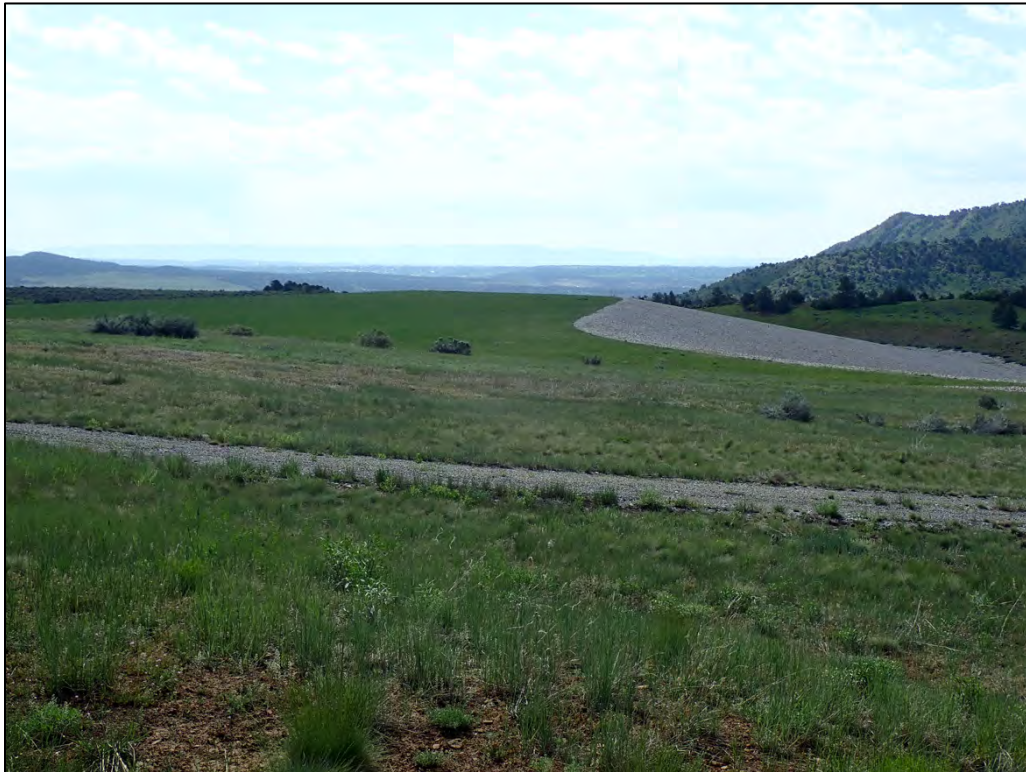
The disposal cell, completed in 1990, occupies 60 acres (PL-5). It has a vegetated cover consisting primarily of perennial grasses and broadleaf plants. There was no evidence of erosion, settling, slumping, or other modifying processes on top of the disposal cell. Inspectors observed several small animal burrows on the disposal cell top slope near site marker SMK-2. The burrows will be monitored but do not require mitigation at this time. No maintenance needs on the disposal cell top slope were identified.

*PL-5. Disposal Cell Top Slope*

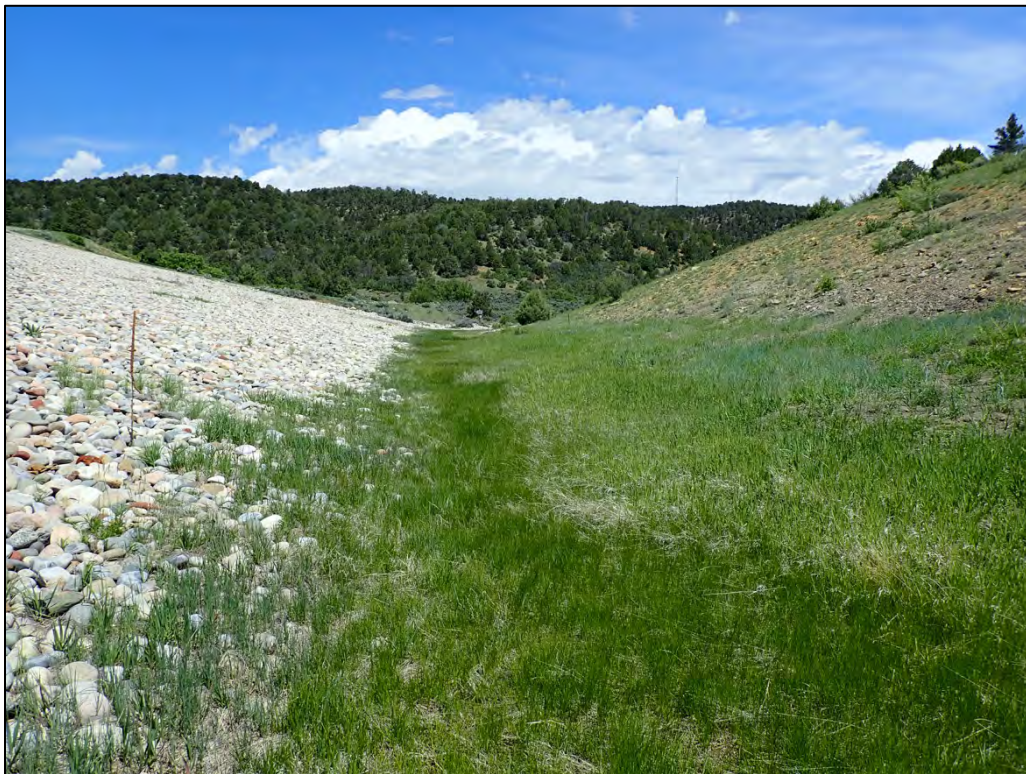
*PL-6. Grass in Drainage Channel near Perimeter Sign P83*

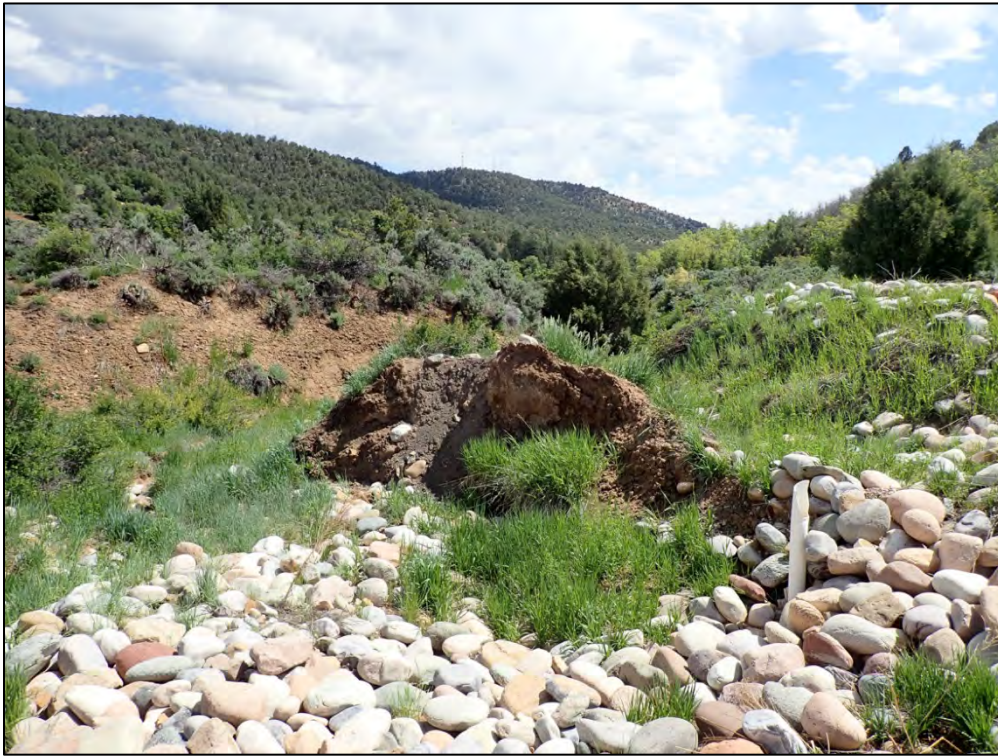
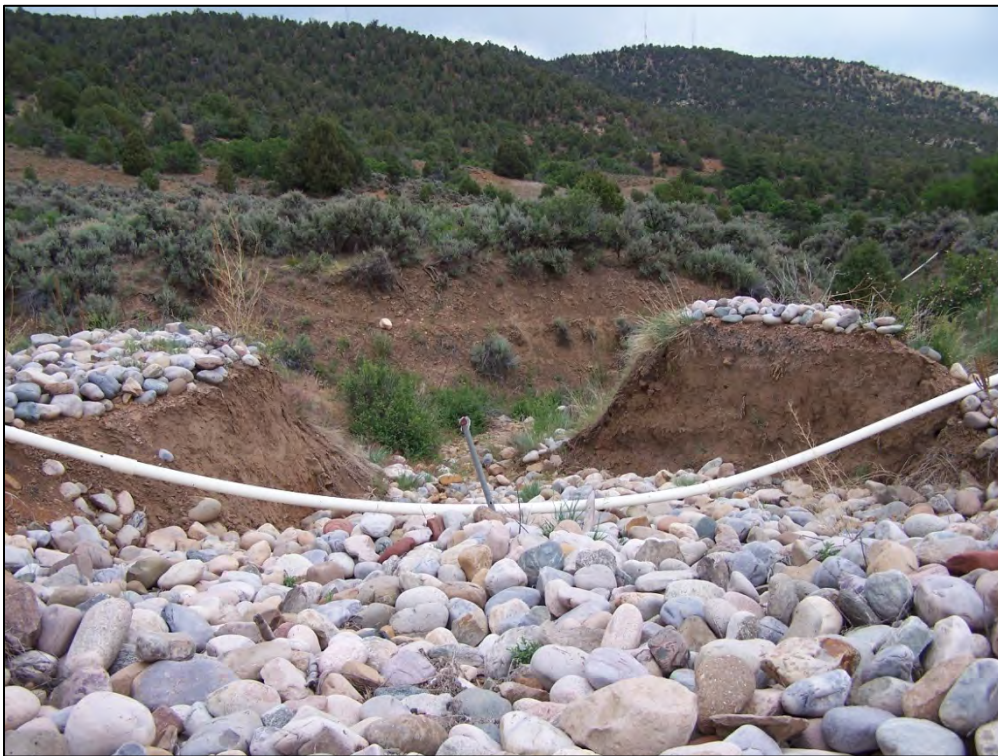
The riprap-covered outflows of the drainage ditches were designed to self-armor over time. The outflows and drainage channels below them are monitored annually. Inspectors observed increased vegetation growth along the east drainage channel (PL-6). A large boxelder tree is growing along the edge of the south outflow channel but does not affect the stability or effectiveness of the channel. A large arroyo has formed below the southeast outflow, which indicates that the drainage ditch is functioning properly. The uplands above the northeast outflow are steadily eroding (PL-7[a] and PL-7[b]), but this is not affecting the stability or effectiveness of the outflow area. No maintenance needs were identified.

*PL-7a. Northeast Outflow Looking Away from Disposal Cell near Well 0618—2023*

*PL-7b. Northeast Outflow Looking Away from Disposal Cell near Well 0618—2006 Photo for Comparison*

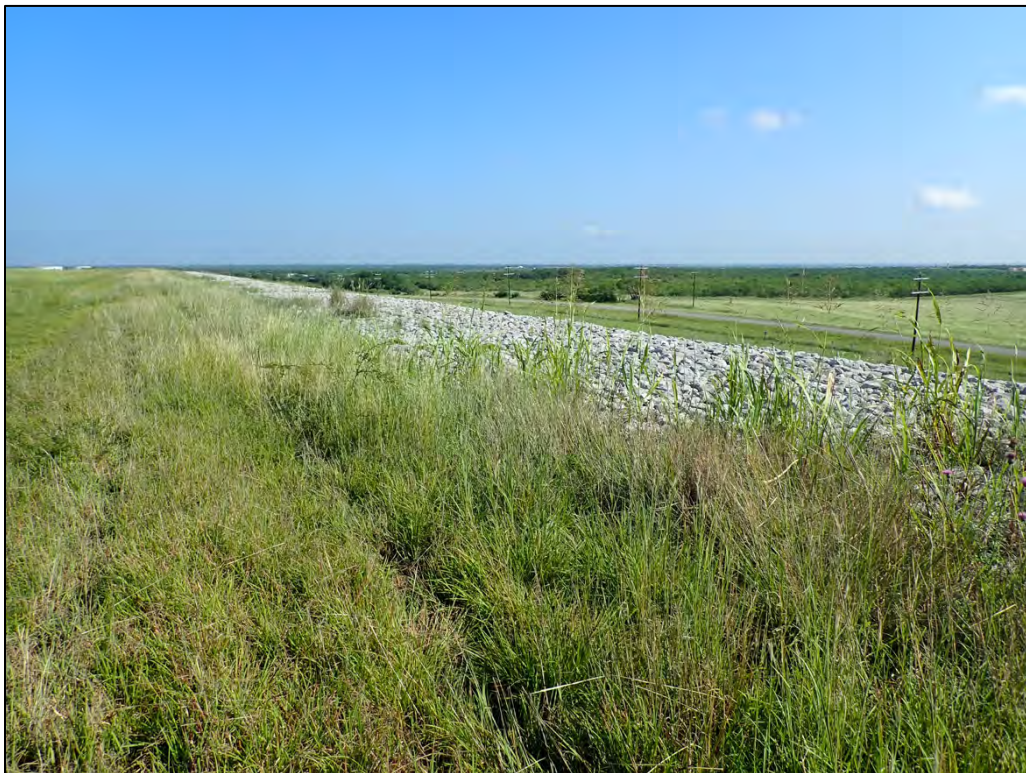
*PL-8. Tall Grass Overgrown on Slide Slope Transition to Riprap*

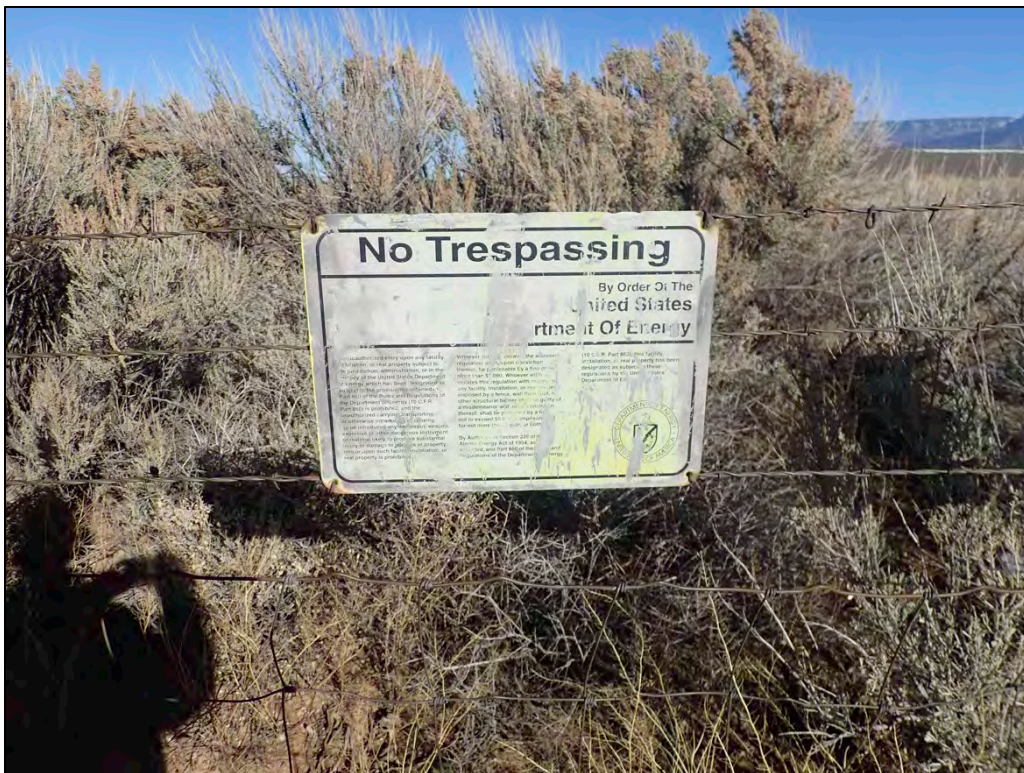
*PL-4. Faded Sign, South Perimeter Fence Line*

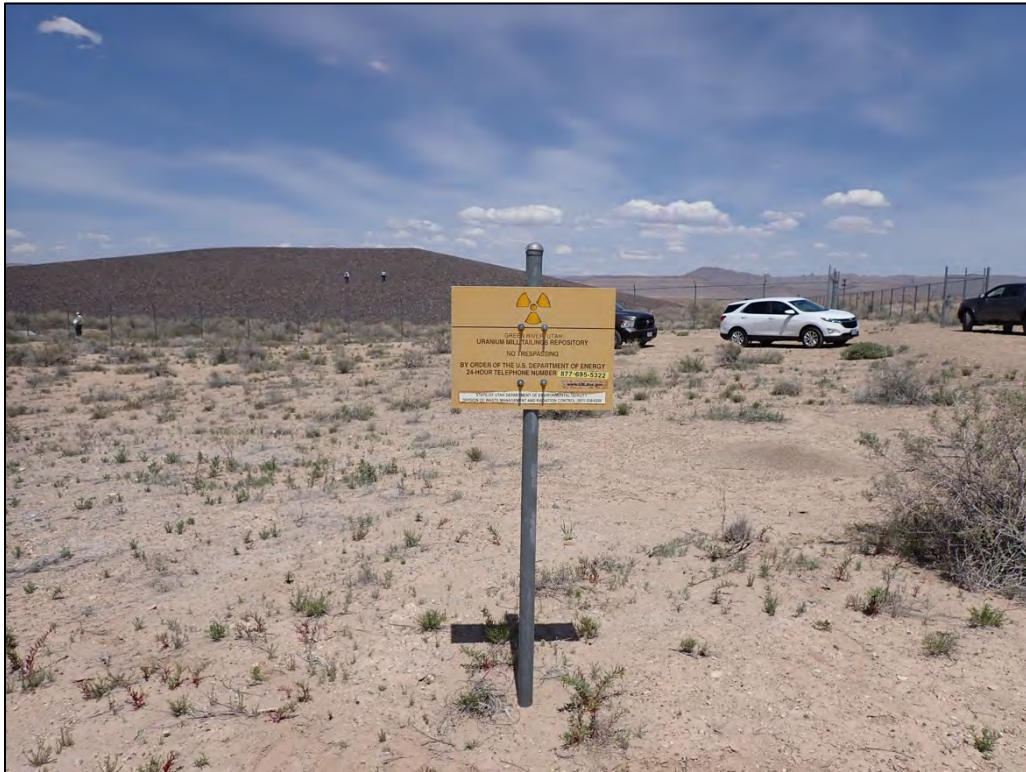
*PL-1. Faded Entrance Sign*

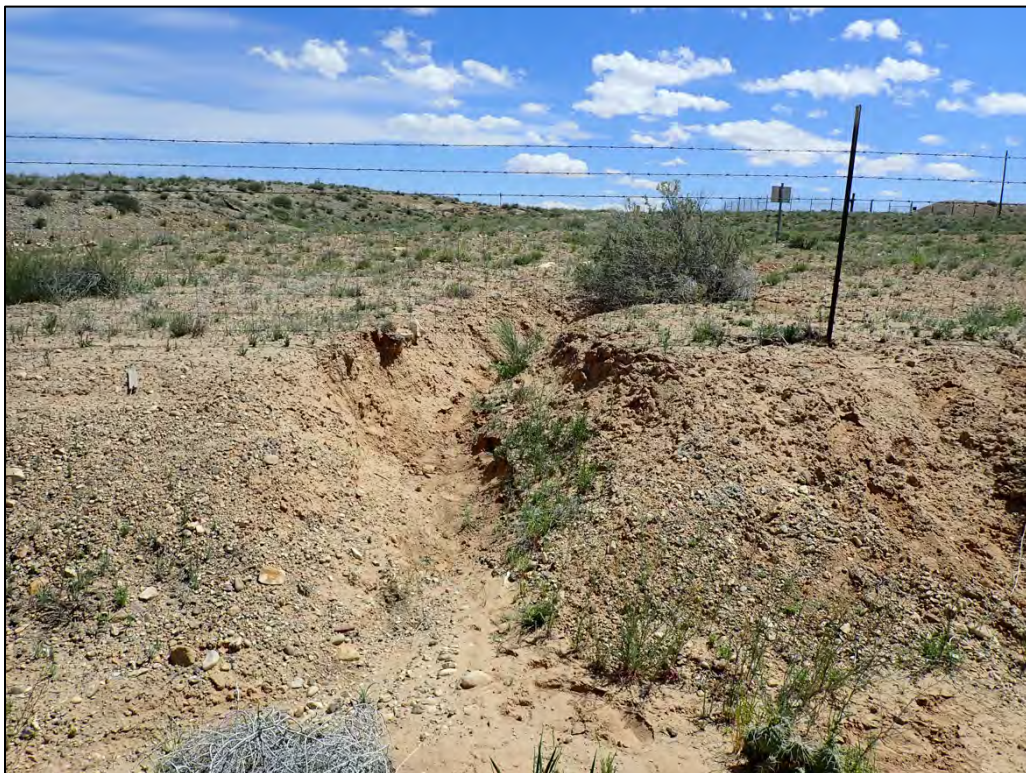
*PL-2. Erosional Rill near Perimeter Sign P16*

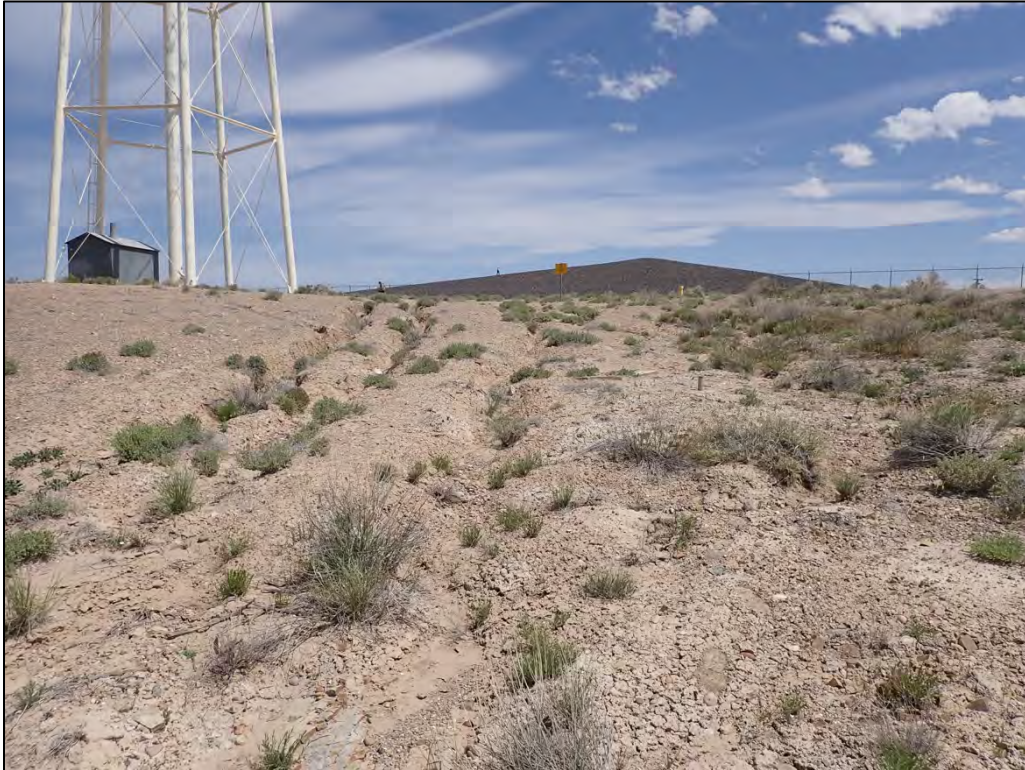
Signs of erosion noted during previous inspections appear in multiple areas in the site perimeter. Erosional rills are present on the west side of the site near perimeter sign P7 and the water tower (PL-7) but are currently not affecting site surveillance features. Rills and gullies are also present along the escarpment northeast of the disposal cell between boundary monument BM-7 and survey monument SM-3 (approximately 400 feet [ft] from the base of the disposal cell). The maximum gully depth in this area is approximately 3 ft, but the erosion appears to be stabilizing as larger rocks drop to the bottom of the gullies and provide armoring. A portion of the stormwater diversion channel along the southeast side of the site continues to erode slowly. These erosional features could eventually damage site surveillance features (i.e., perimeter signs, boundary monuments, and the security fence). The closest erosional features are approximately 300 ft from the disposal cell and do not pose a risk to its integrity at this time. Inspectors will continue to monitor these features. No immediate maintenance needs were identified.

*PL-7. Rills and Erosion near Water Tower*

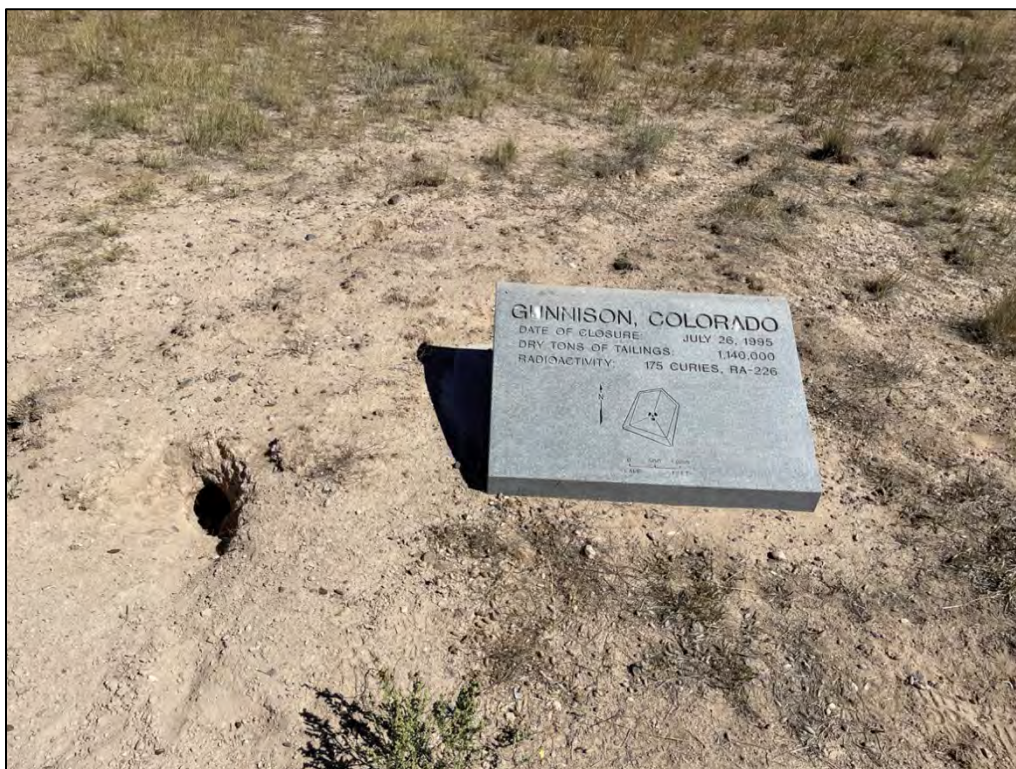
*PL-2. Site Marker SMK-1*

The site has two granite site markers. Site marker SMK-1 (PL-2) is just inside the entrance gate, and site marker SMK-2 is on the top slope of the disposal cell. The concrete base of site marker SMK-2 has cracks lining up with each of the four monument corners but remains stable. No maintenance needs were identified.

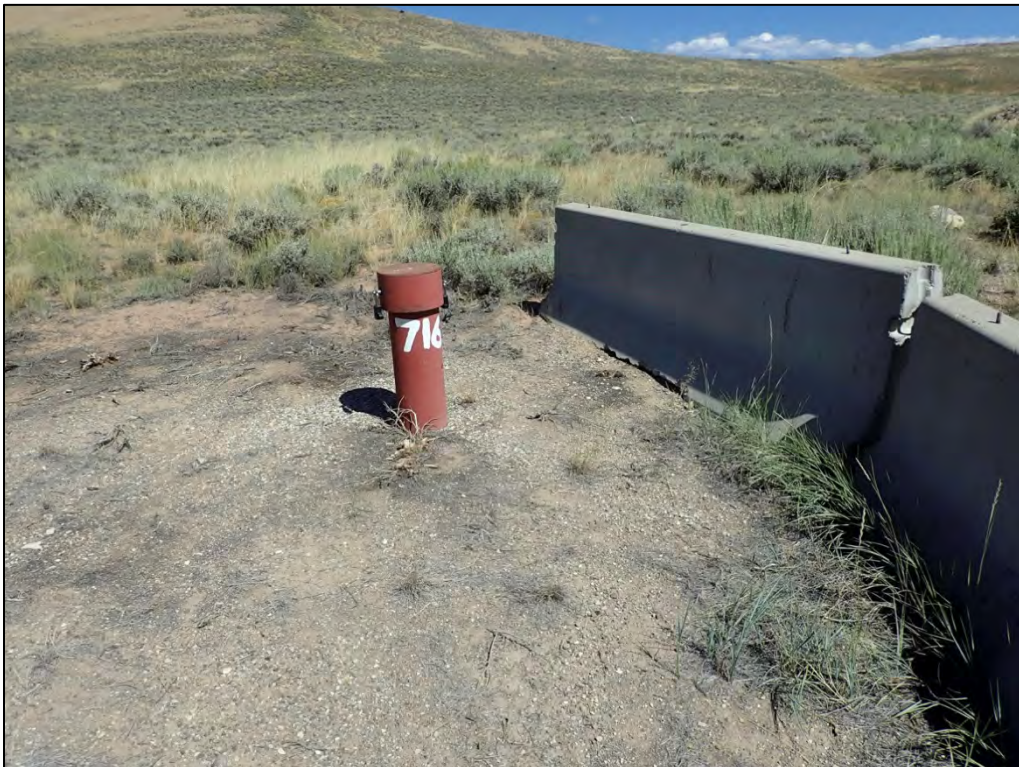
Gunnison County owns the land adjacent to the site boundary to the north and east and uses the land for a municipal landfill. The nearest landfill operations continue to be approximately 400 feet north of the property boundary. Although landfill activities do not affect the site, inspectors will continue to monitor the level of activity occurring near the site boundary and surveillance features (e.g., fences and monitoring wells). There is a spoil pile near monitoring well 0716 (Figure 8-1) that inspectors will continue to monitor. No maintenance needs were identified.

*PL-4. Monitoring Well 0716 with Concrete Barriers*

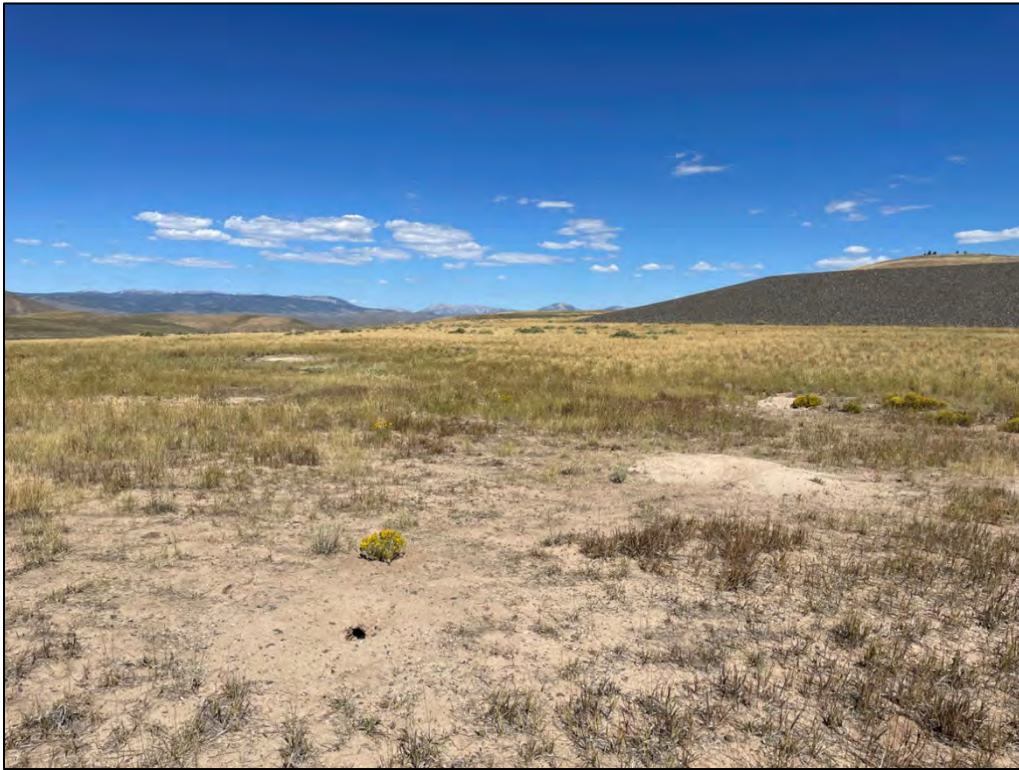
*PL-7. Prairie Dog Colony Area*
