# 2023 Annual Site Inspection and Monitoring Report for Uranium Mill Tailings Radiation Control Act Title I Disposal Sites

March 2024

Legacy  
Management

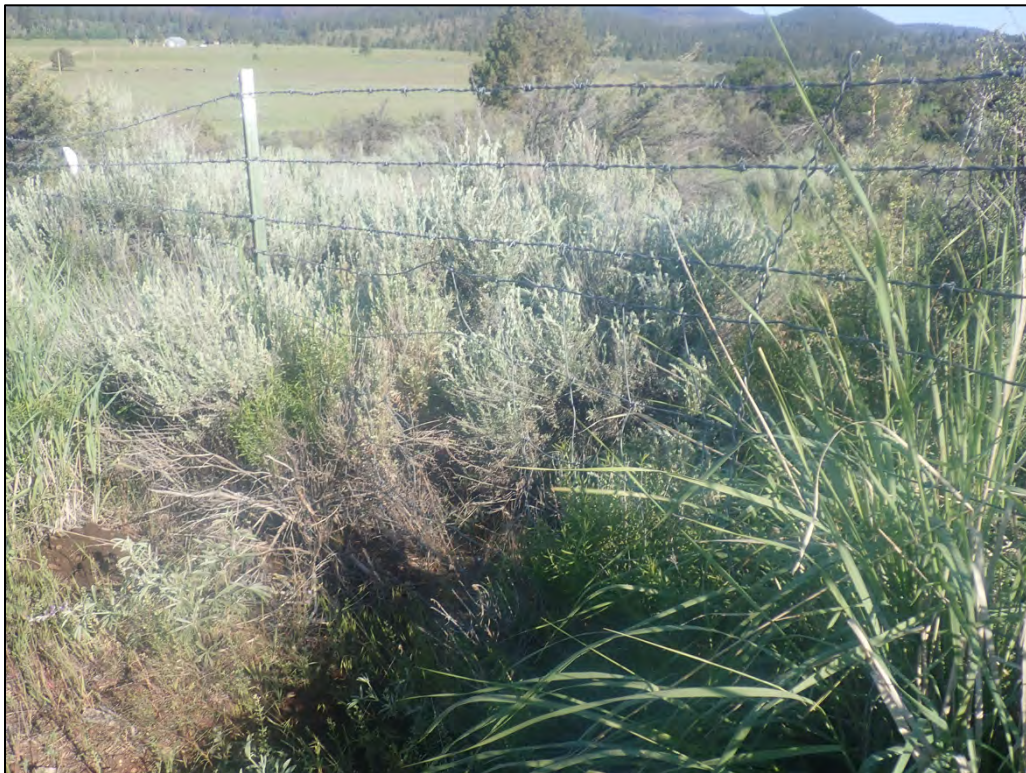
*PL-2. Hole in Sheep Fence*

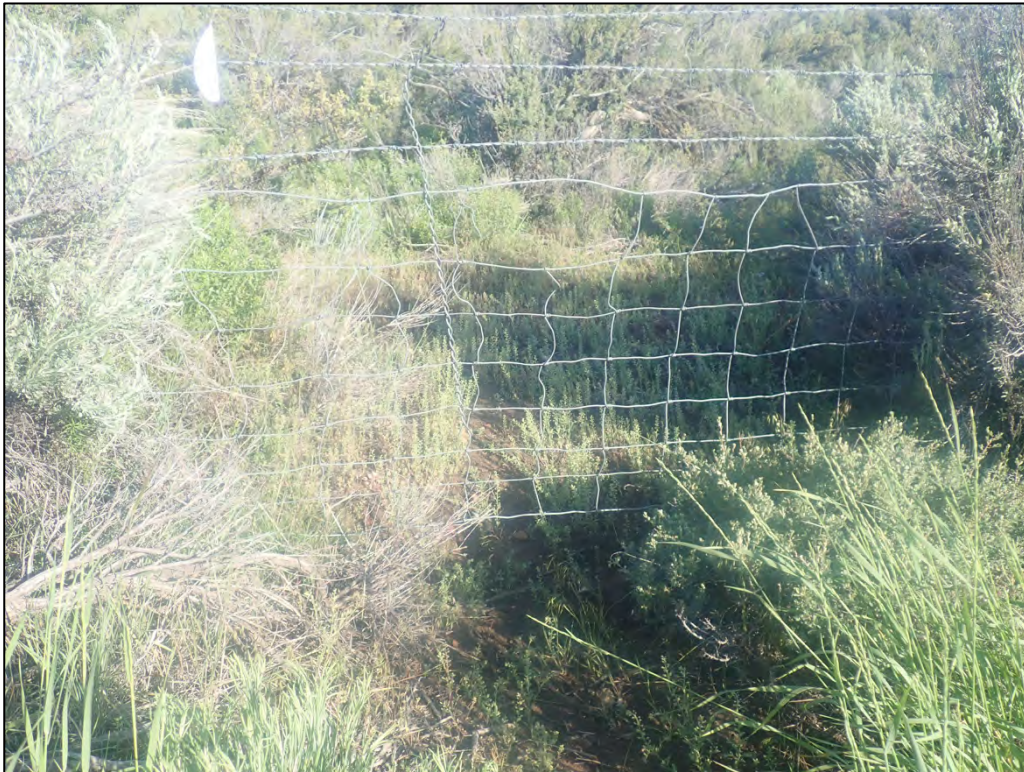
*PL-3. Animal Burrow Under Fence*

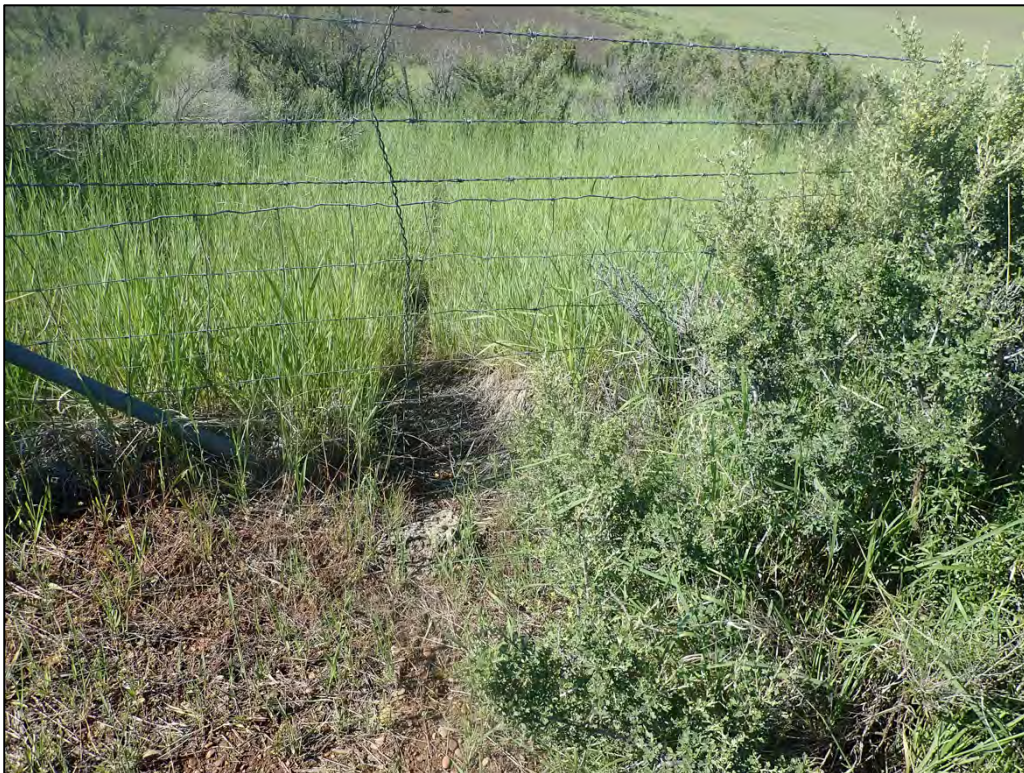
A four-strand barbed-wire perimeter fence (five-strand along much of the western boundary) encloses the site. Sheep fencing is on the southeastern and southern boundaries of the site. Some vegetation is growing near, and entangled in, the perimeter fence line, but the fence appeared stable and remains functional. A bent fence post observed during the 2021 inspection near the southeast corner of the site will be repaired in the future. An empty post was found near the south fence that will be removed in the future. A small hole in the sheep fence was observed in the southern fence line (PL-2). The hole appears to be man-made, possibly to help small animals escape through the fence. Evidence of minor erosion from animals digging under the fence was identified near the southeast corner of the fence line during the 2022 inspection (PL-3) and several new locations along the northern fence line were identified during the 2023 inspection (PL-4), but this is not a concern to the site security or the integrity of the fence.

*PL-4. New Animal Burrow*

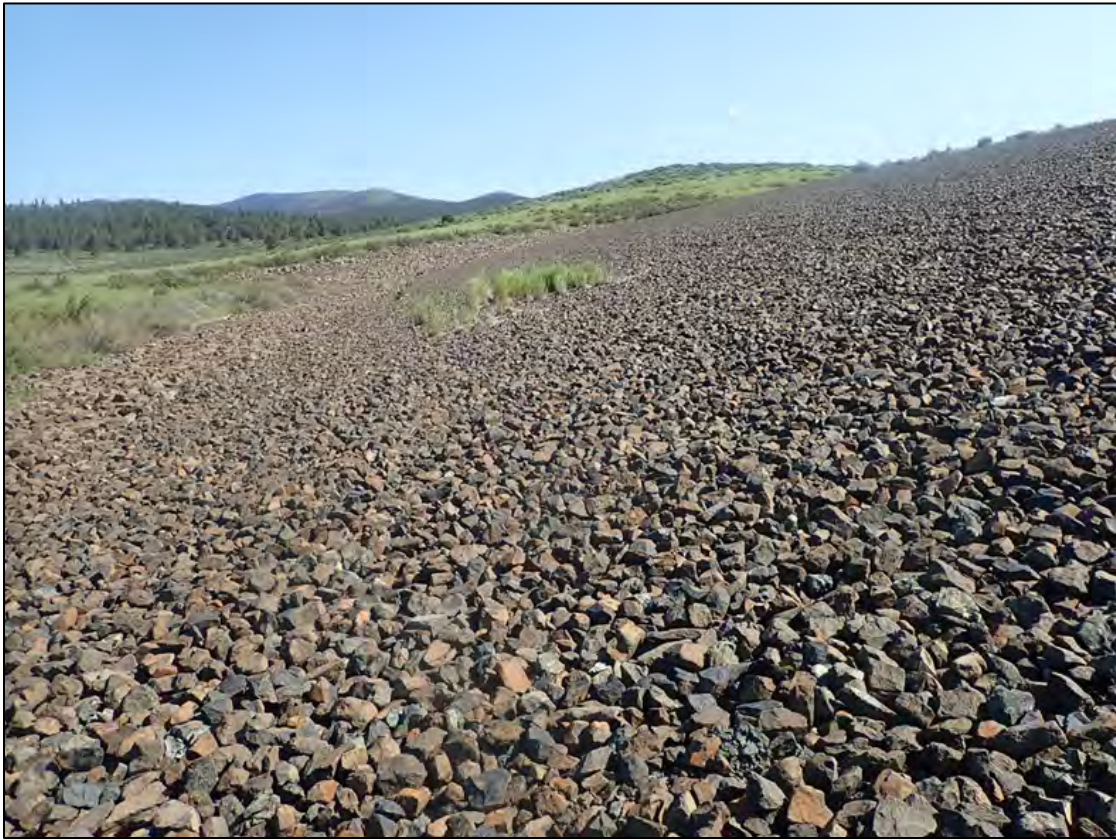
*PL-11. Grass Patch on Riprap Between Water Flux Meters WFM2 and WFM3*

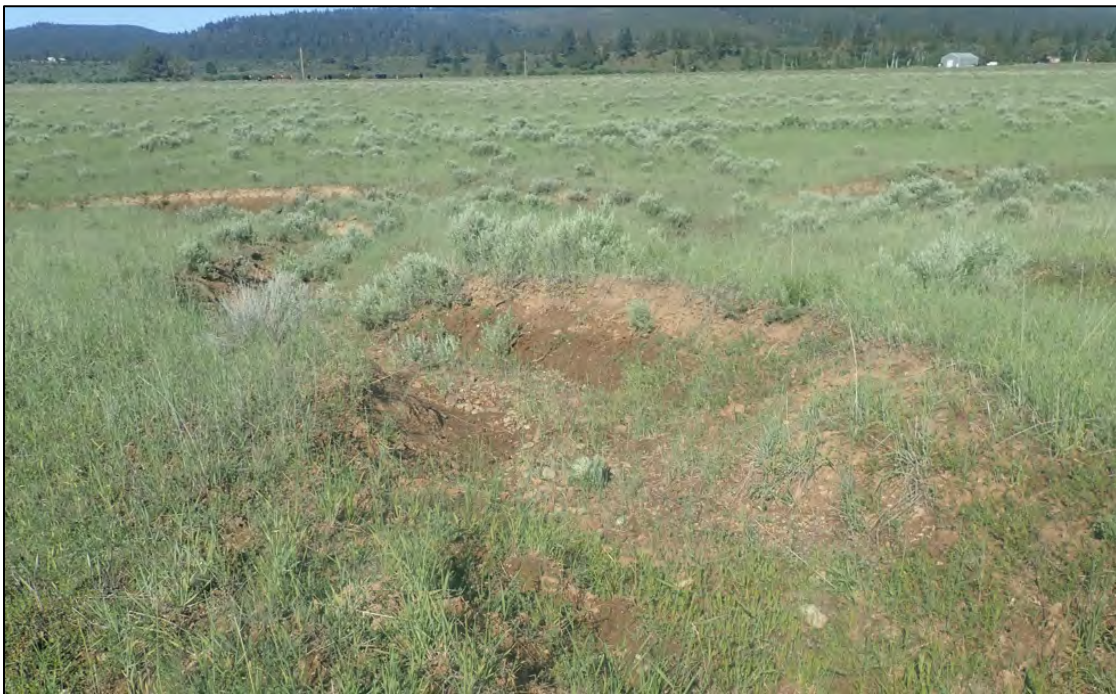
*PL-12. Gully near Monitoring Well 0515*

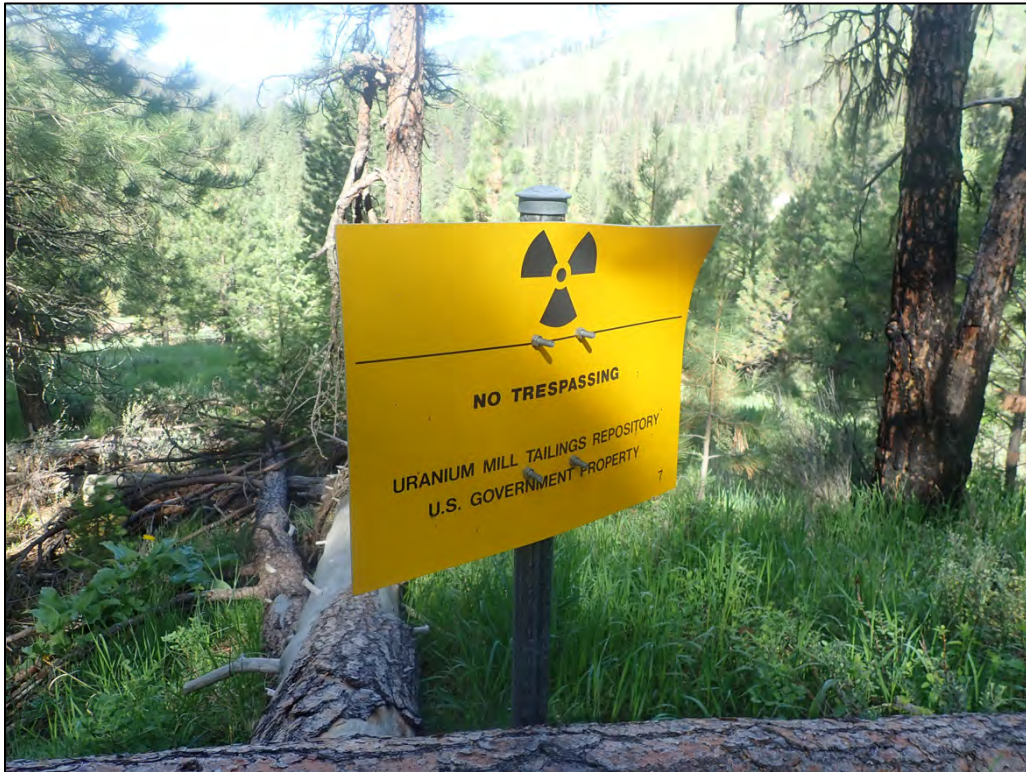
*PL-1. Bent Perimeter Sign P7*

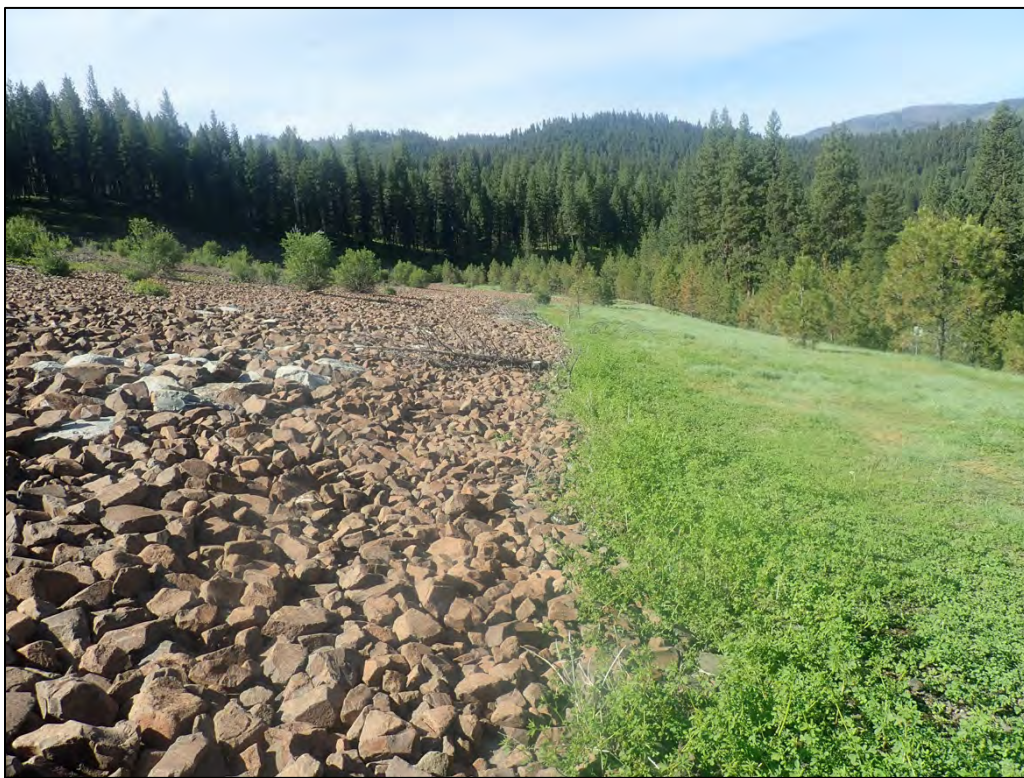
*PL-4. Disposal Cell Apron*

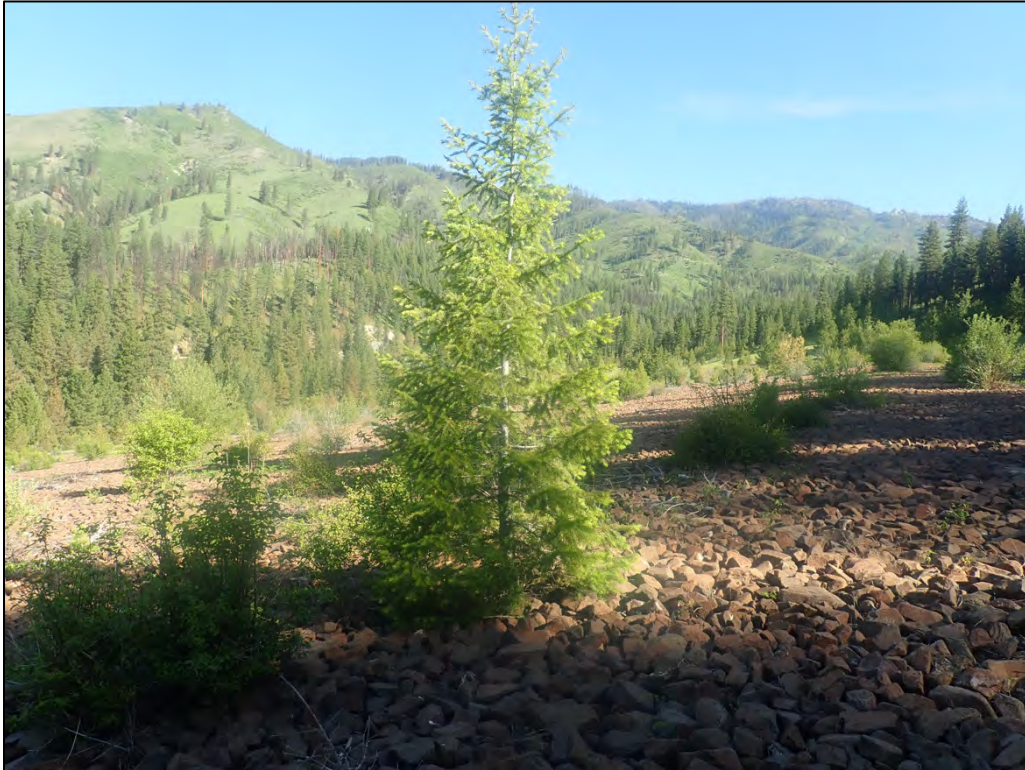
Natural vegetation continues to encroach on the top and side slopes of the disposal cell. Although the LTSP states that control of vegetation growth on the cell is not needed, LM concluded that controlling the growth of conifers—primarily ponderosa pine, but also Douglas fir—would be a best management practice. Mature conifers could potentially become uprooted during windstorms and damage the surface of the disposal cell. Numerous ponderosa pine trees were cut down in 2018. Additional ponderosa pine and Douglas fir trees have established since then and were removed following the inspection (PL-5). Other plants growing on the disposal cell do not threaten the integrity of the disposal cell and are not controlled. Inspectors will continue to monitor this area. No other maintenance needs were identified.

Inspectors noted that treatment of the coniferous ponderosa pine and Douglas fir trees on the disposal cell cover was needed. The trees were treated following the inspection. No other maintenance needs were identified.

*PL-5. Trees on Disposal Cell*

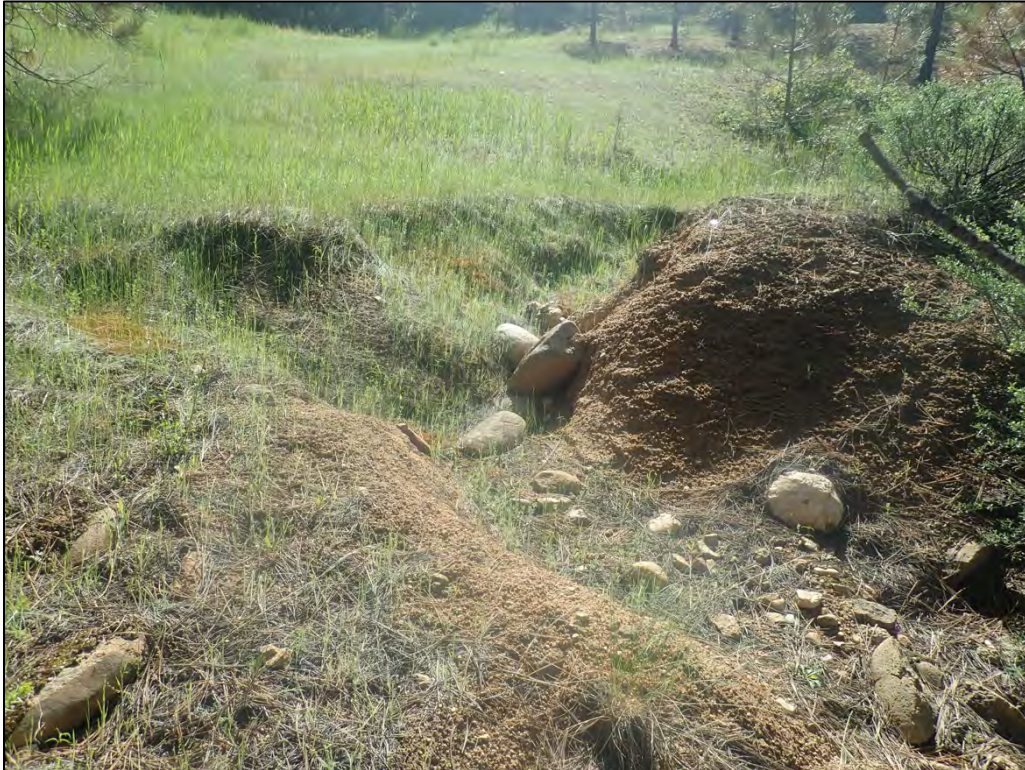
Clear Creek. Over time, minor erosion has breached the benches in several locations, and LM repaired this erosion in 2016. Rock armoring has been very successful in preventing further erosion, and vegetation has become well established. Minor erosion was noted within and around the geocell grid on the north end of the interceptor benches where they are routed into Clear Creek (PL-7). This will continue to be monitored. No maintenance needs were identified.

*PL-7. Erosion on North Side of Interceptor Benches*

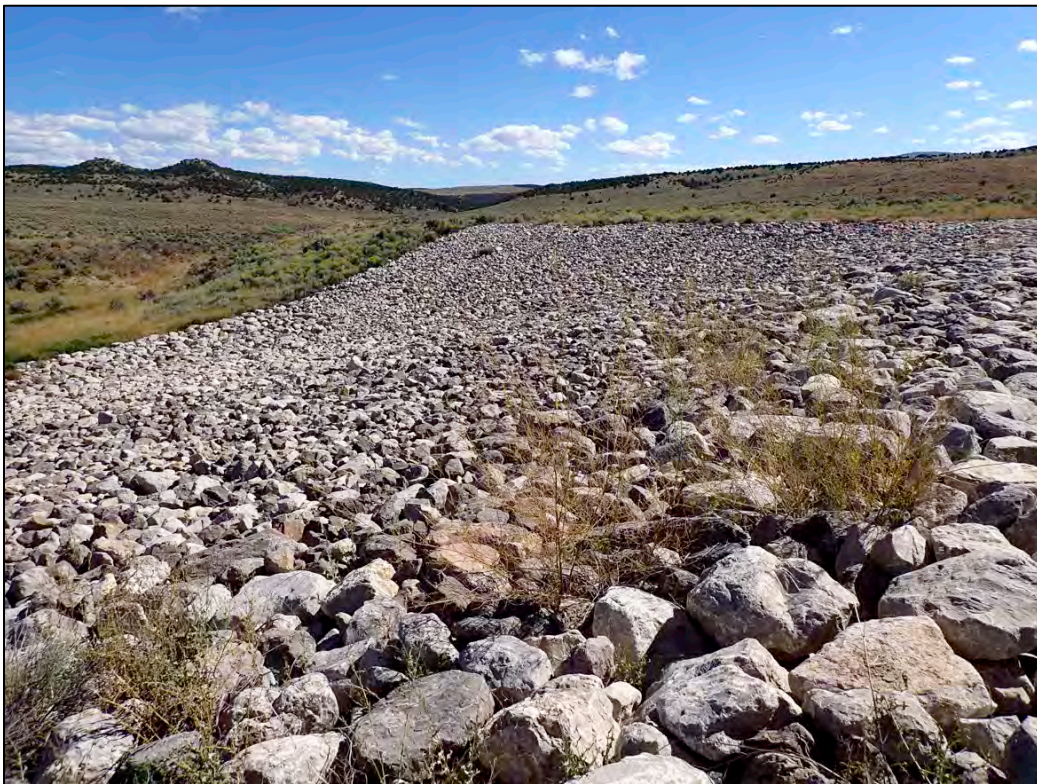
*PL-4. Cobble Blanket and Gully No. 1*

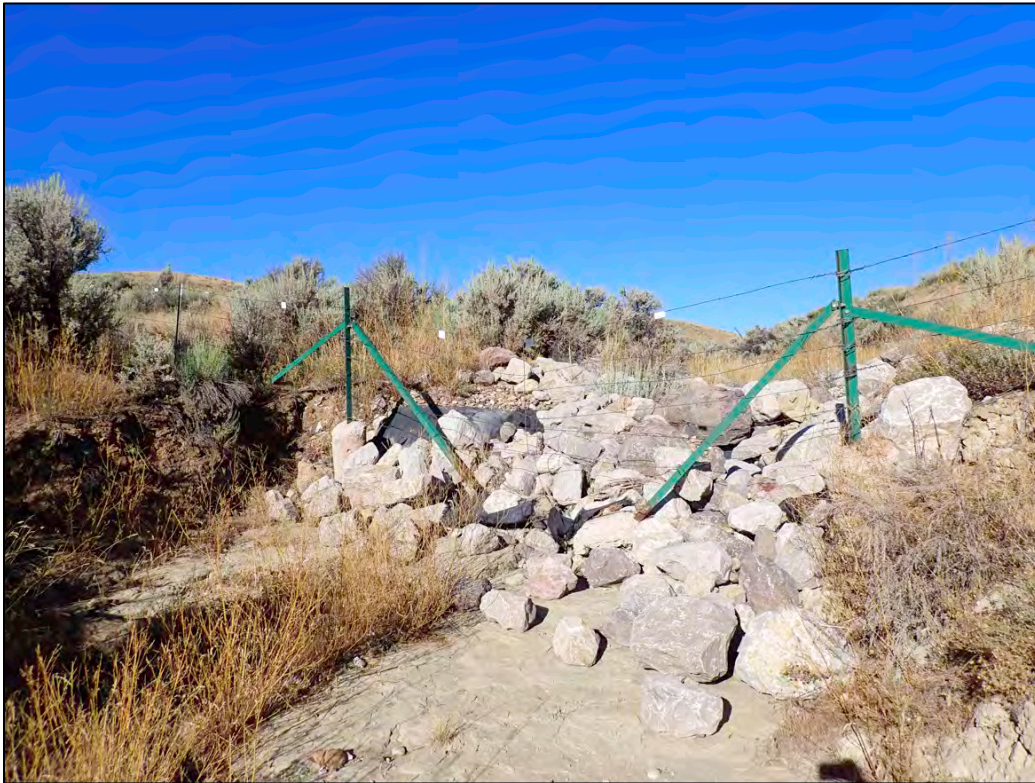
*PL-7. Exposed Geofabric Below Diversion Channel No. 1*

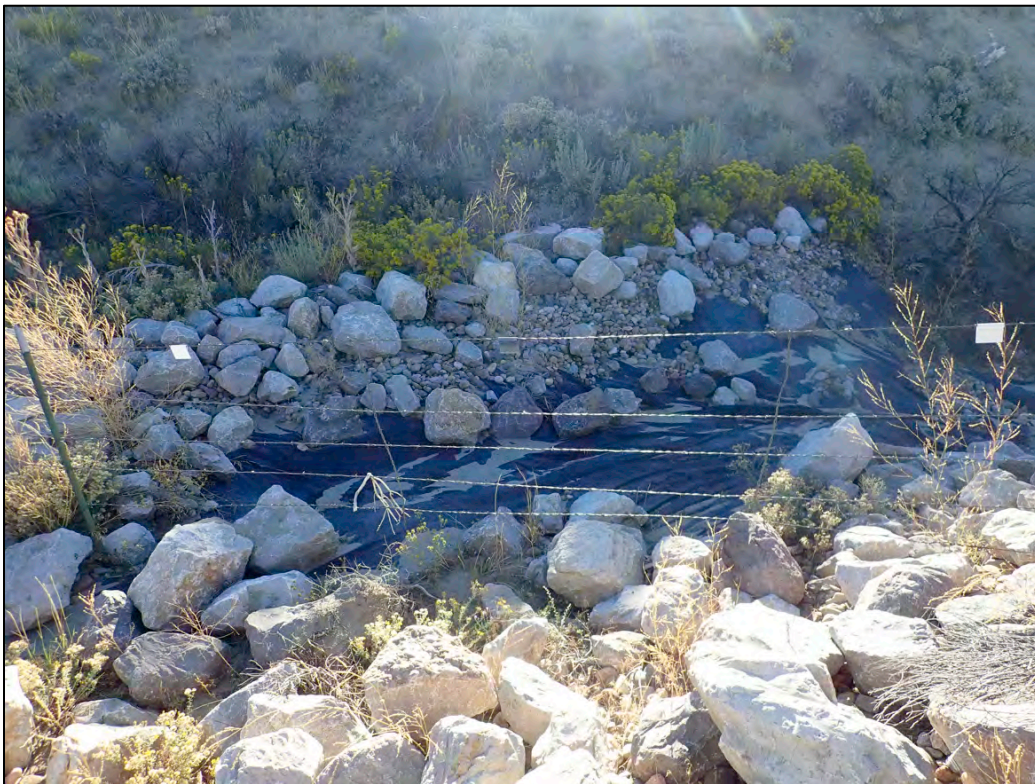
*PL-8. Exposed Geofabric in Outlet of Swale No. 1*

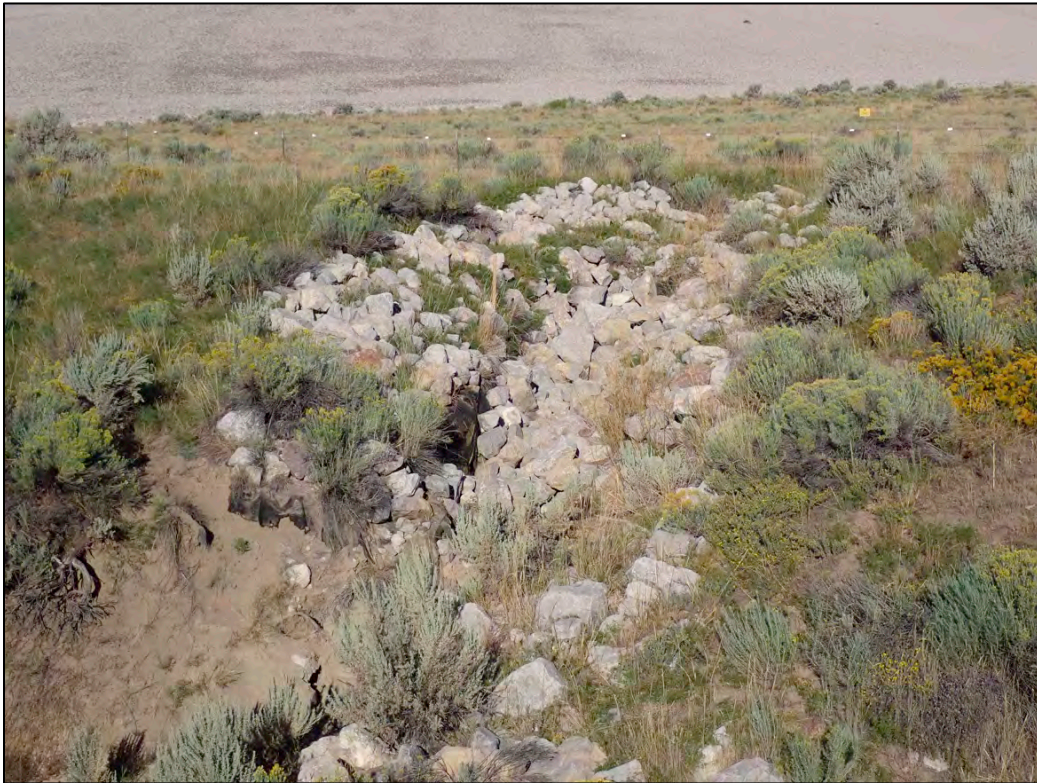
*PL-9. Exposed Geofabric in Swale No. 2*

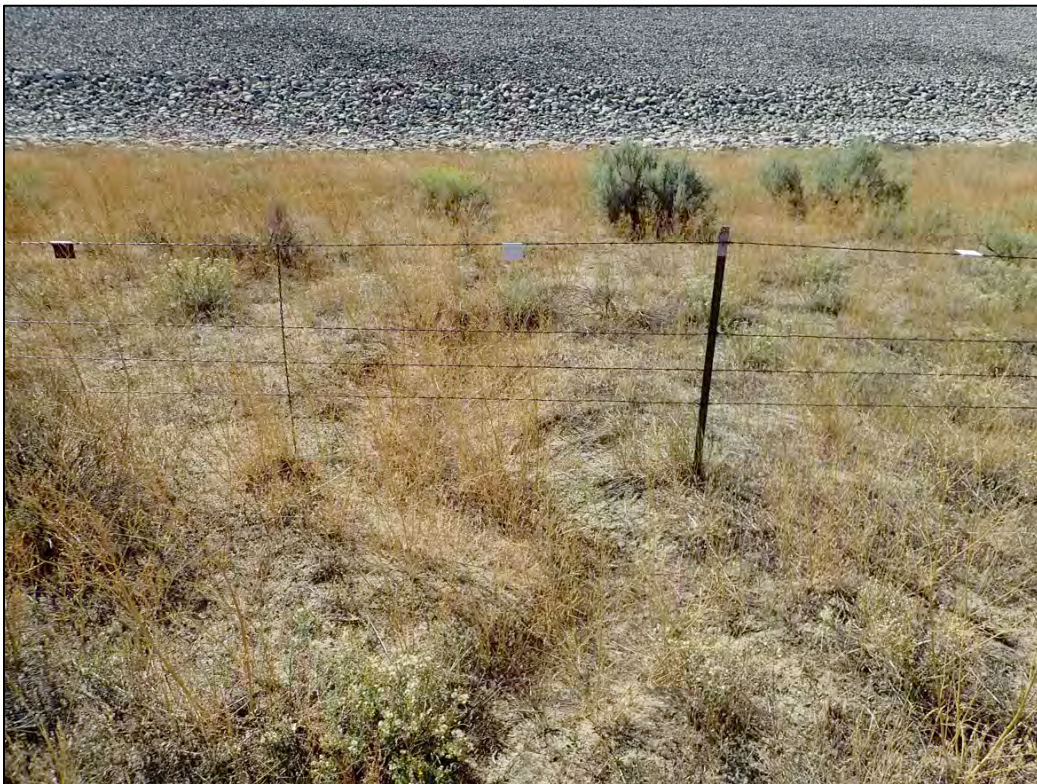
*PL-10. Minor Rilling Under Fence*

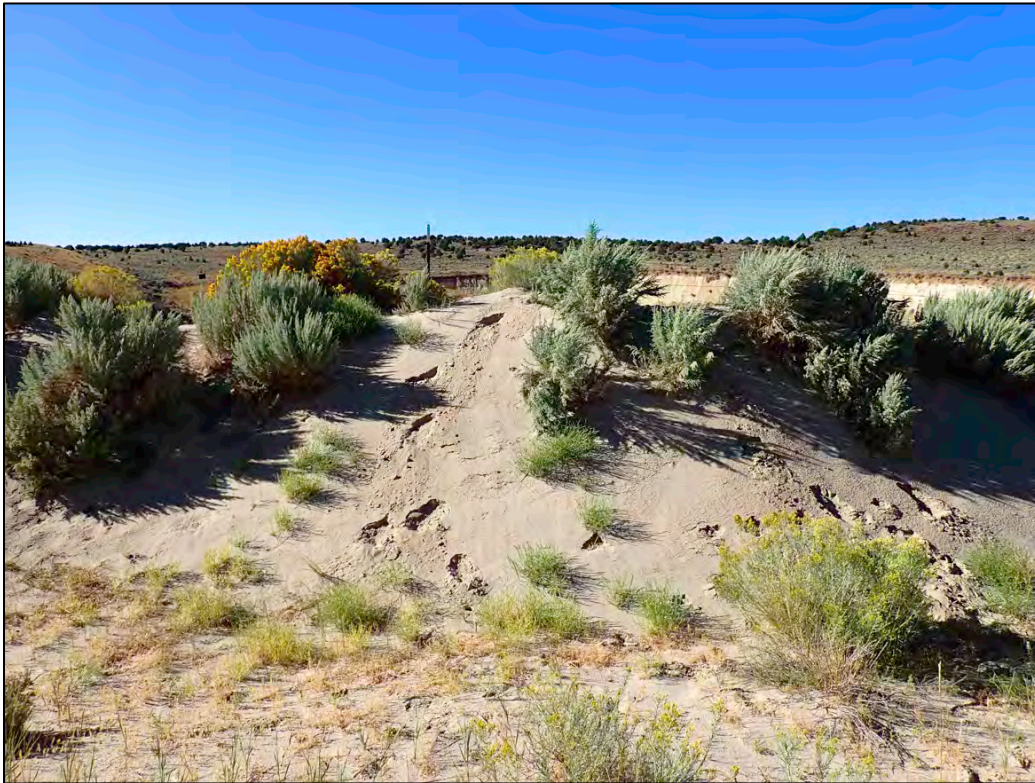
*PL-11. Sand Encroachment near Pit*

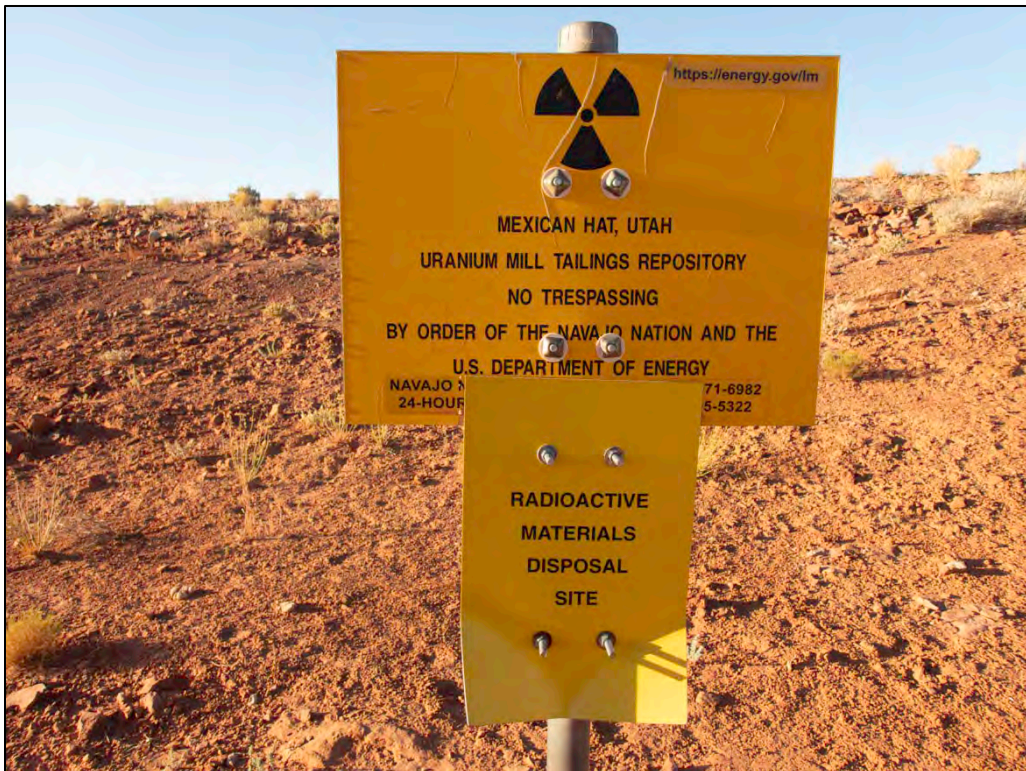
*PL-2. Perimeter Sign P6 with Blocked Numbers*

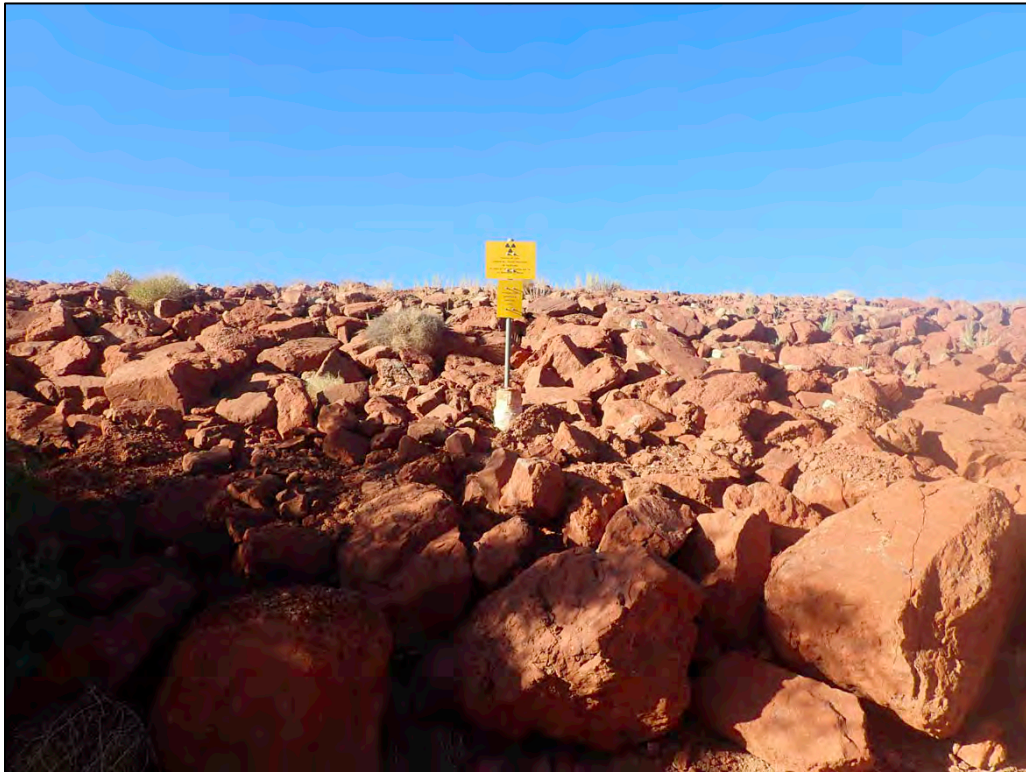
*PL-3. Perimeter Sign P7 with Exposed Base*

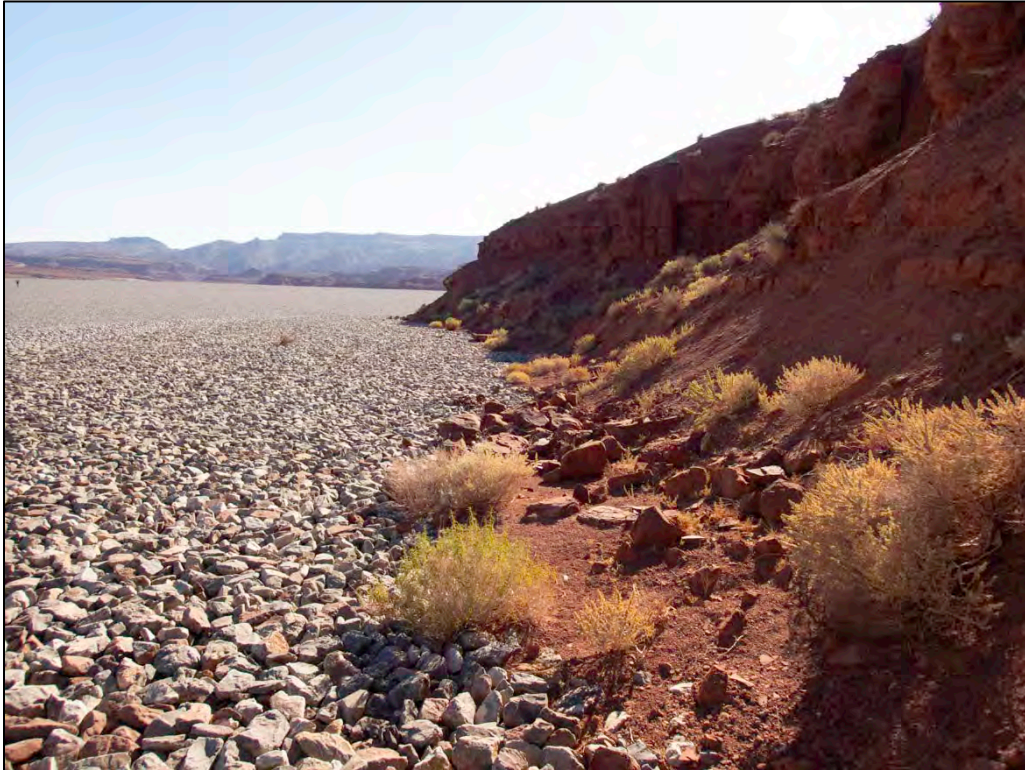
*PL-9. Sloughing Rock Along South Apron*

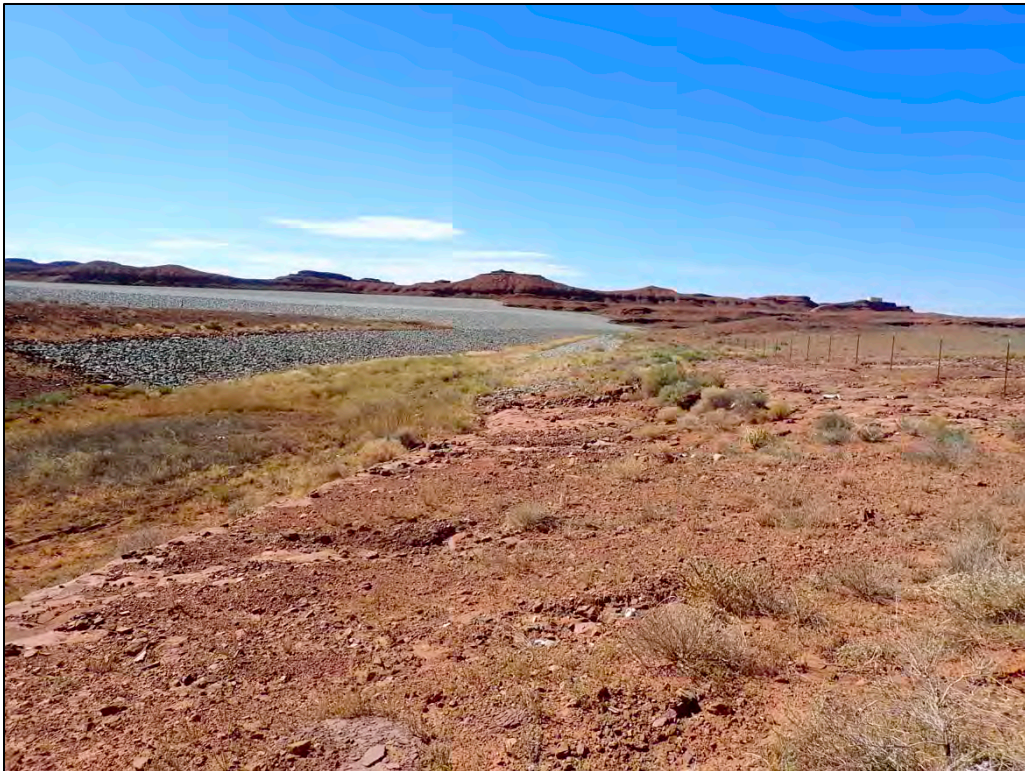
*PL-10. Vegetation in West Diversion Channel*

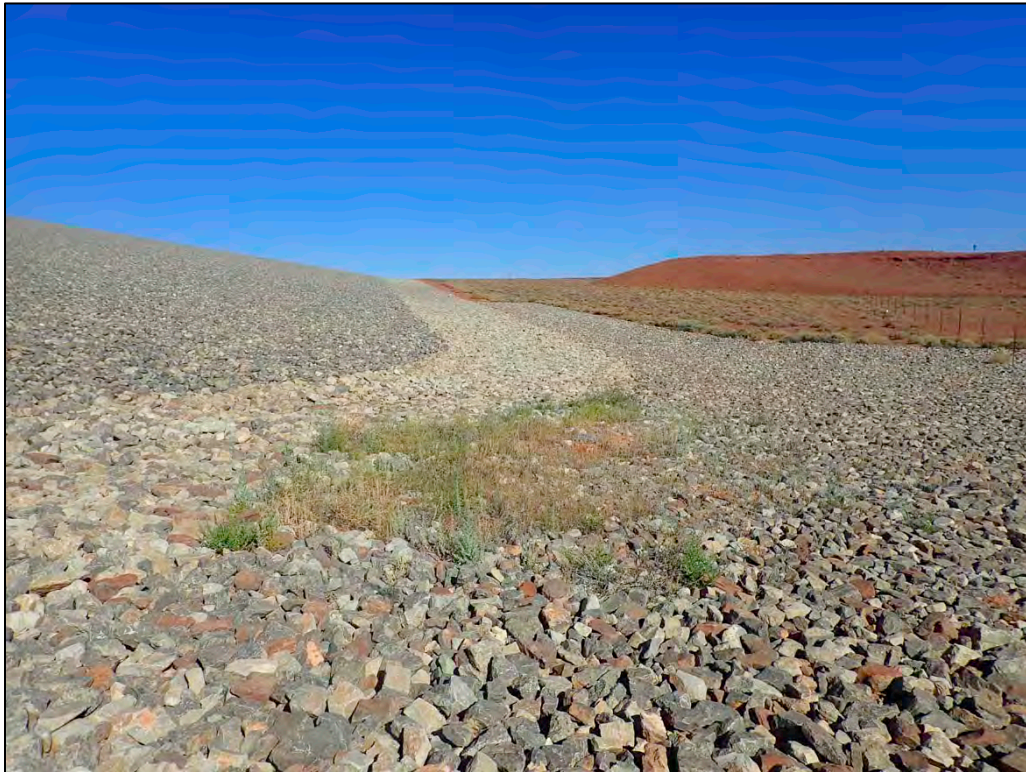
*PL-11. Vegetation in Northeast Toe Drain*

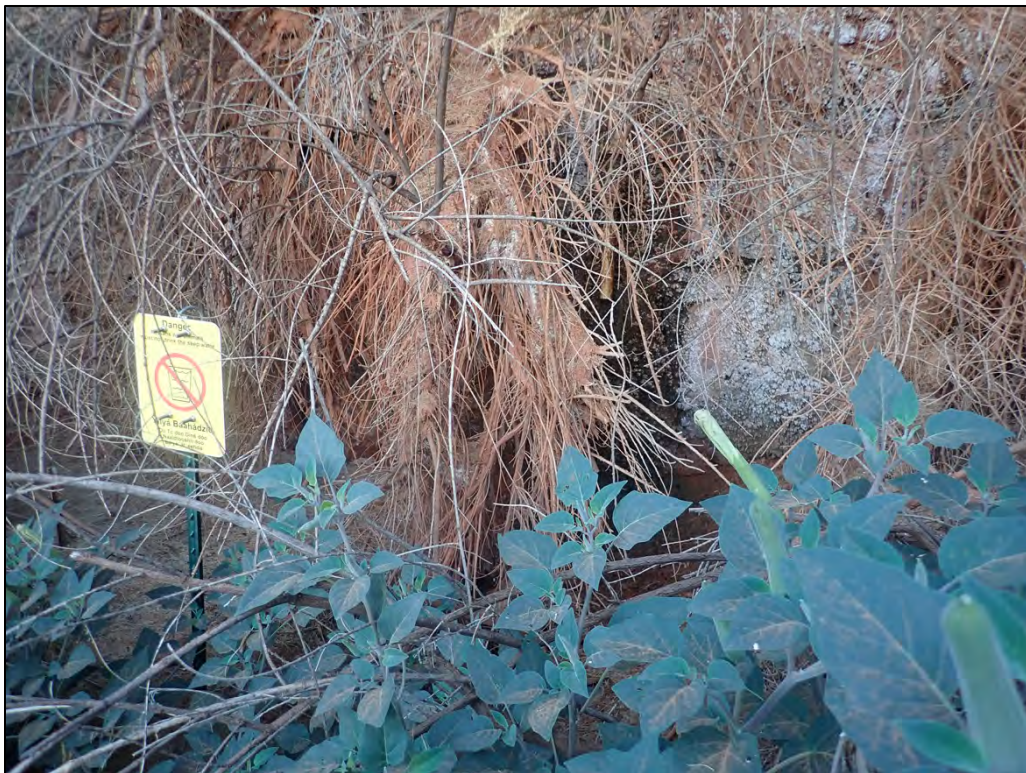
*PL-12. Seep 0248 (Dripping/Wet)*

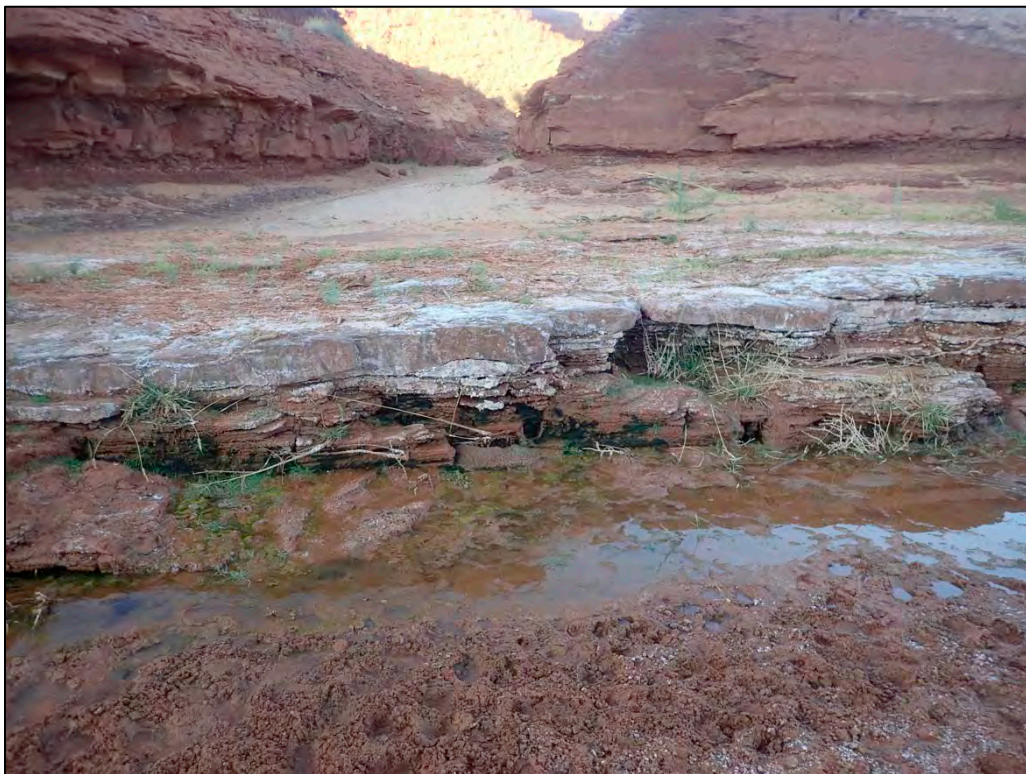
Upgradient (background) seep 0261 (PL-18), approximately 0.5 mile upstream of seep 0248 in Gypsum Creek, was observed to be dripping during the inspection.

*PL-18. Seep 0261 (Background—Dripping/Wet)*

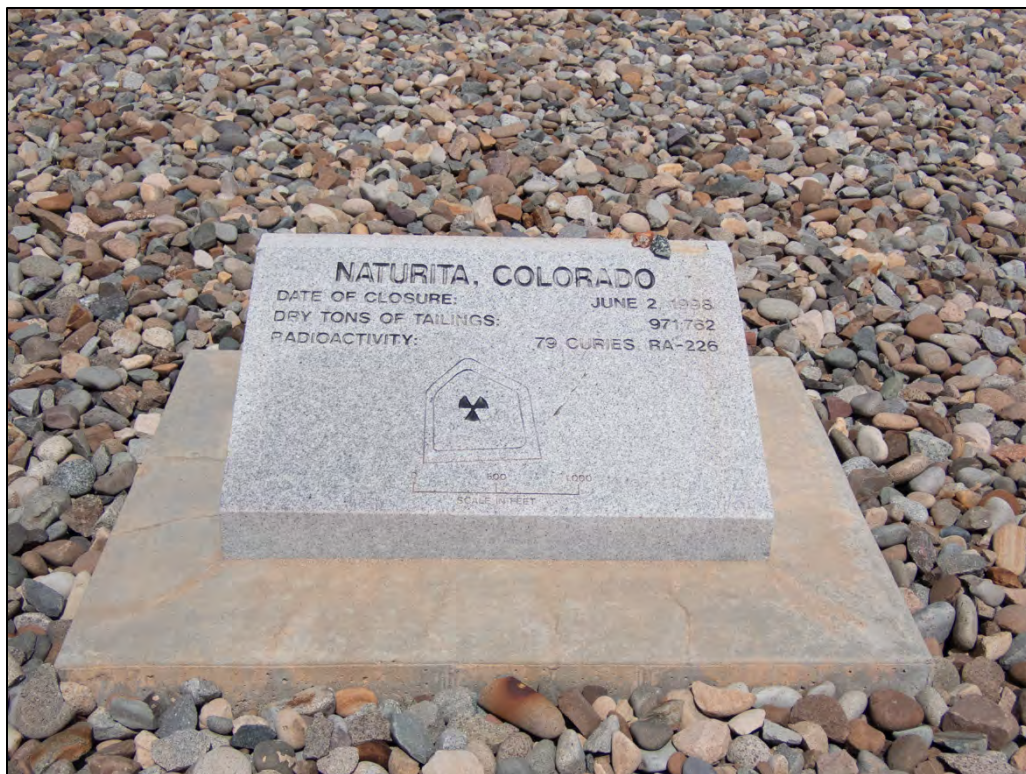
*PL-4. Site Marker SMK-2*

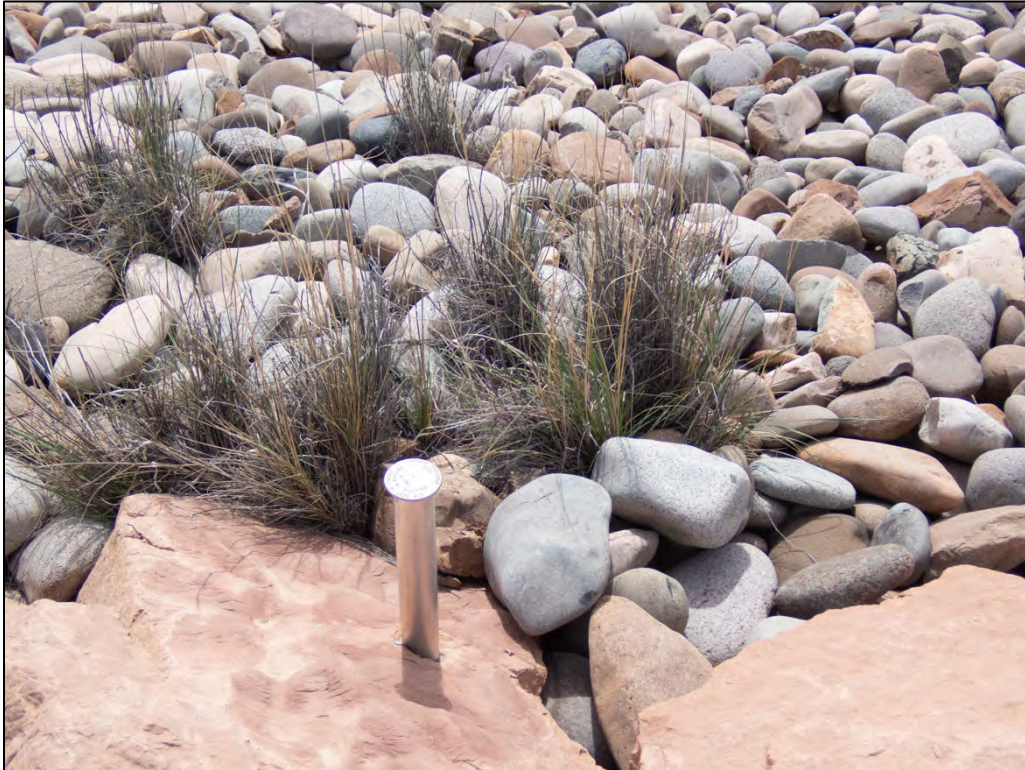
*PL-5. Boundary Marker BM-6*

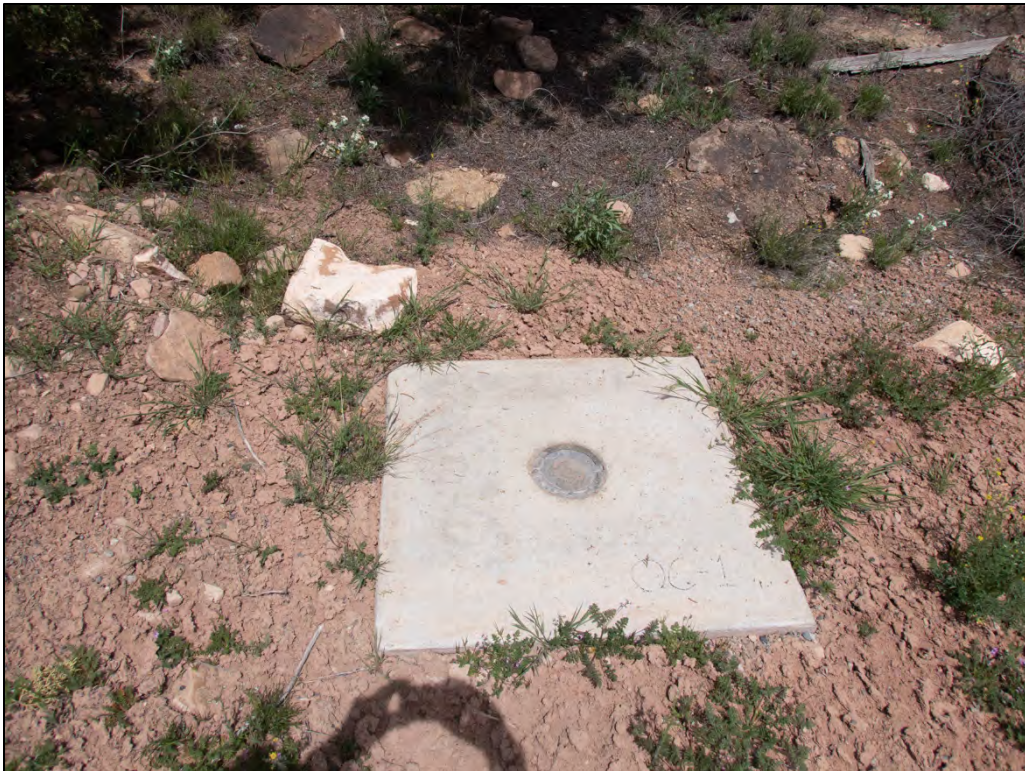
*PL-6. Aerial Survey Quality Control Monument QC-1*

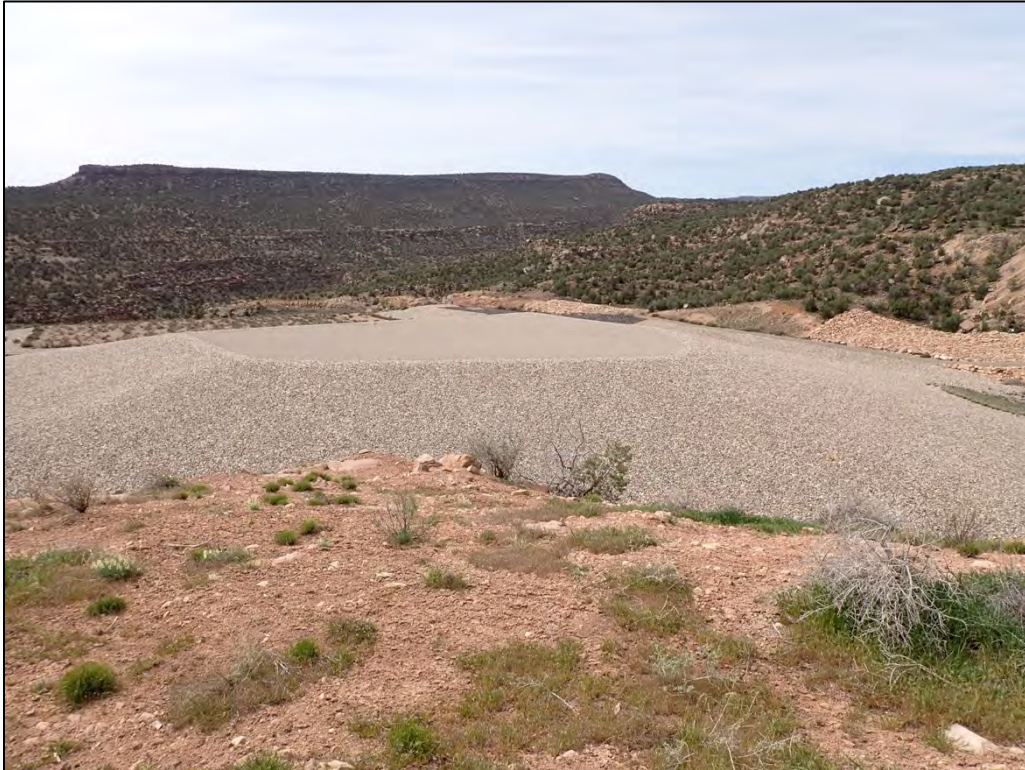
*PL-7. Disposal Cell*

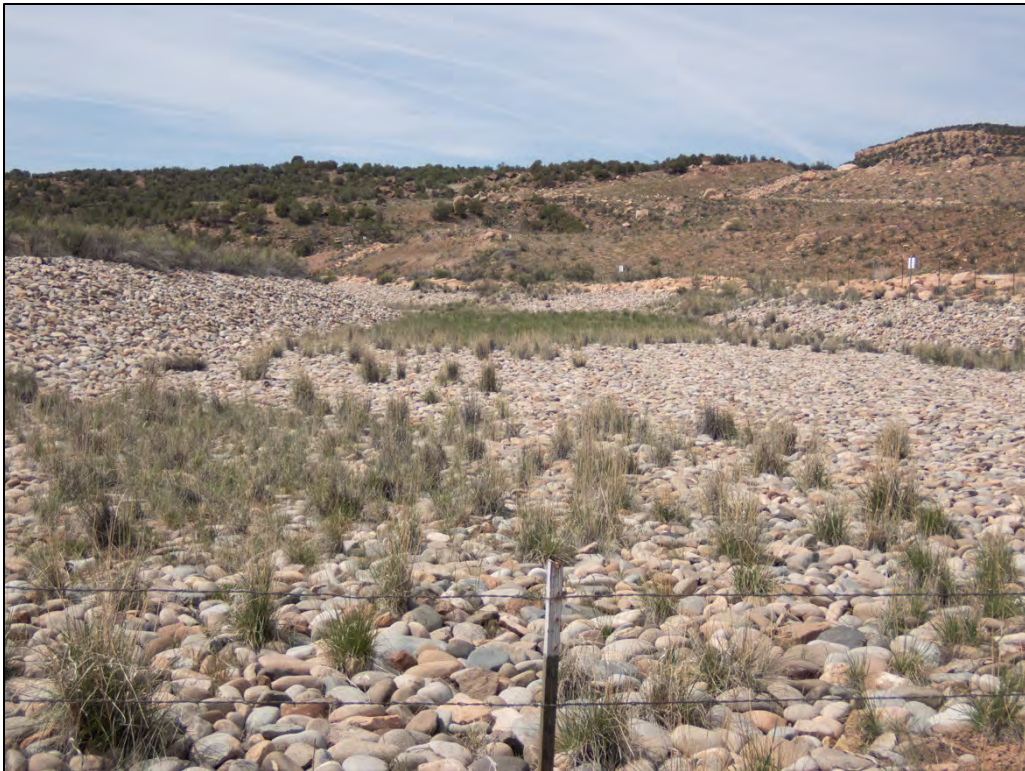
*PL-8. Interceptor Trench on Northern Side of Disposal Site*
