# 2023 Annual Site Inspection and Monitoring Report for Uranium Mill Tailings Radiation Control Act Title I Disposal Sites

March 2024

Legacy  
Management

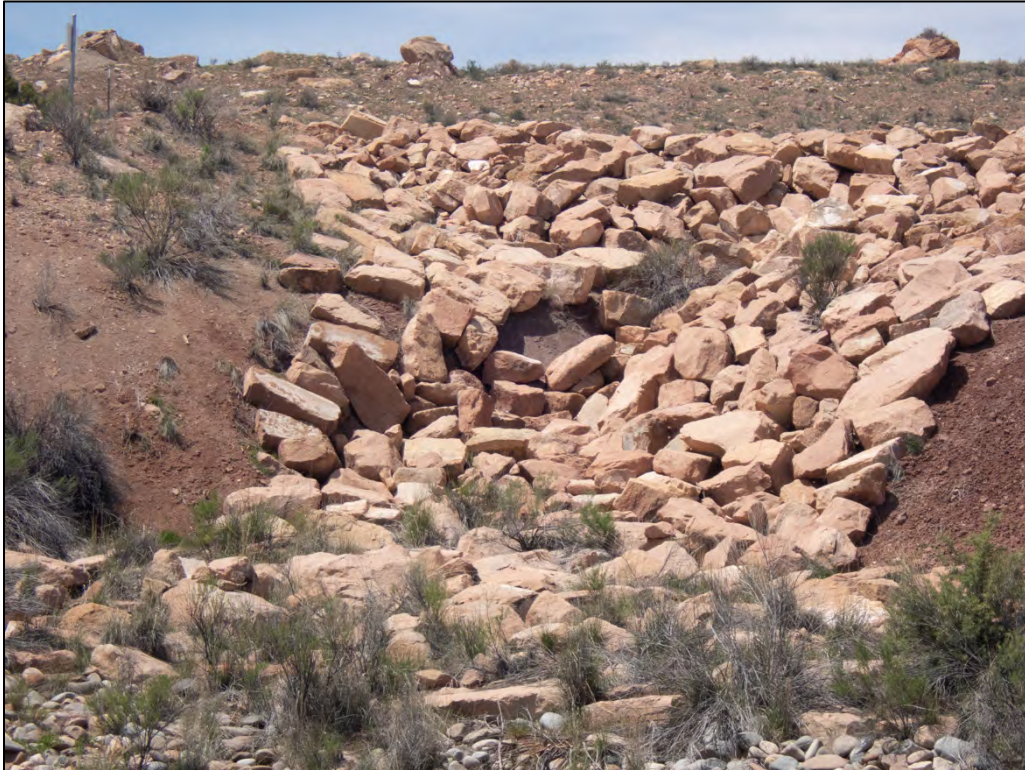
*PL-9. Rocks in Spillway*

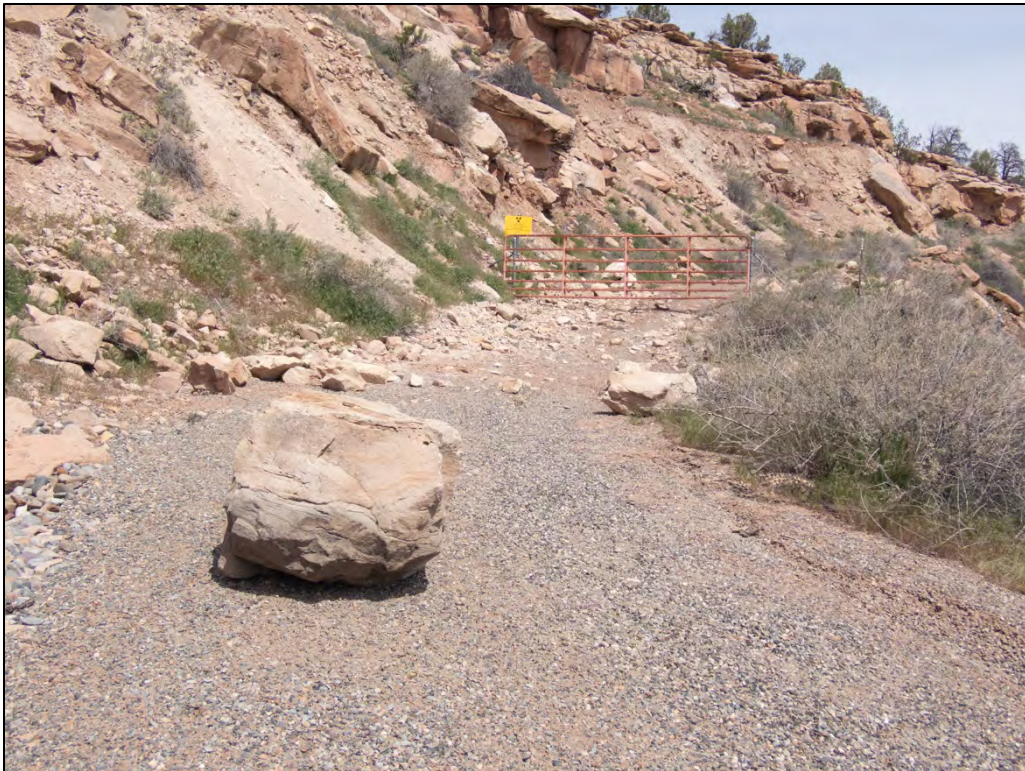
*PL-10. Boulders in Access Road*

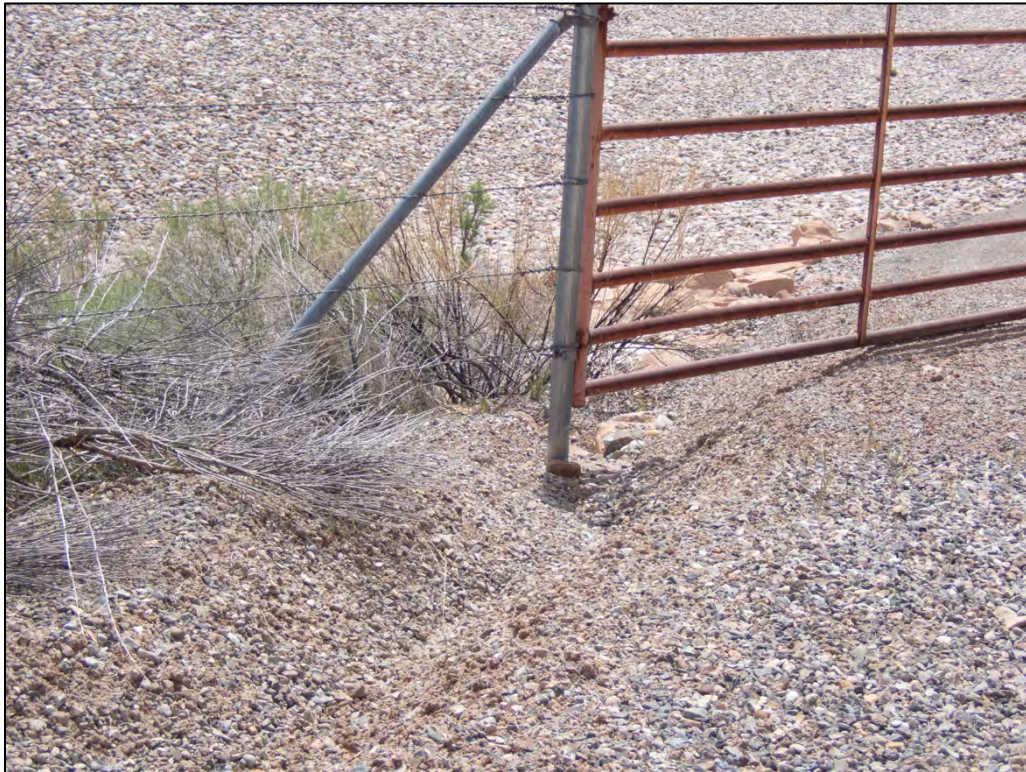
*PL-11. Erosion Forming near Gate Post Along Access Road*

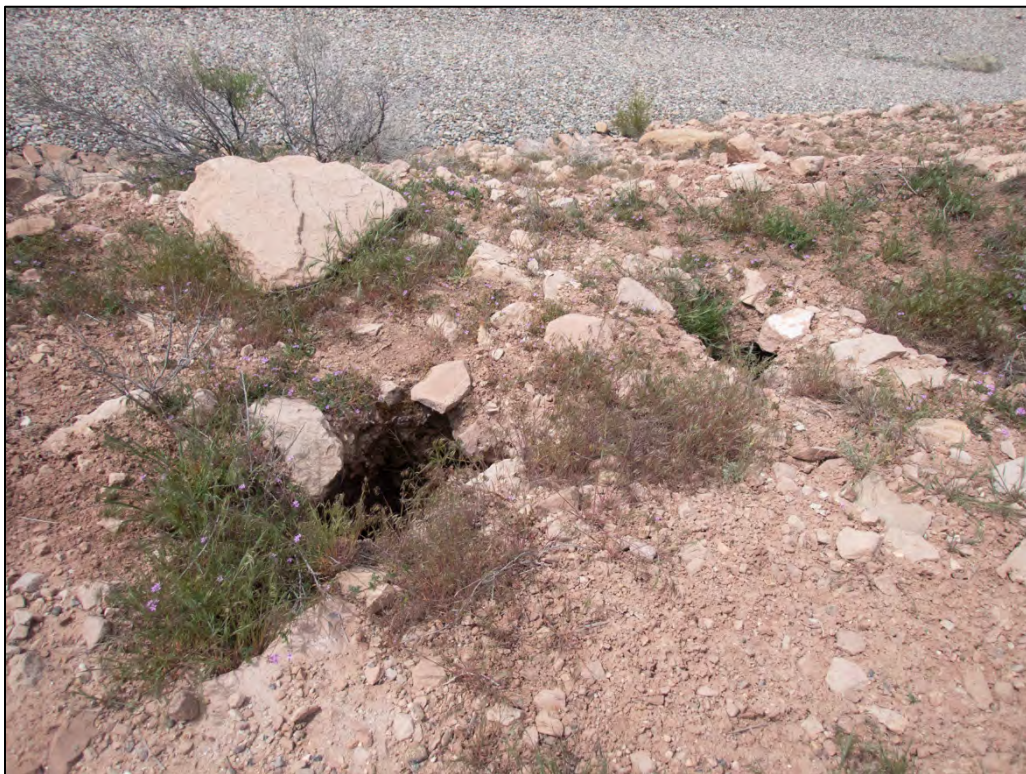
*PL-12. Erosional Channeling Along North Cliff Above Disposal Cell*

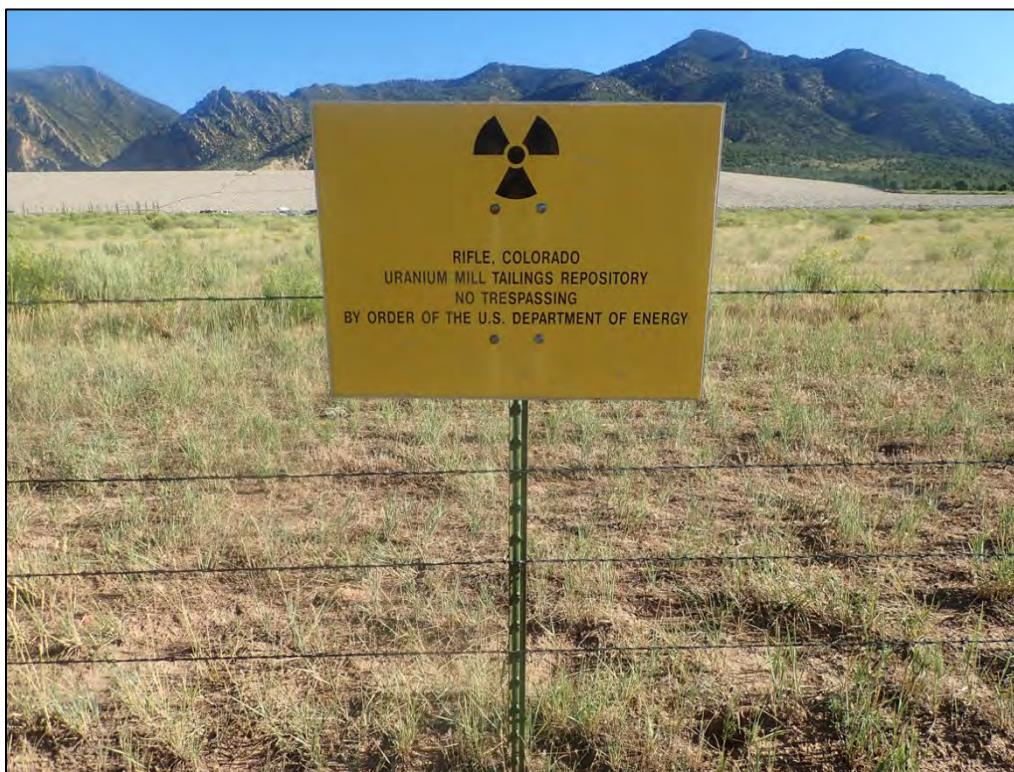
There are 27 perimeter signs positioned along the site perimeter. Perimeter signs P0 through P11 are attached to the stock fence, and perimeter signs P12 through P26 are attached to steel posts set in concrete and set back 5 ft from the boundary. Perimeter signs P15 and P19 have bullet damage but remain legible. Perimeter signs P1, P16, P18, P22, P24, and P26 have minor cracks and are peeling but remain legible. The sign number on perimeter sign P10 is faded, and the sign numbers on perimeter signs P8 and P9 are missing. Perimeter signs P0 through P7 are scratched but legible (PL-3). No maintenance needs were identified.

*PL-3. Perimeter Sign P7, Scratched but Legible*

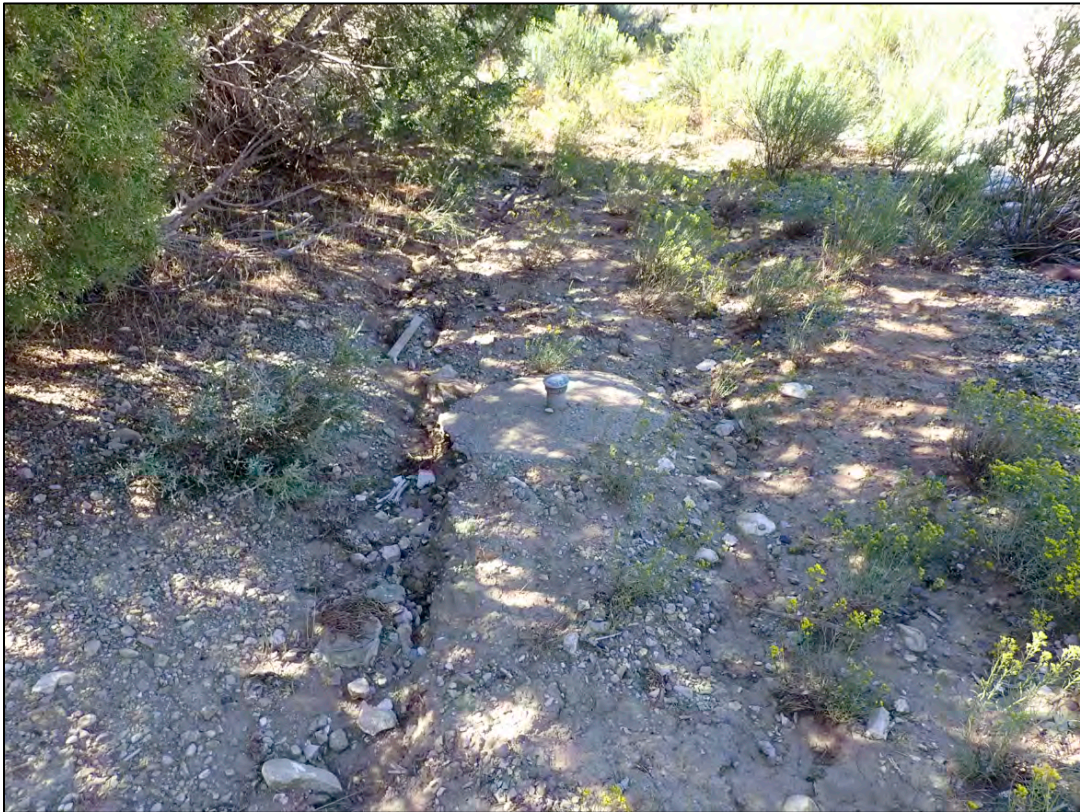
*PL-5. Boundary Monument BM-3 with Concrete Base Undercutting*

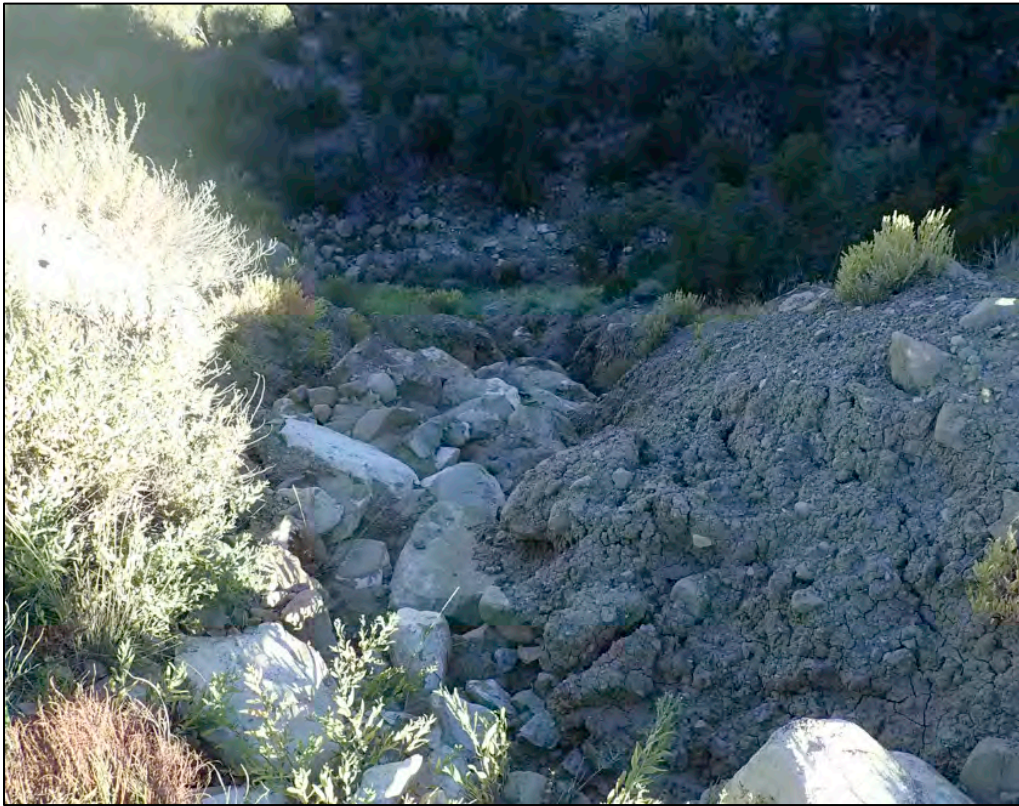
Minor erosion, anticipated in the design, remains evident in the channel at the toe ditch outlet. Rock previously placed in the outlet to stabilize the erosion has dropped into and armored the eroded areas. Inspectors found two depressions in the rock during the 2017 annual inspection (one about 15 × 12 ft in area and 4 ft deep and one about 6 × 6 ft in area and 2 ft deep) and another depression during the 2018 annual inspection (about 15 × 5 ft in area and 3 ft deep). These depressions were formed near the outlet of the toe ditch on the east end after the underlying soil eroded away. A fourth depression was noted in the toe ditch near quality control monument QC-1 during the 2023 annual site inspection. They are not a concern at this time but will continue to be monitored. No maintenance needs were identified.

*PL-9. Gully at Toe of Interceptor Trench*

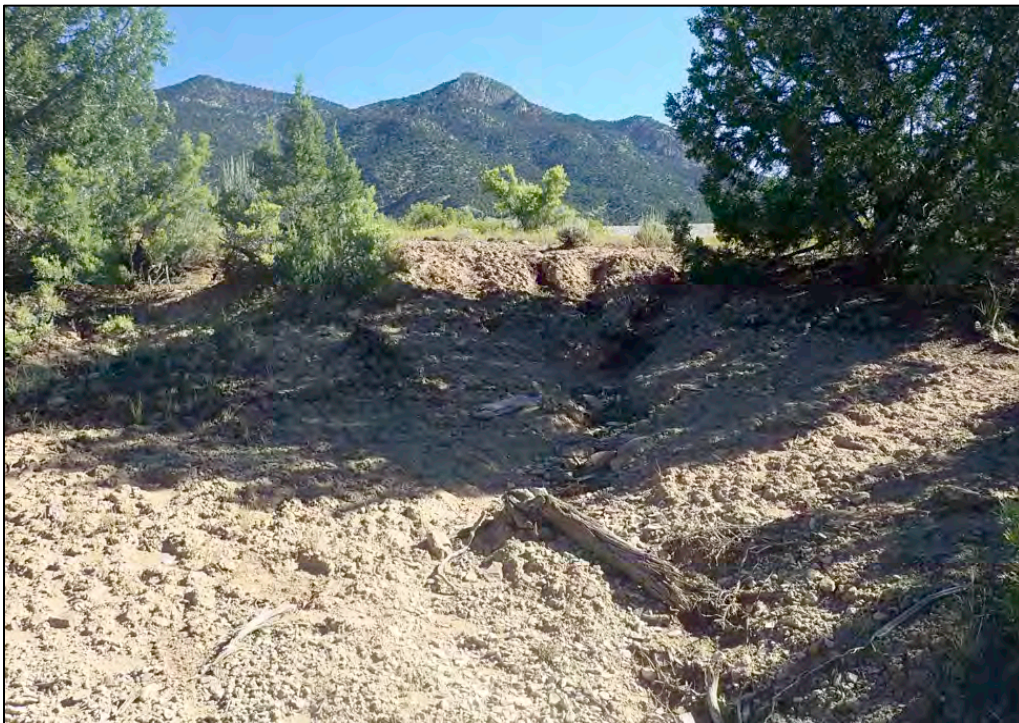
*PL-10. Erosion near Perimeter Sign P26*

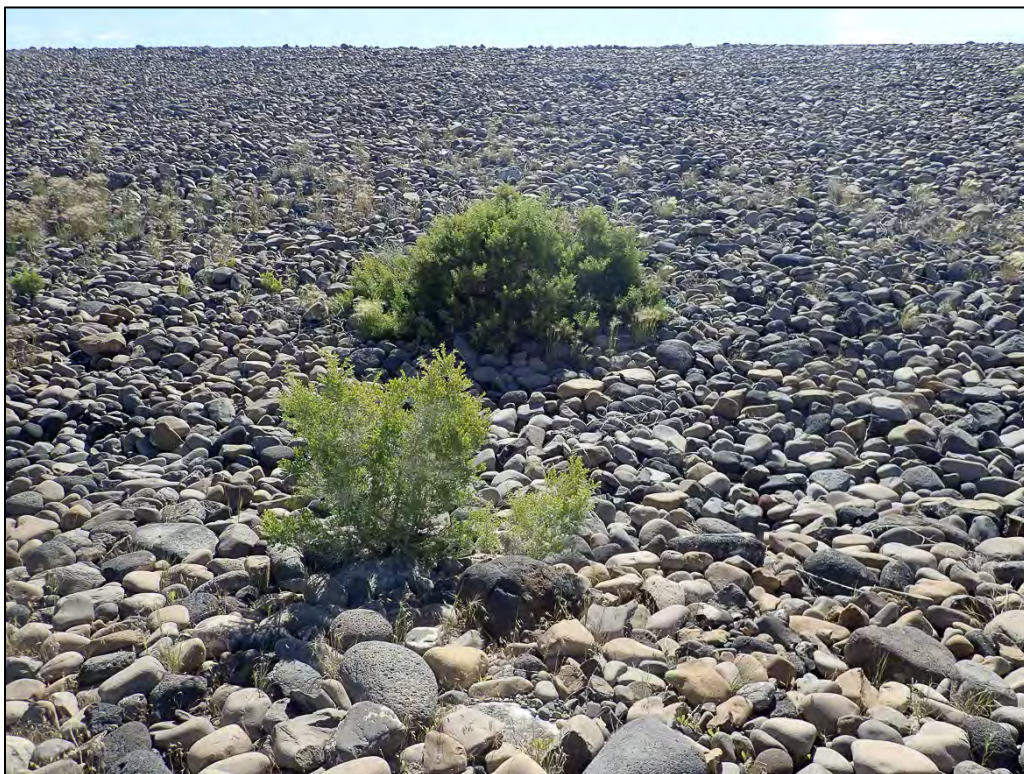
*PL-8. Infilled Soil in Rock-Quality Monitoring Plot IV*

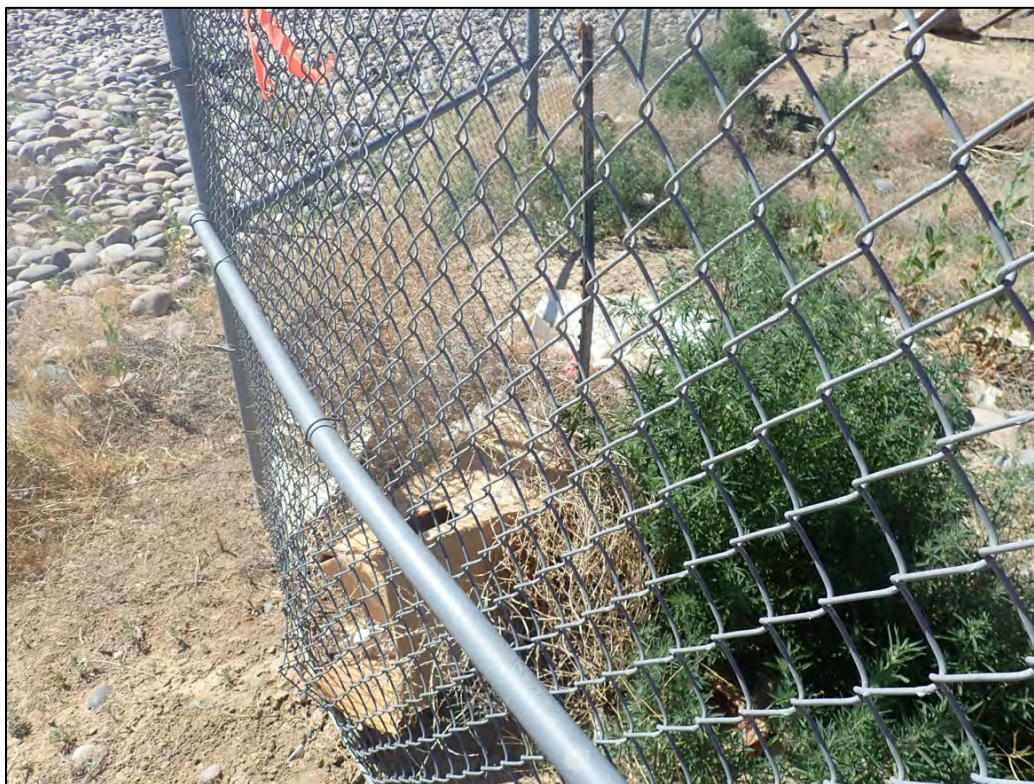
*PL-2. Boundary Monument BM-2 with Vegetation and Trash*

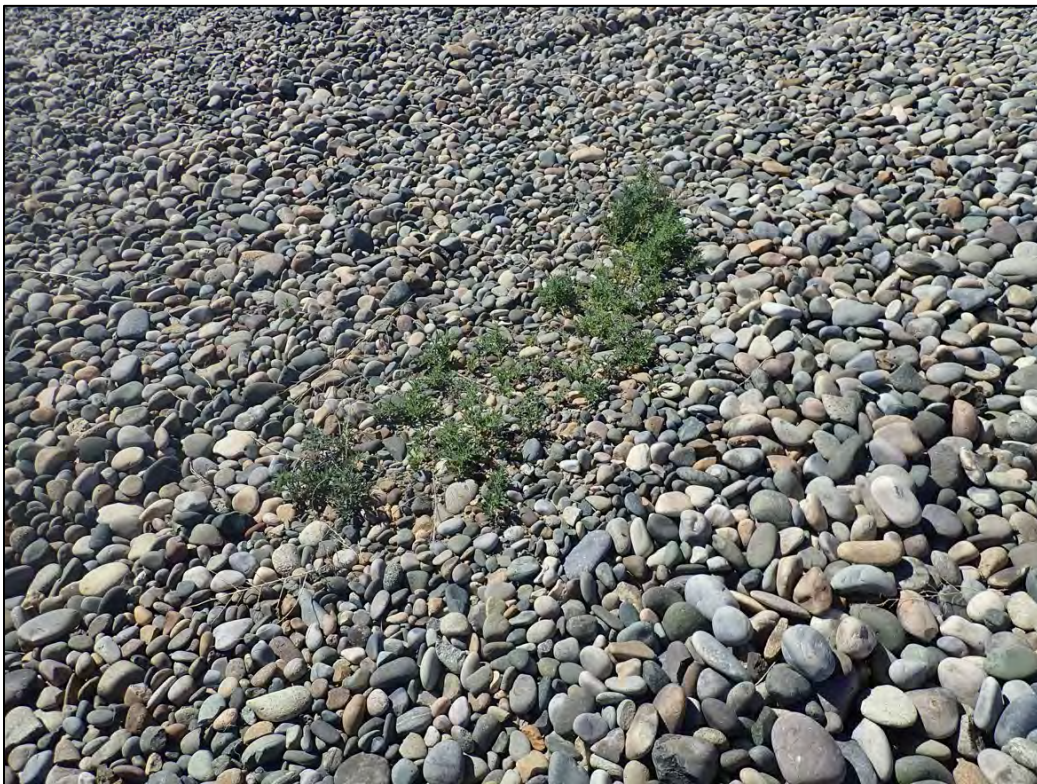
*PL-4. Smaller Riprap Exposed Along Northern Ridge of Disposal Cell Top Slope*

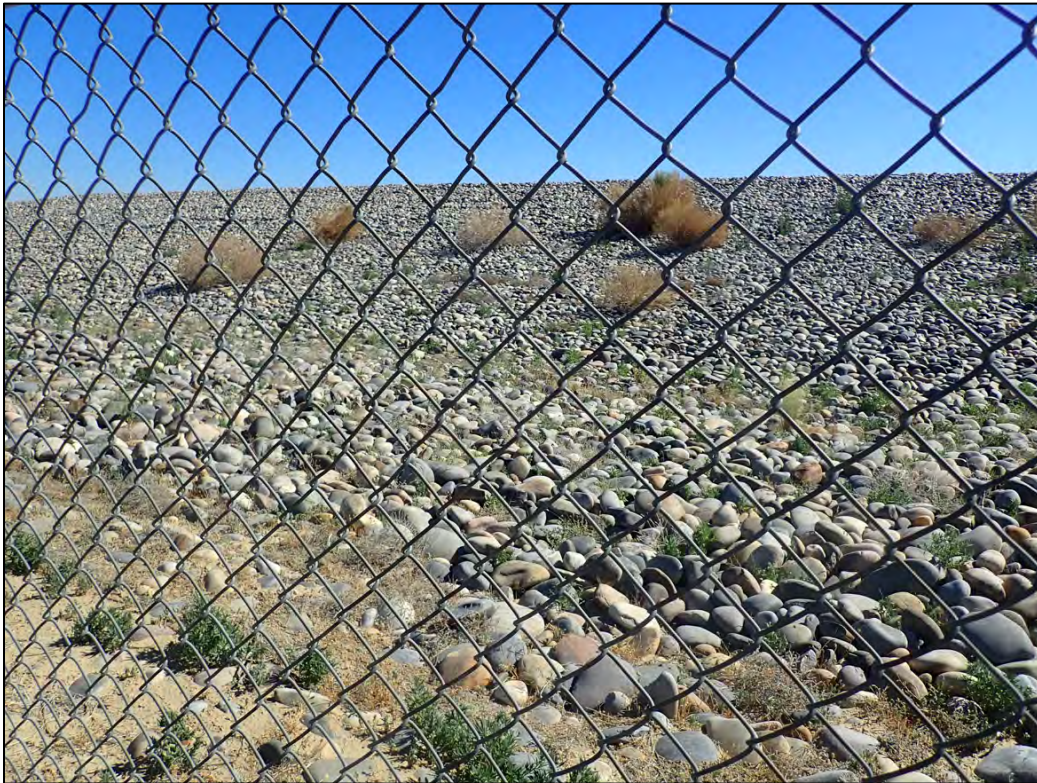
*PL-5. Treated Vegetation on Side Slope*

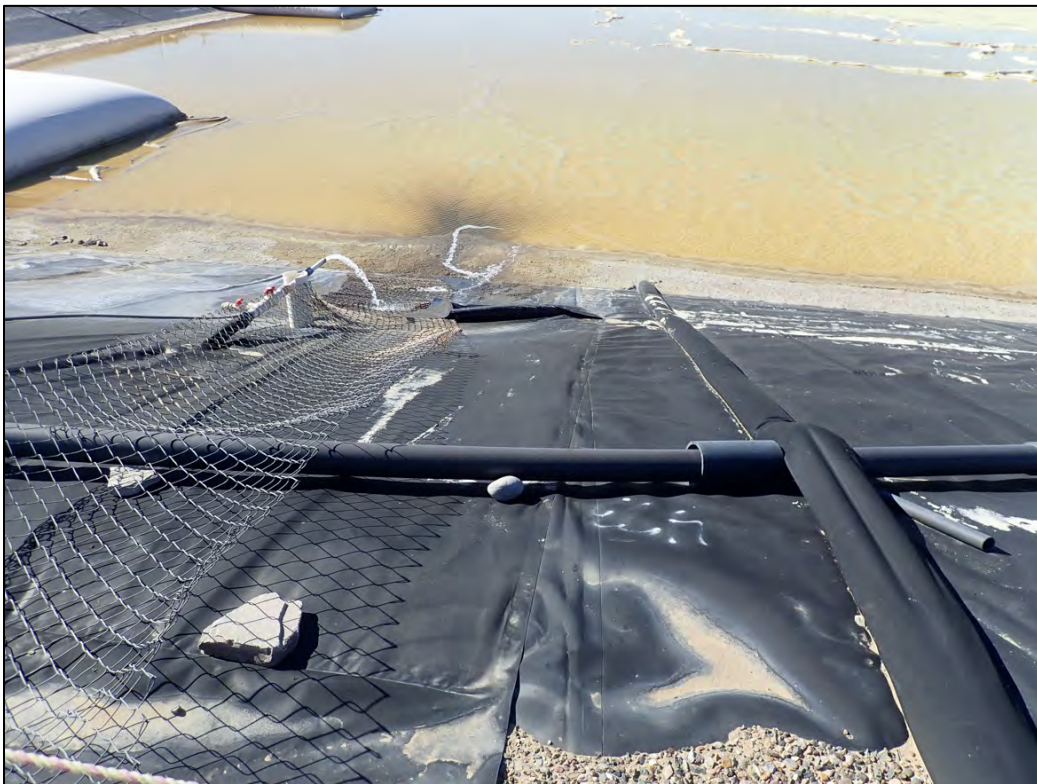
*PL-6. Evaporation Pond Liner*

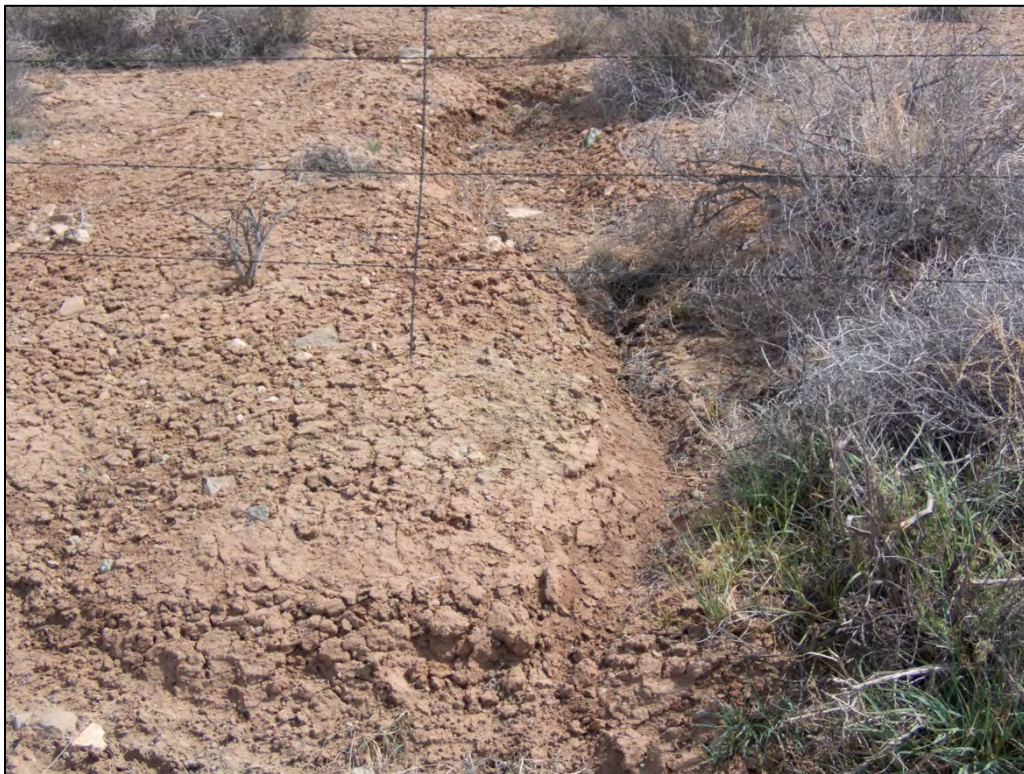
*PL-2. Gully Forming Under Fence Line Along County Road T11*

- Stabilization of the fence posts between perimeter signs P30 to P32
- Repairs to the rills and gullies forming along site marker SMK-1 and extending to the fence line along County Road T11
- Replacement of perimeter sign P27

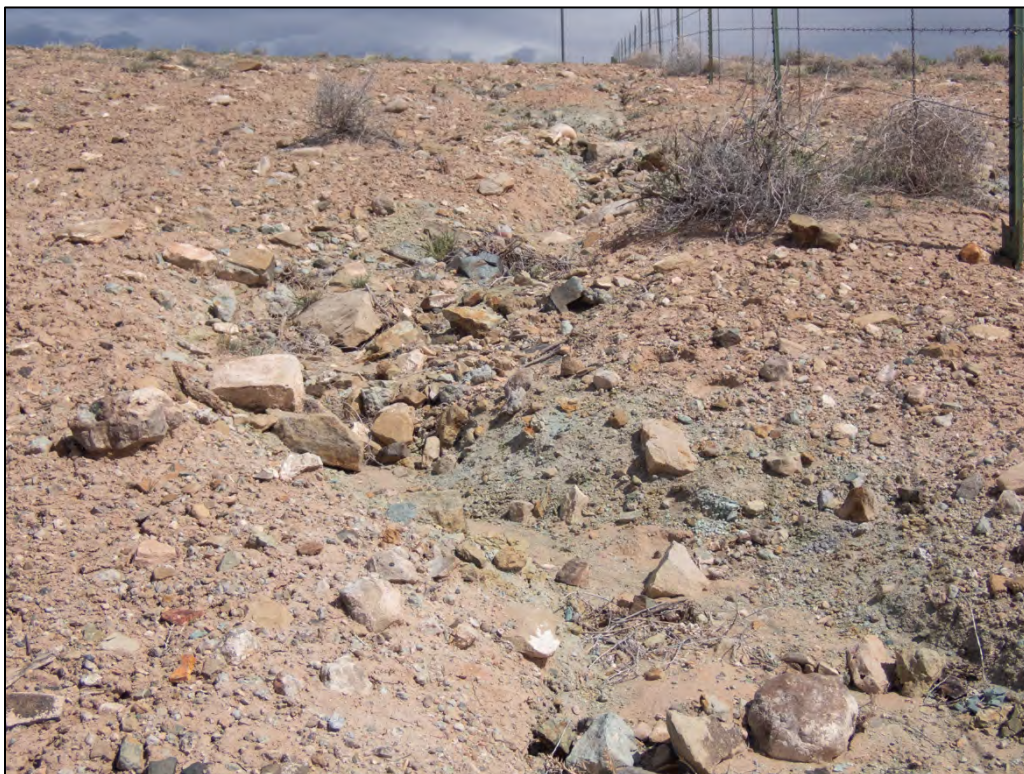
*PL-3. Small Gully Along Western Perimeter Fence*

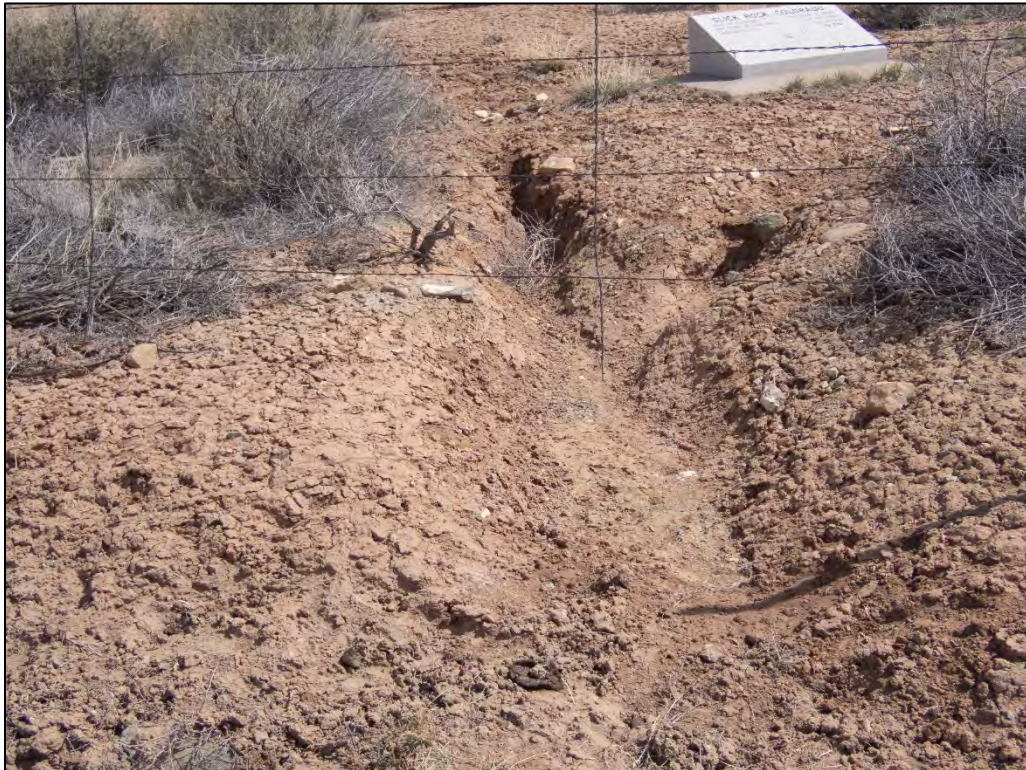
*PL-5. Erosion Forming Around Survey Monument SMK-1*

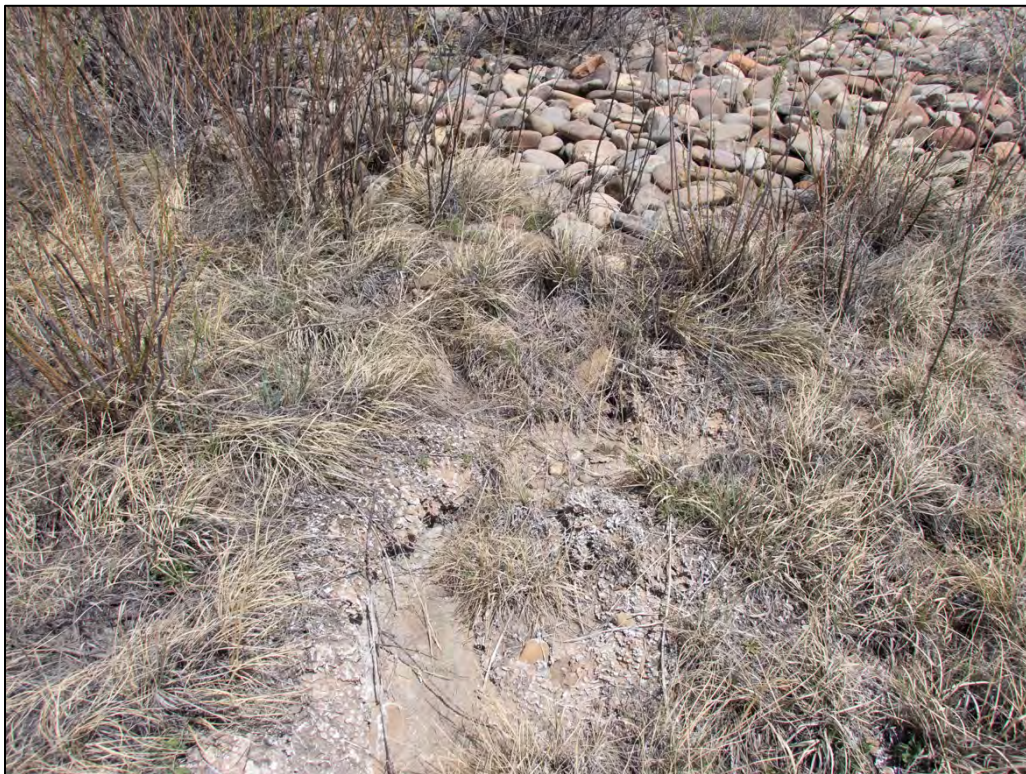
*PL-8. Gully near Apron Area*

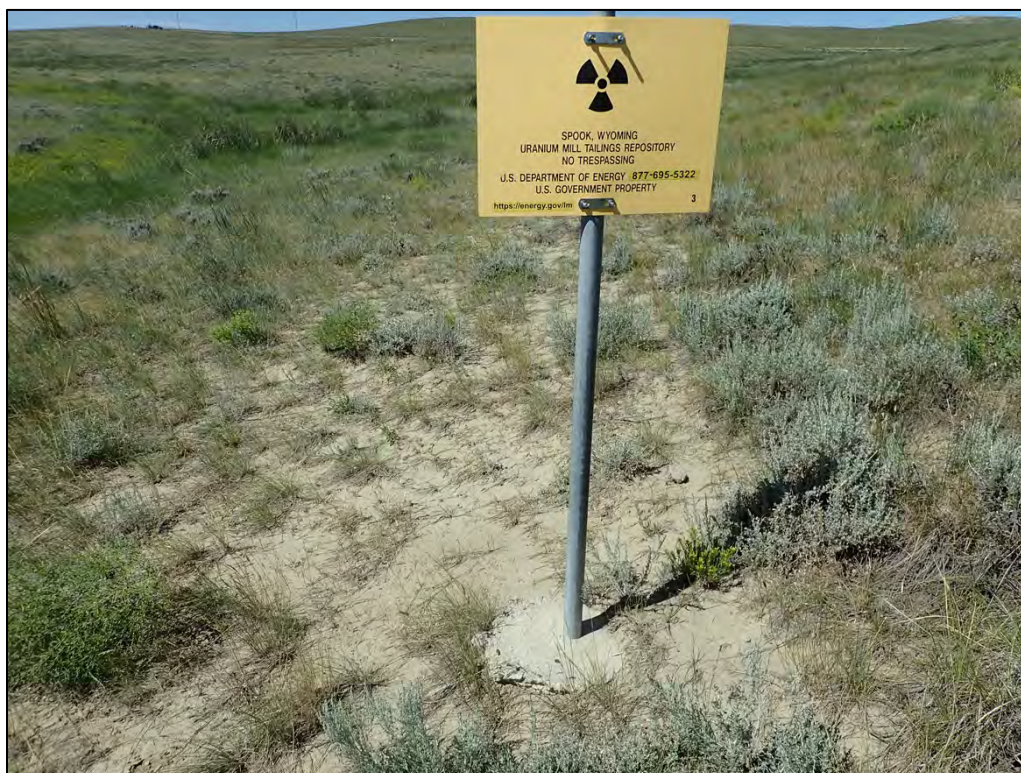
*PL-2. Perimeter Sign P3 with Headcutting*

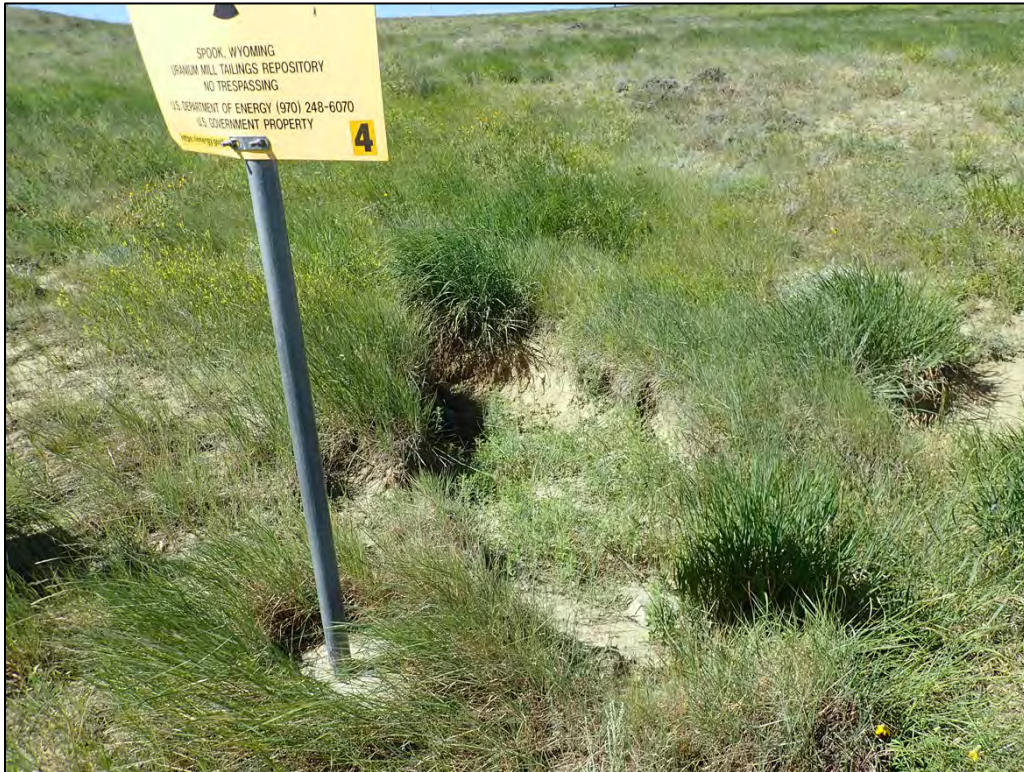
*PL-3. Perimeter Sign P4 with Headcutting*

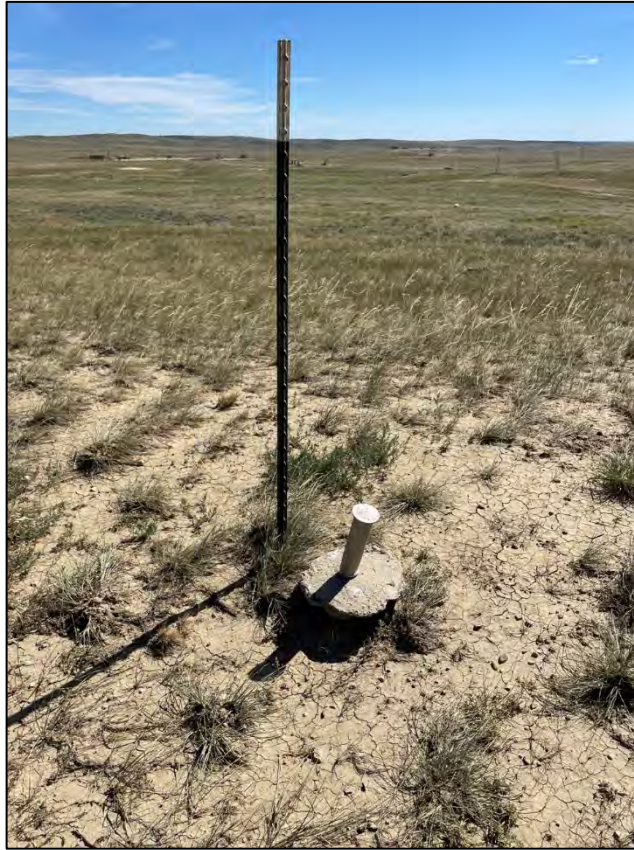
*PL-5. Boundary Monument BM-6*

The site has three survey monuments and eight boundary monuments. Boundary monument BM-6 is bent, and the base is eroded but stable (PL-5). The boundary monuments, survey monuments, and perimeter signs are outside the property boundary. The owner of the surrounding property (Hornbuckle Ranch) is aware that the monuments are on his property, but he is not concerned. However, in spring 2024, new boundary monuments will be installed in the correct locations and the original boundary monuments will be removed. No maintenance needs were identified.

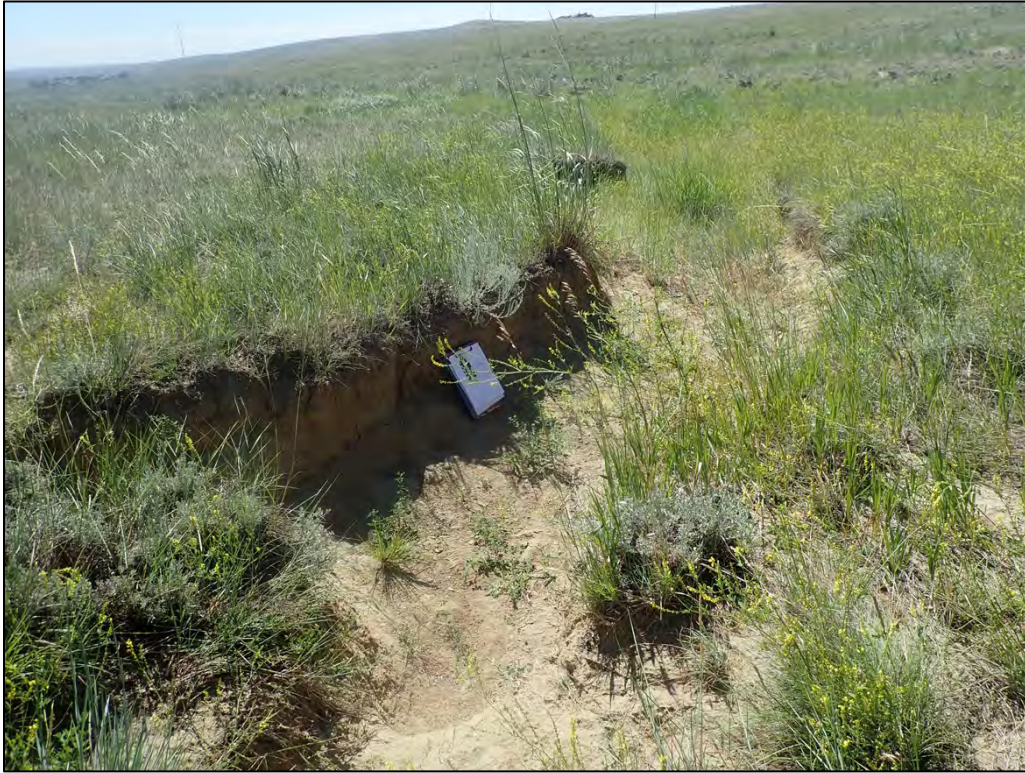
*PL-7. Erosion Gully near Perimeter Sign P7 in Outlying Area*

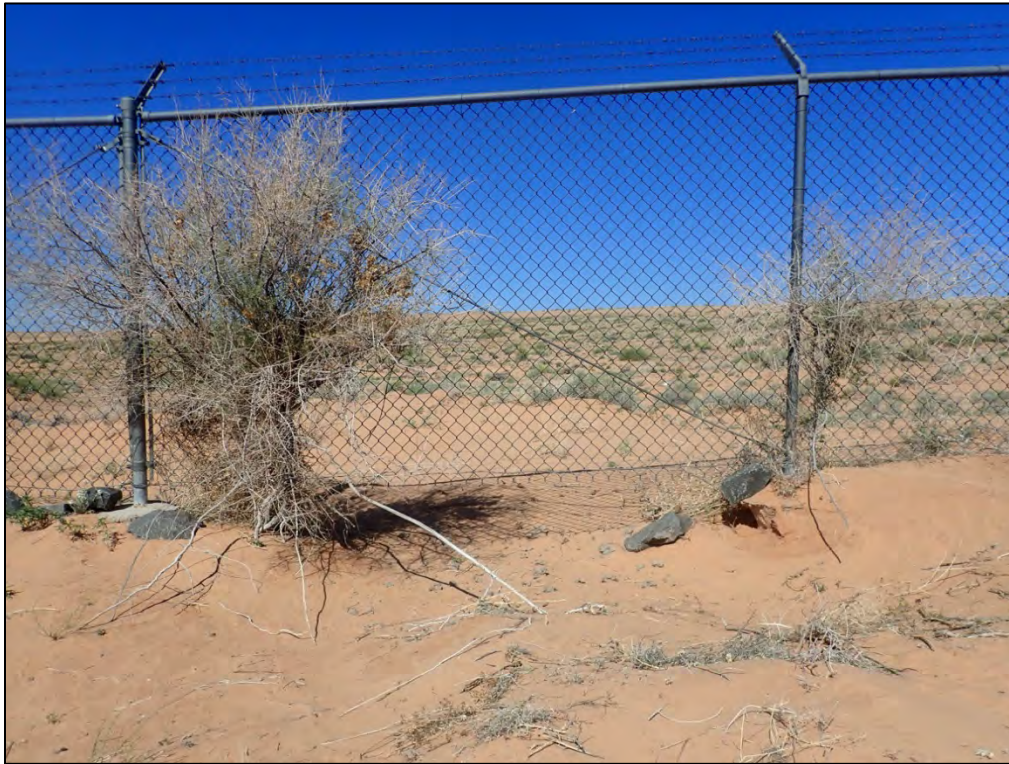
*PL-1. Gap Under Fence near Perimeter Sign P9*

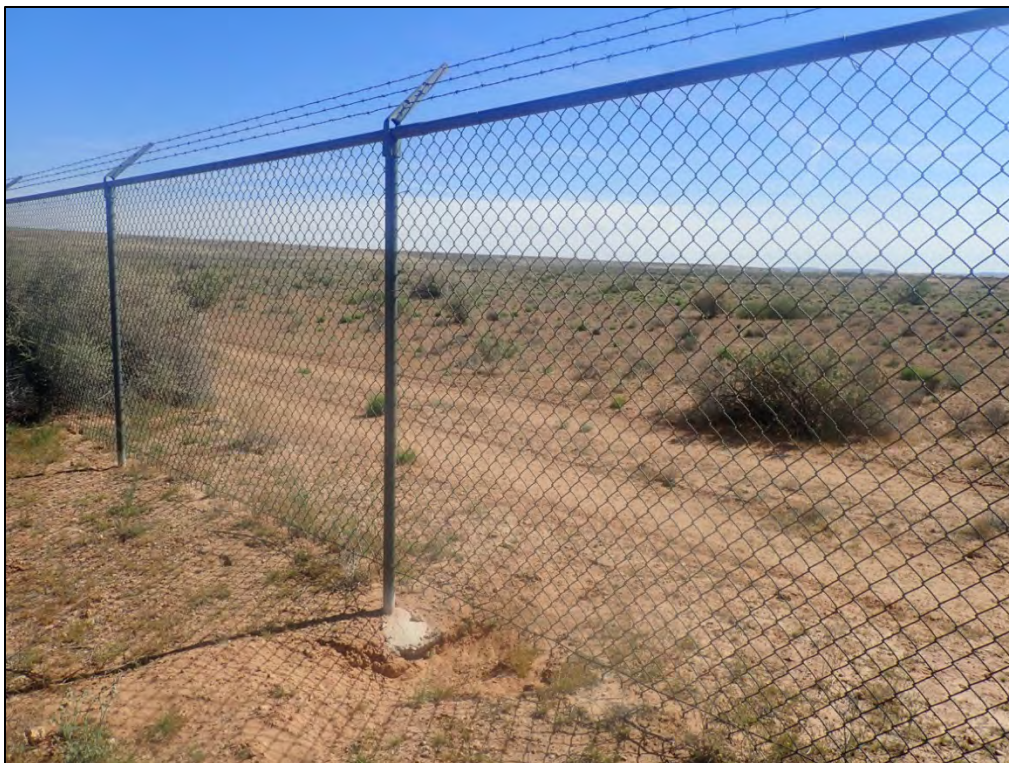
*PL-2. Gap Created by Animals Under Fence Between Perimeter Signs P21 and P22*

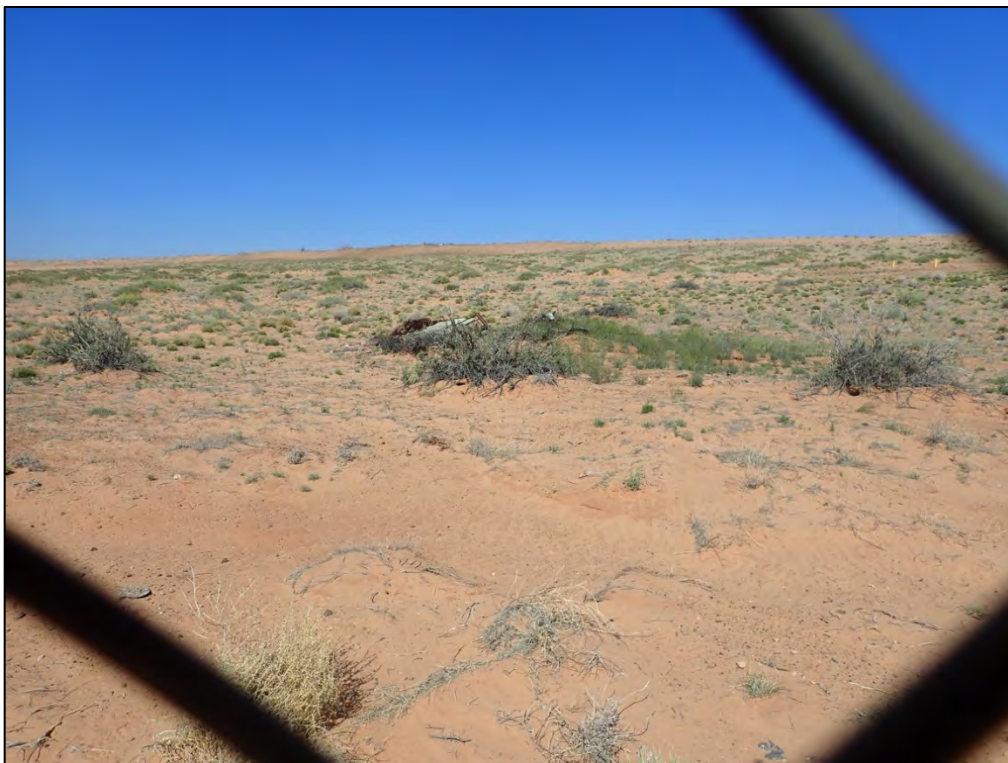
*PL-4. Debris near Perimeter Sign P9*

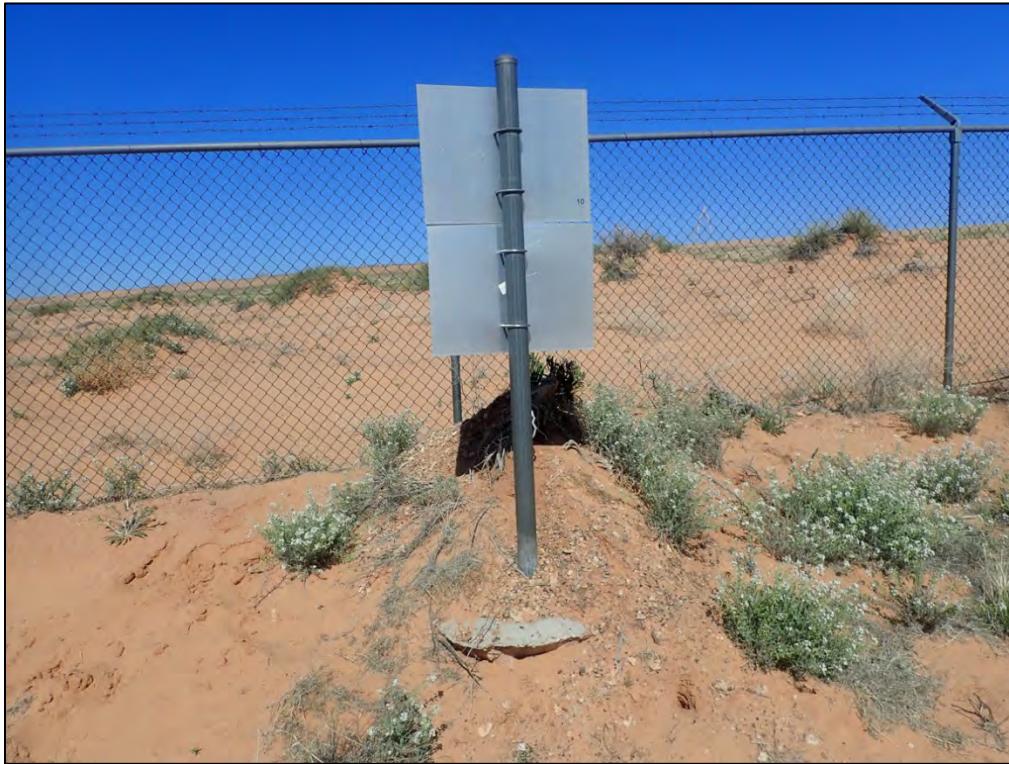
*PL-5. Erosion Under Base of Perimeter Sign P10*

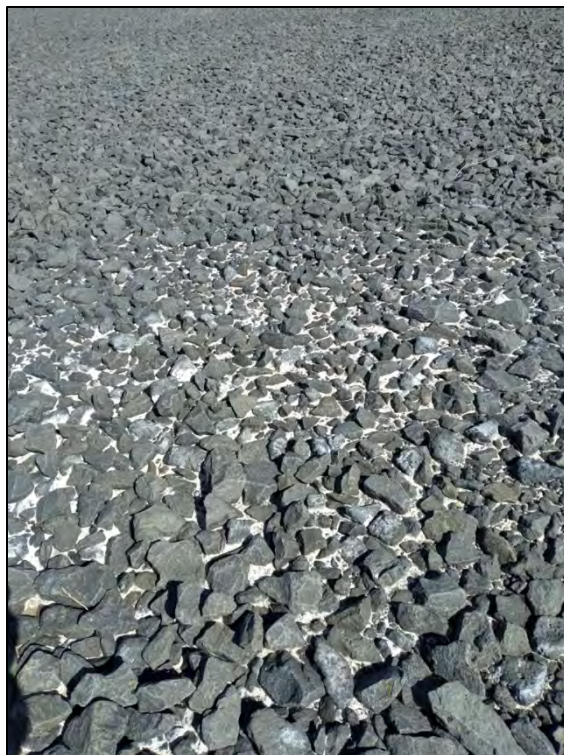
*PL-8. Evaporative Minerals on Top Slope of Disposal Cell*

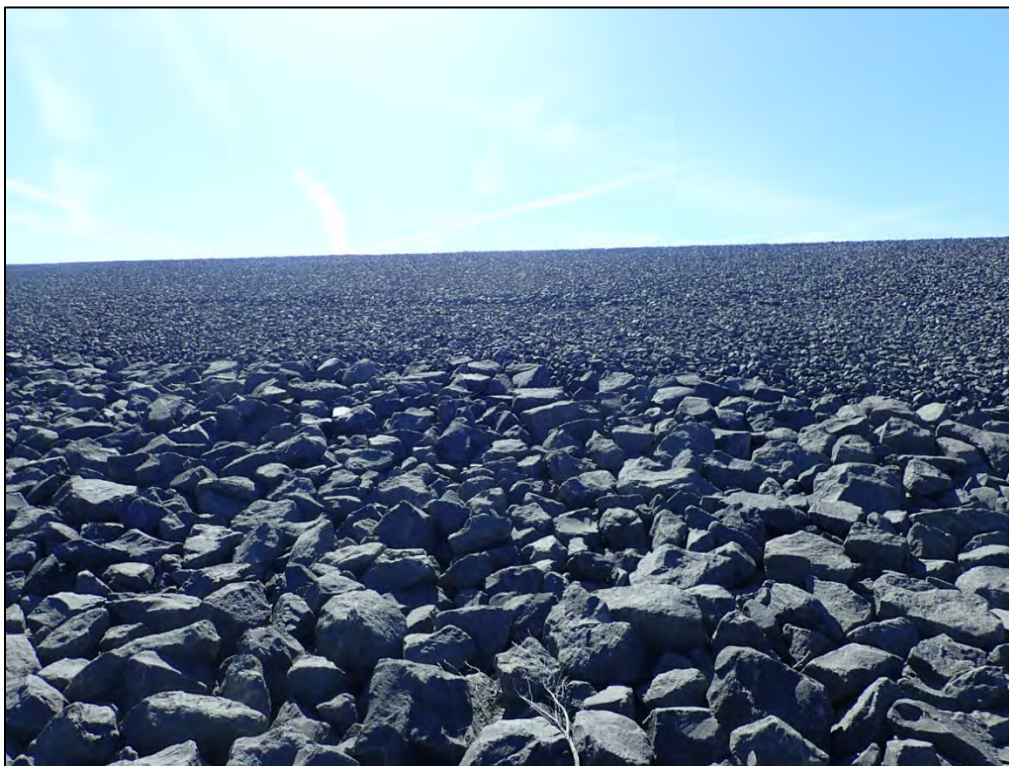
*PL-9. Horizontal Lines on West Slope of Disposal Cell*

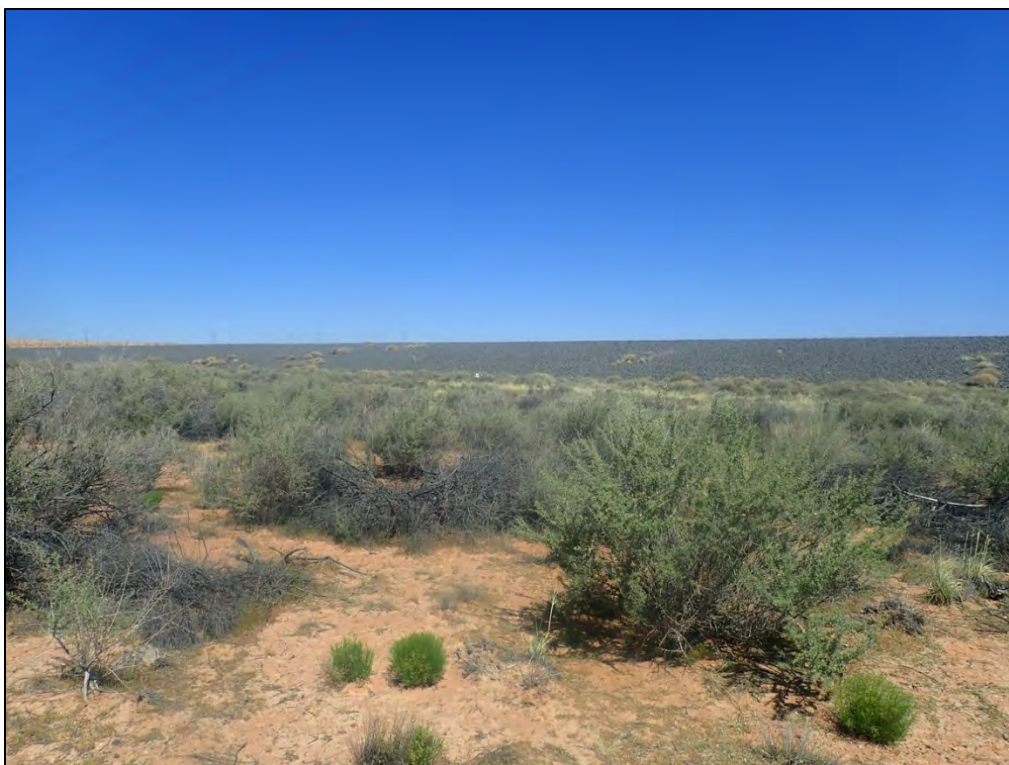
*PL-10. Vegetation on South Slope of Disposal Cell*
