# 2023 Annual Site Inspection and Monitoring Report for Uranium Mill Tailings Radiation Control Act Title I Disposal Sites

March 2024

Legacy  
Management

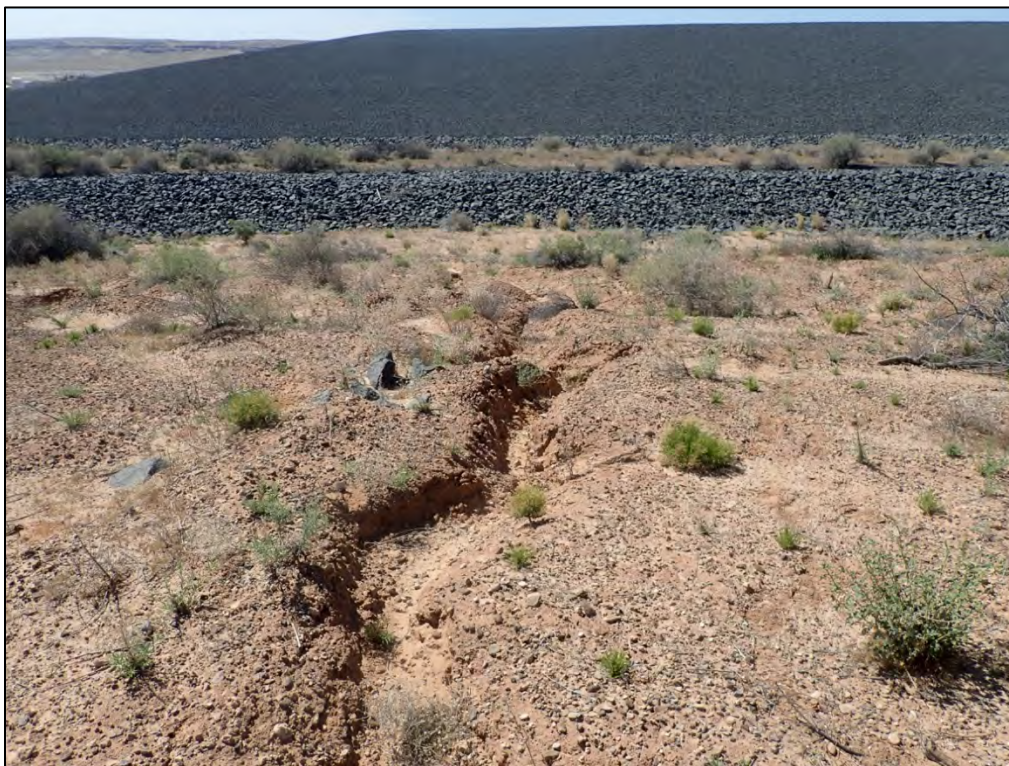
*PL-11. Erosion Gully and Soil Accumulation in Diversion Ditch North of Disposal Cell*
