U.S. DEPARTMENT OF  
**ENERGY**

Legacy  
Management

# 2019 Annual Site Inspection and Monitoring Report for Uranium Mill Tailings Radiation Control Act Title II Disposal Sites

December 2019

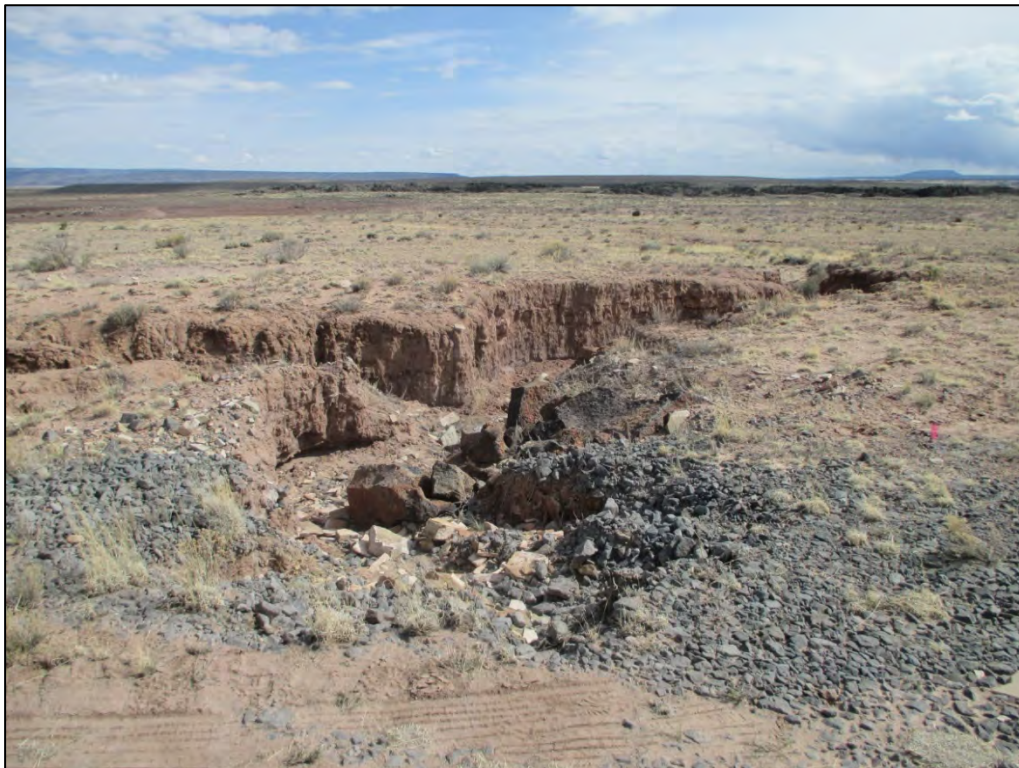
Interior roads used to access LM assets consist of a dirt track covered at places with crushed basalt. The roads are susceptible to erosion and are repaired when they become impassable. Increased erosion continued to be observed on a road northwest of the main tailings disposal cell (PL-1 and PL-2). A gully intersecting the road at this location required maintenance in the past. Riprap previously was added to repair this section of the road; other repair options were evaluated in 2019. LM is proposing to repair the road in 2020 and to construct two armored low-level crossings to protect against future erosion. No other maintenance needs were identified.

*PL-2. Erosion Near the Site Perimeter Road (North Area)*

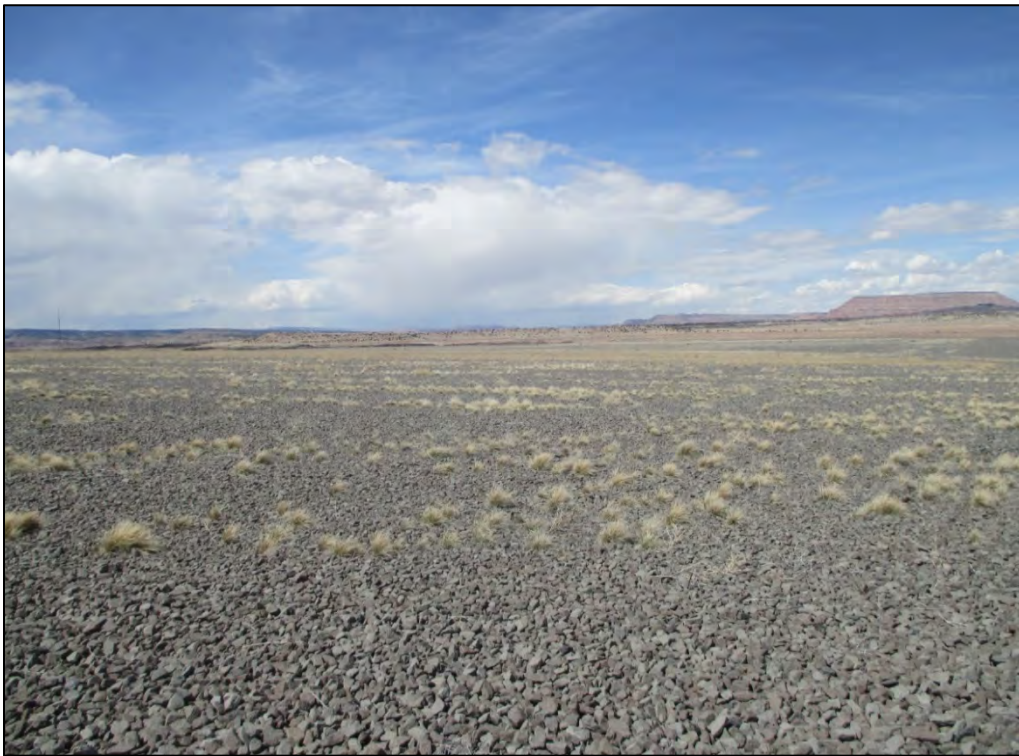
Plant encroachment (by annual weeds, perennial grasses and forbs, and scattered perennial shrubs) continues on the main tailings disposal cell top and side slopes (PL-6). Siberian elm saplings on the top slope are managed to prevent the establishment of trees that could damage the main tailings disposal cell cover materials; none were observed during the inspection.

*PL-6. Top Slope of the Main Tailings Disposal Cell*

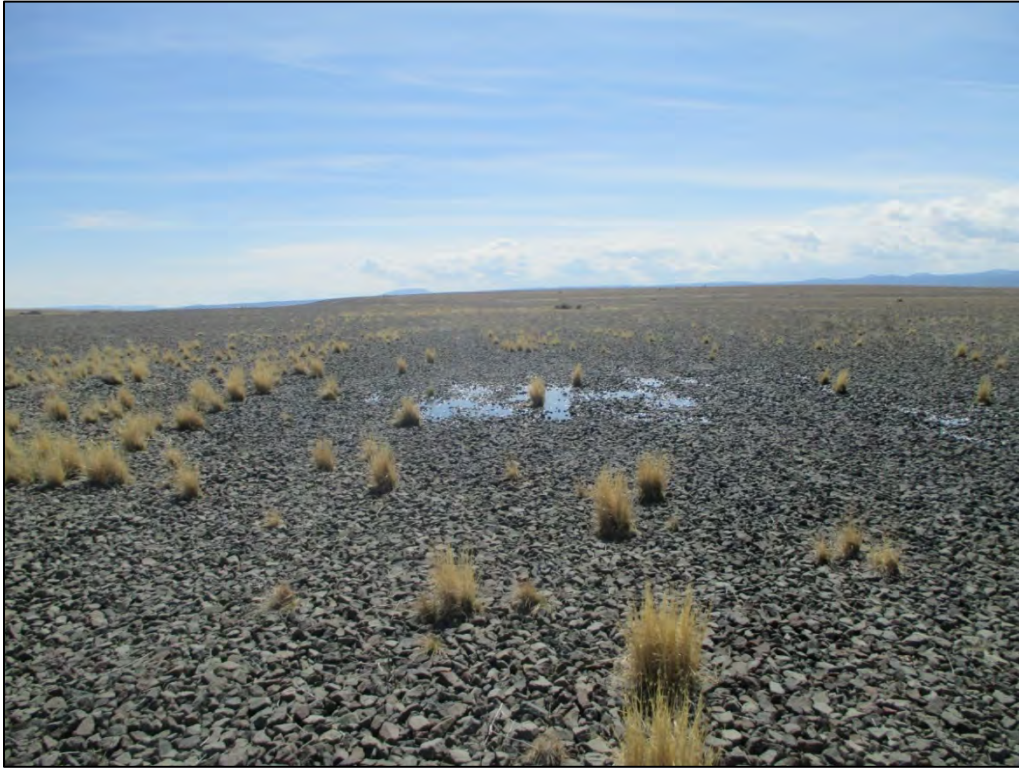
*PL-7. Ponding on the Top Slope of the Main Tailings Disposal Cell*

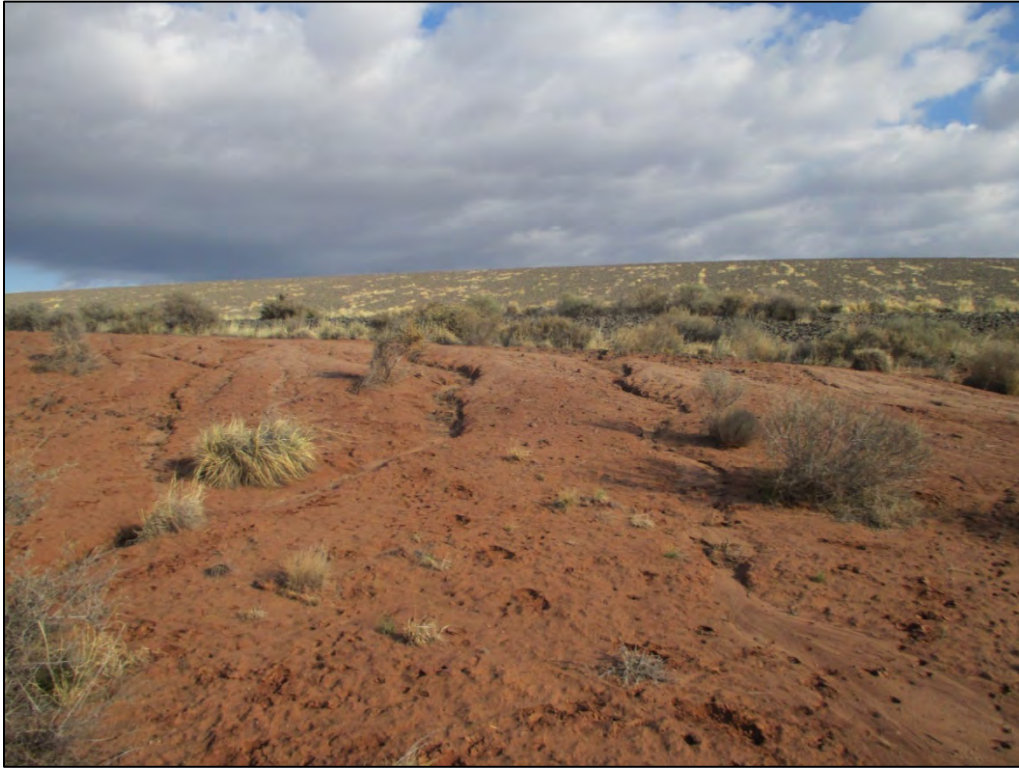
*PL-11. Rills at the Base of the South Bench Disposal Area*

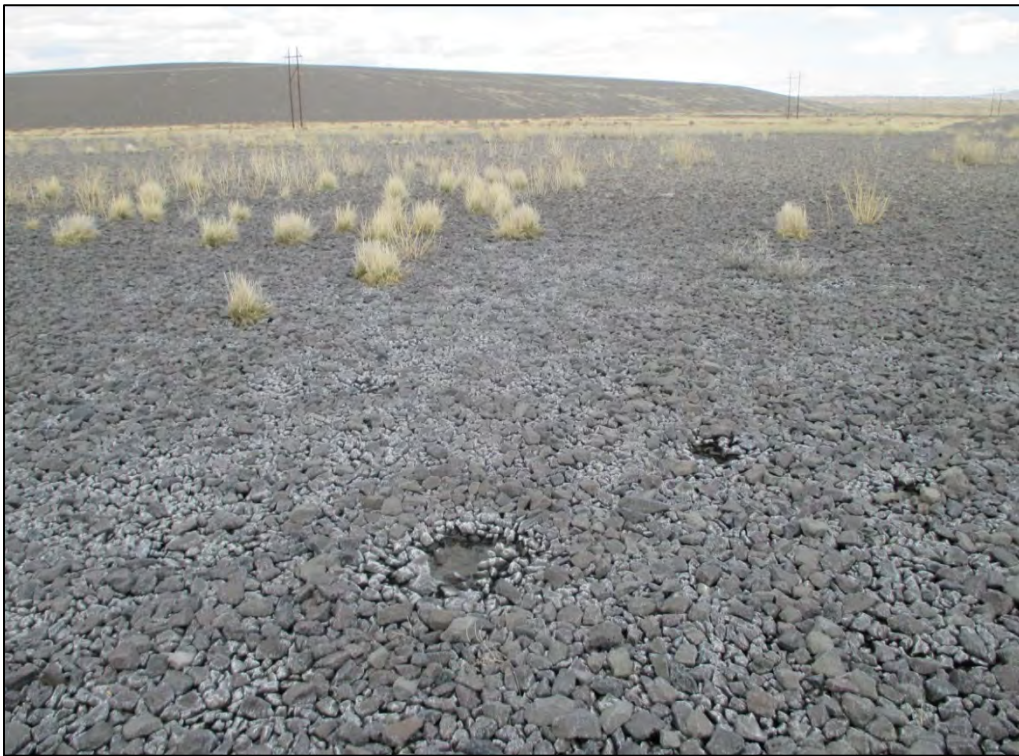
*PL-12. Minor Ponding in the Shallow Depression on the Northwest Extension of the Carbonate Tailings Disposal Cell*

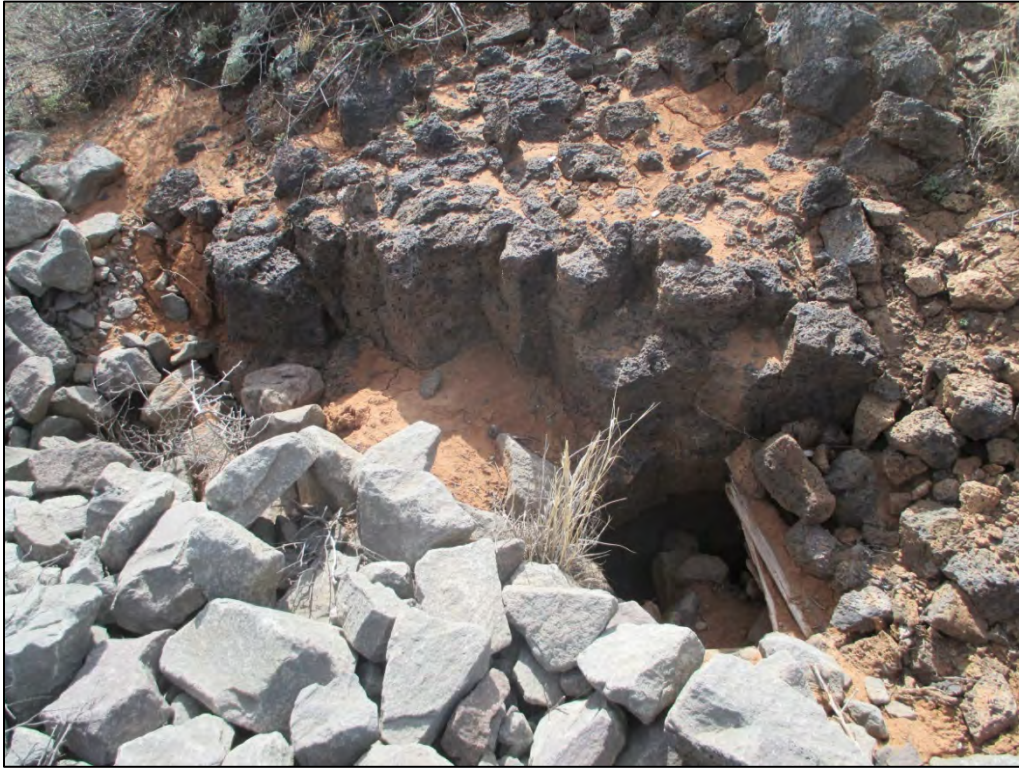
*PL-17. Settlement in Fill Covering Basalt at the Interface of the East Dump Cover*

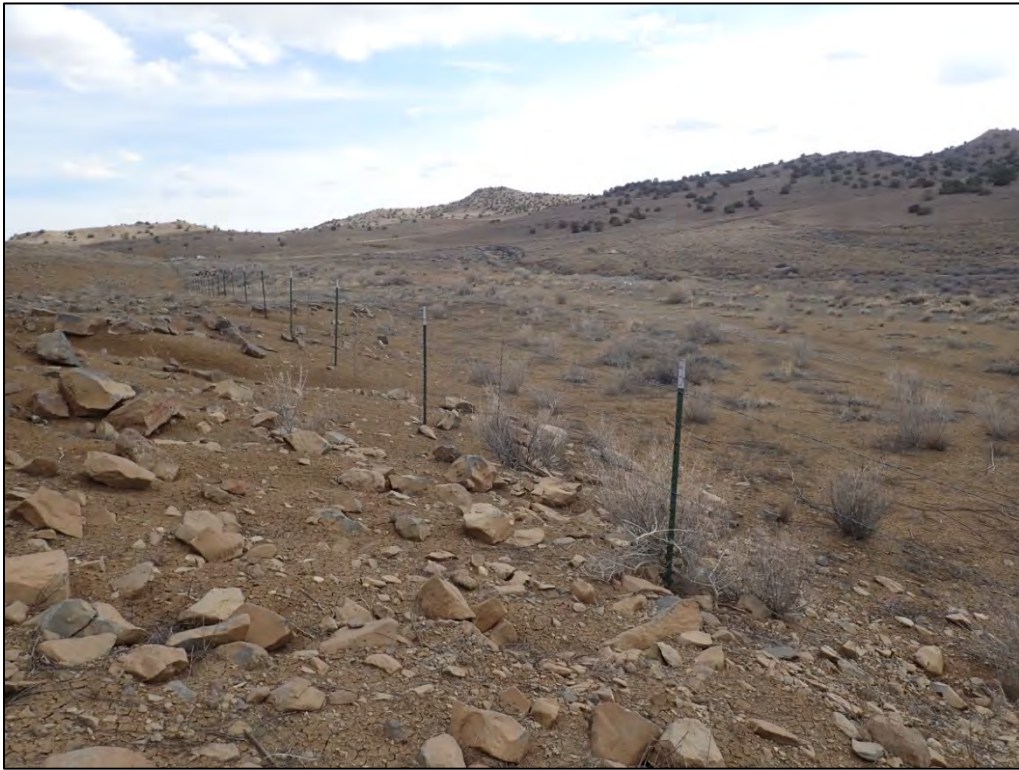
*PL-1. Fence Along East Side of Southeast Drainage Area*

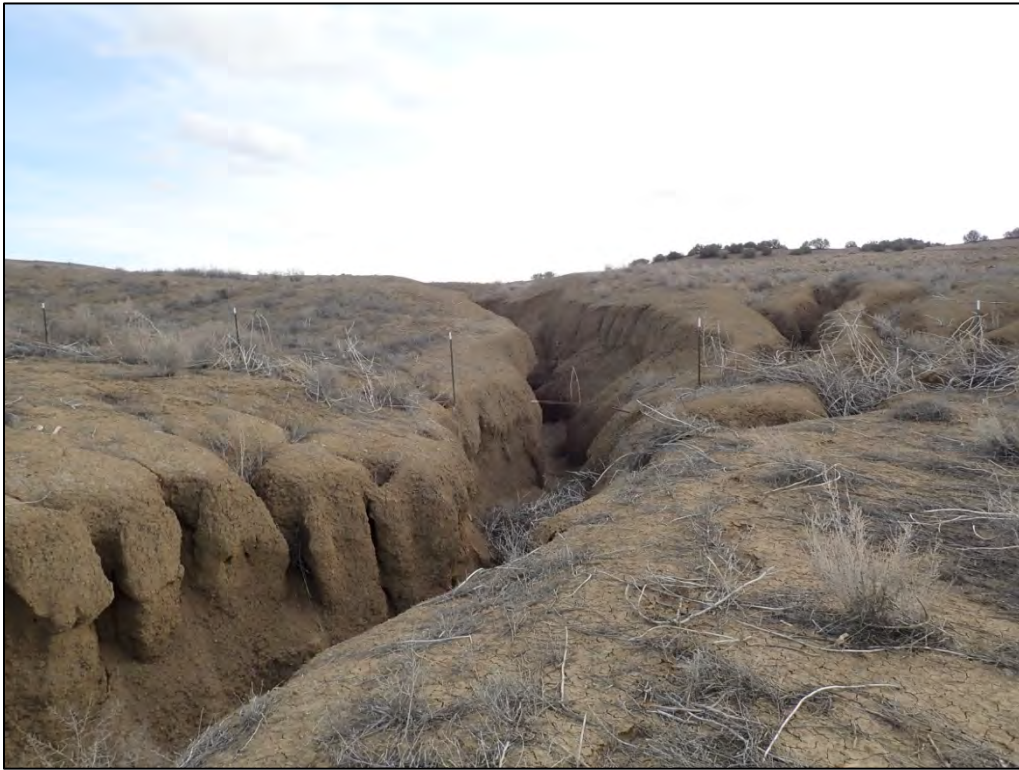
*PL-11. Gully Upgradient of Sediment Trap*

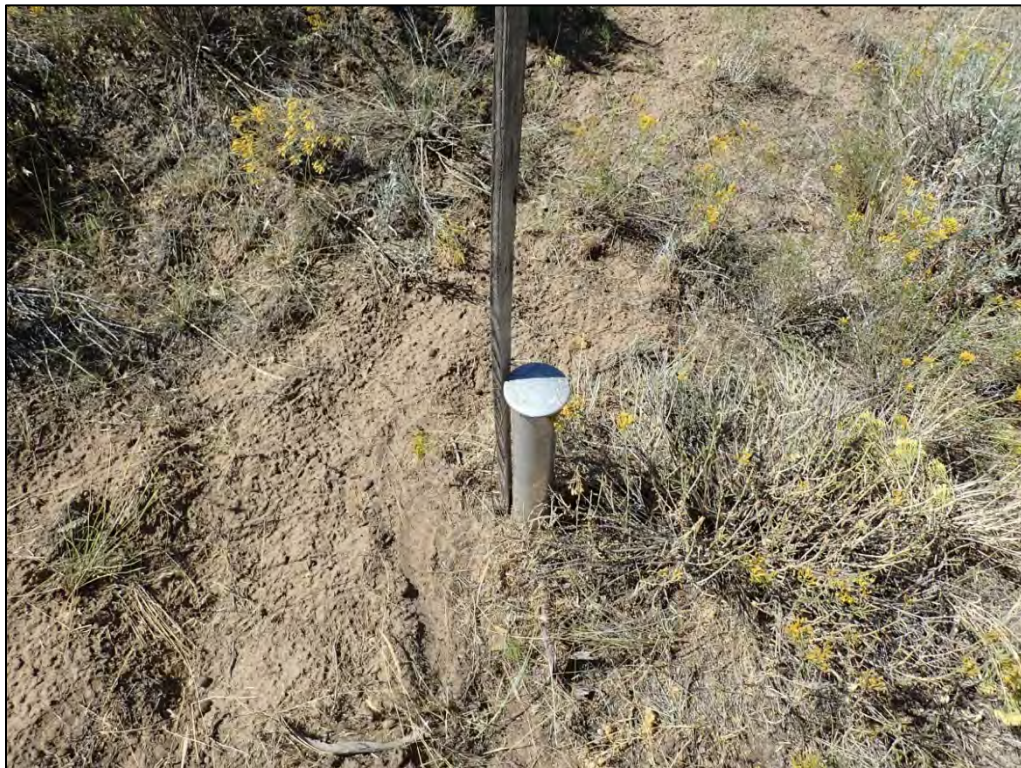
Eight boundary monuments are on the site boundary outside the fenced area (PL-4). Four of the monuments are at the property corners, and the other four define an approximate 20-foot offset along the north and south boundaries where the private land that LM acquired in fee adjoins the BLM withdrawal area on the western portion of the site. Boundary monuments BM-3 and BM-6 (capped pieces of rebar) define the two 20-foot offsets. Boundary monument BM-3 (PL-5) was first observed to be bent during the 2017 annual inspection; since then attempts to straighten the monument were not successful, and repair or replacement options are being evaluated. No other maintenance needs were identified.

*PL-4. Boundary Monument BM-4*

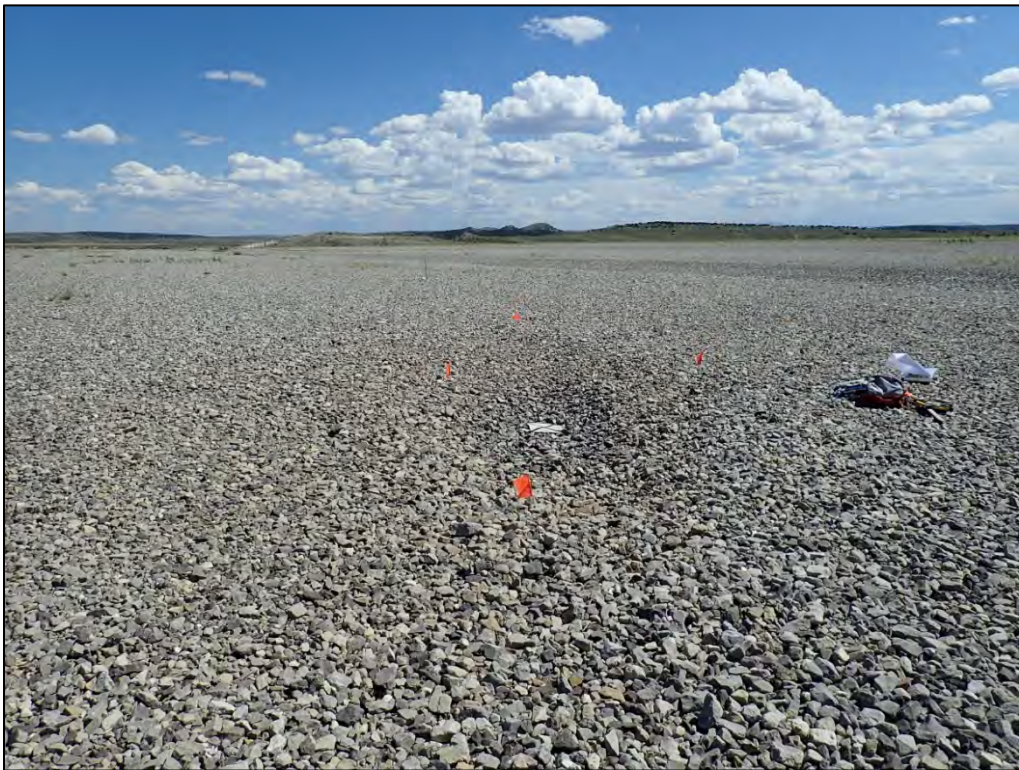
The disposal cell is on the reclaimed site of a former heap leach processing area. The top slope of the riprap-armored disposal cell occupies about 60 acres of the site. The top of the disposal cell showed no signs of significant erosion, settling, or other modifying processes that would affect the cell’s integrity. However, three small, shallow depressions have been observed (just north of Diversion Channel No. 1) since the site transitioned to DOE in 2010. These depressions appear to be the result of the underlying materials settling since completion of the disposal cell. Depression No. 1 was discovered during the initial annual inspection in 2010 (PL-6). A second smaller and shallower depression (Depression No. 2) was first noted just west of the first

depression during the 2016 annual inspection. A third, smaller depression (Depression No. 3) was first observed during the 2018 annual inspection. All three depressions appeared during the 2019 inspection to be approximately the same size as observed during the 2018 annual inspection. Measurements taken year to year vary due to the methodology employed (i.e., using a handheld tape measure) and the individual taking the measurements.

No standing water was observed in any of the depressions during the inspection. These depressions currently do not threaten the integrity or performance of the disposal cell. No maintenance needs were identified.

*PL-6. Depression Feature on Top of Disposal Cell*

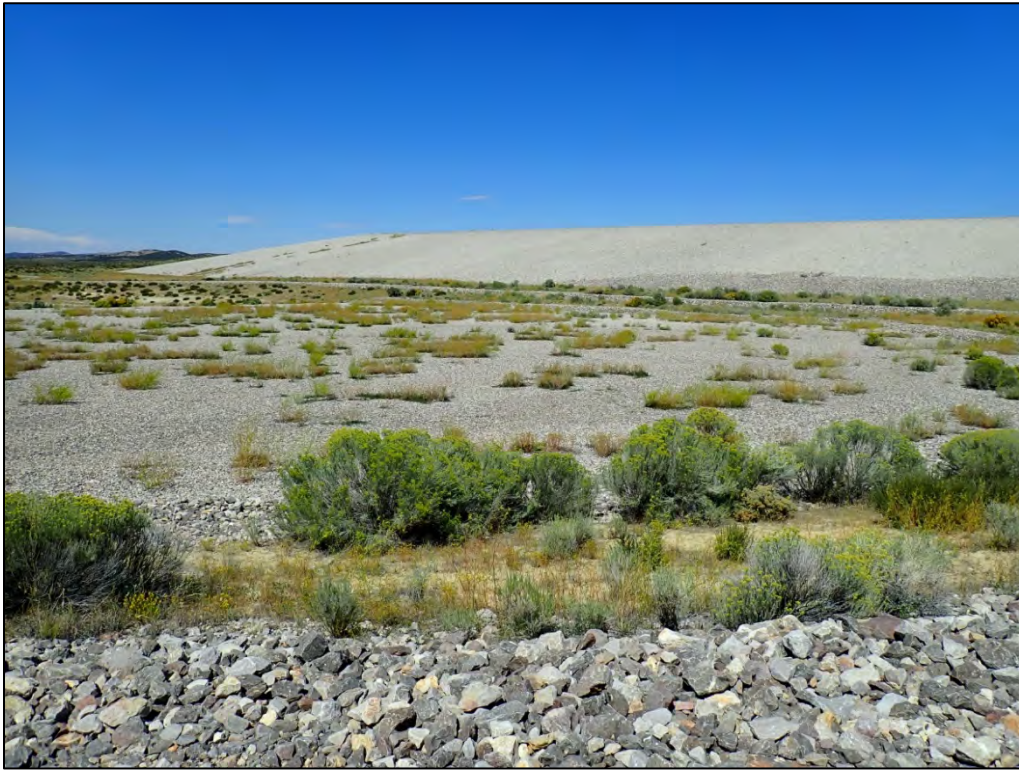
*PL-13. Ancillary Cell Top Slope*

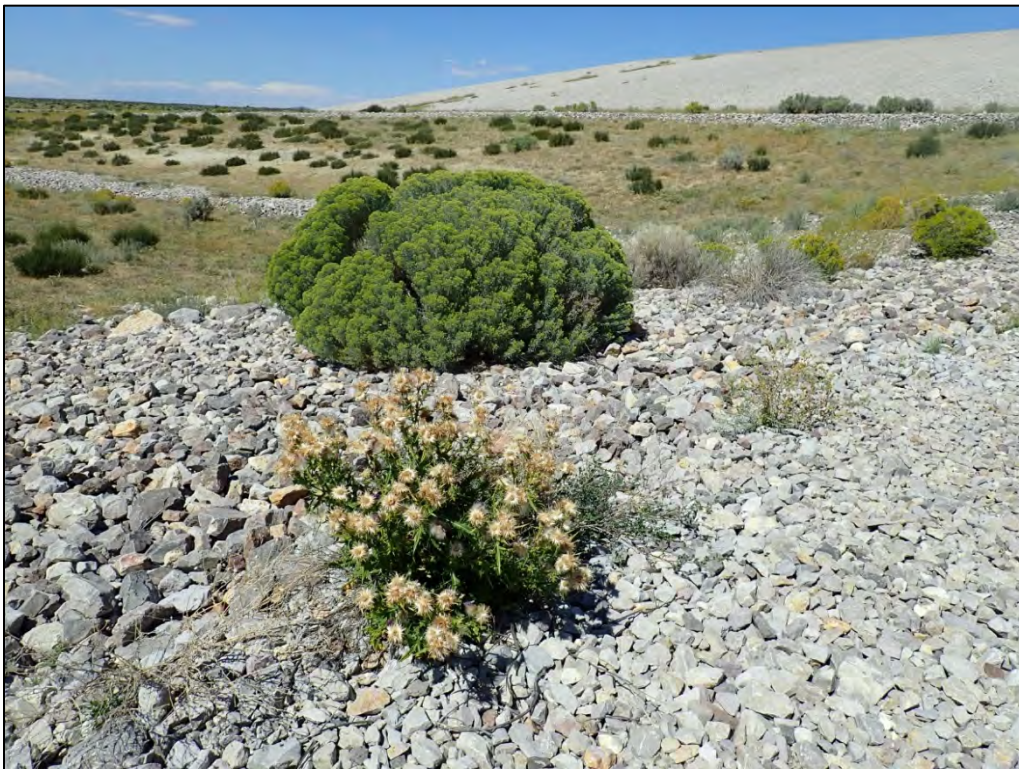
*PL-14. Noxious Weed and Rubber Rabbitbrush on Ancillary Cell*

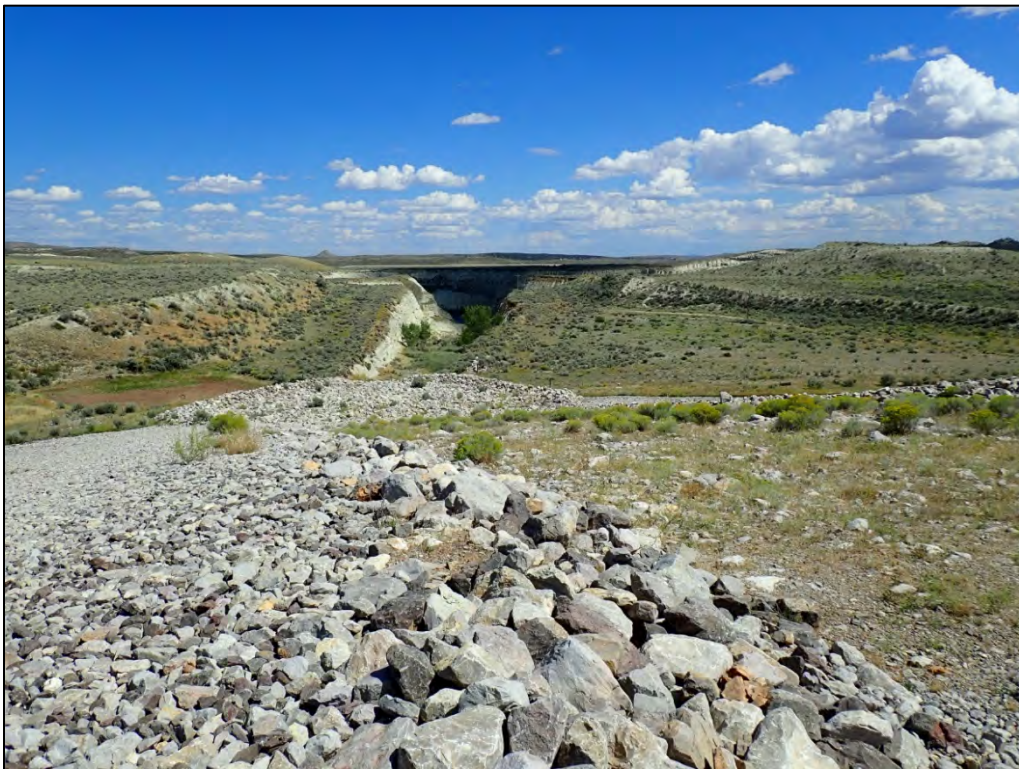
*PL-16. Launch Rock Erosion Protection Basin on Disposal Cell East Side Slope; Rob Pit in Background*

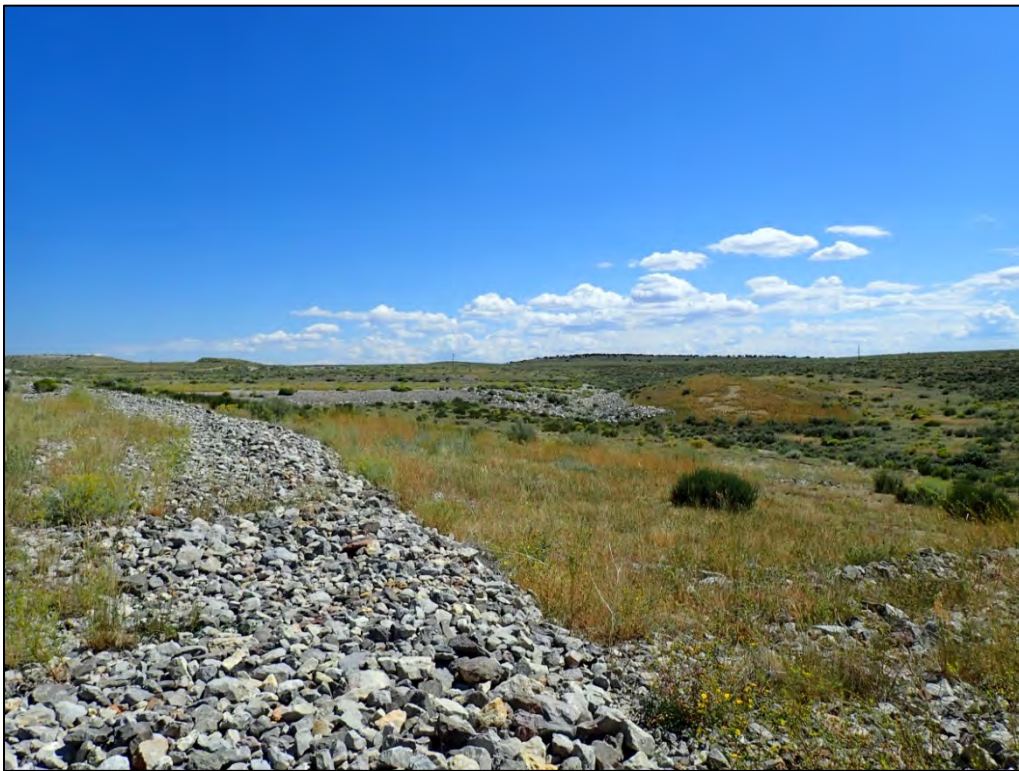
*PL-18. Erosion Protection Rock Berm with Ancillary Cell and Diversion Channel No. 2 in Background*

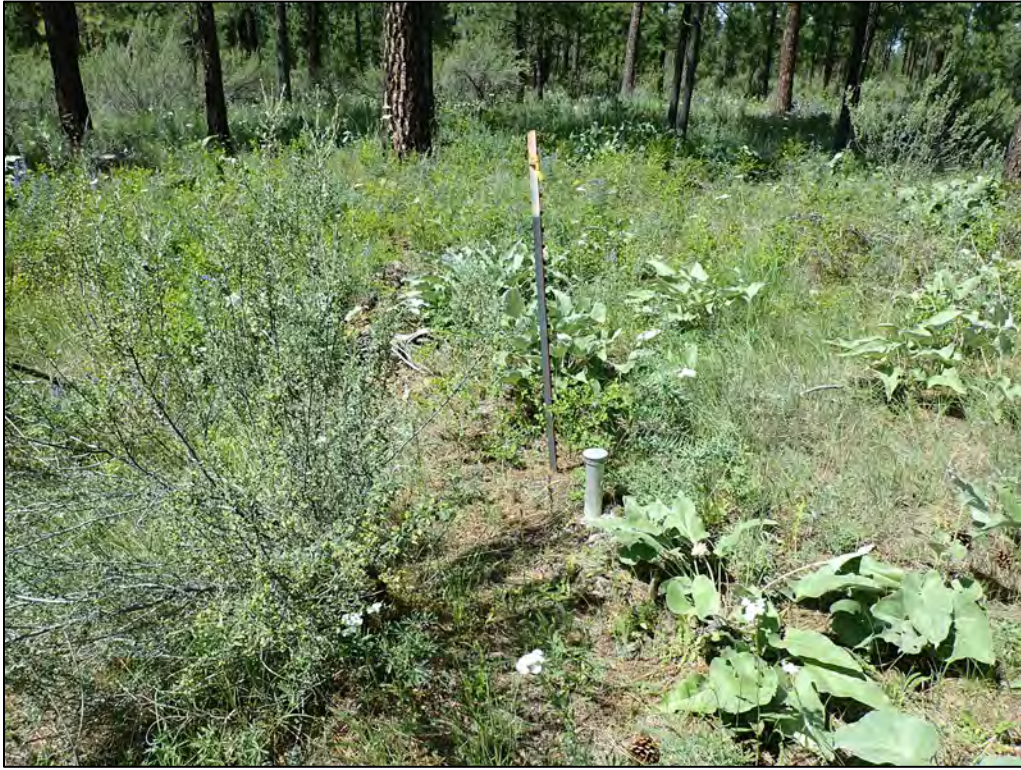
Six boundary monuments set in concrete define the site boundary. Because surrounding vegetation has made it difficult to locate some of the monuments, metal T-posts were installed at each monument location (PL-3). All boundary monuments were inspected. No maintenance needs were identified.

*PL-3. Boundary Monument BM-4*

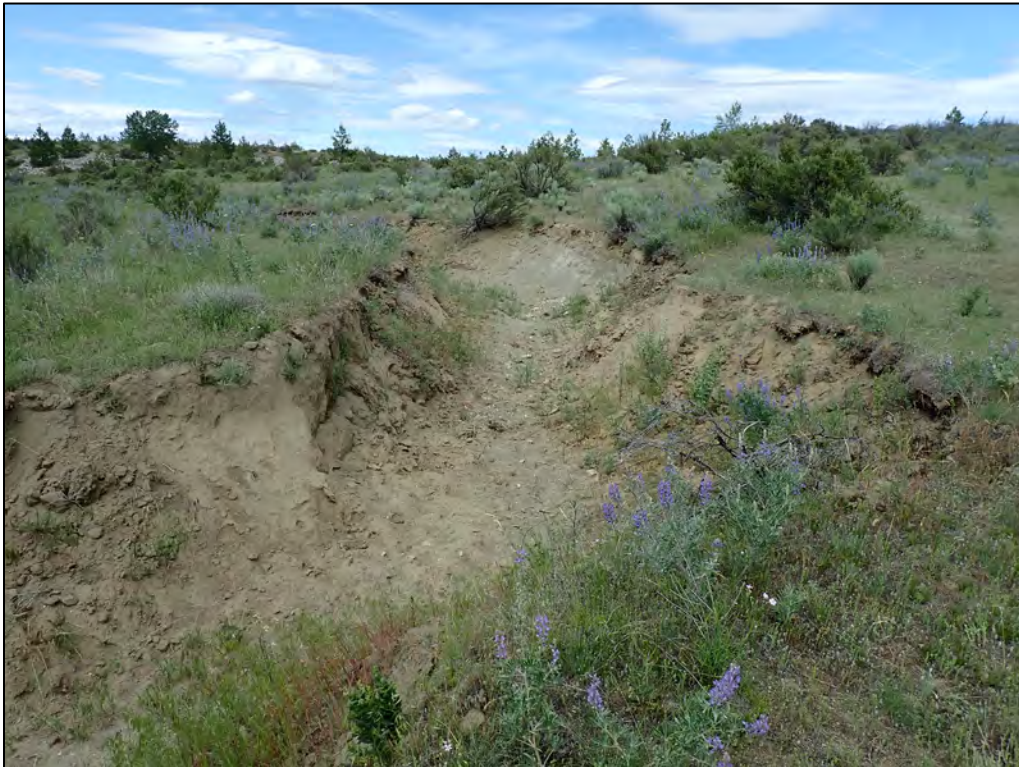
A gully just offsite was first observed in 2009 downgradient of the riprap-armored swale near perimeter sign P1. The gully is photographed periodically to monitor its development (PL-6). Although erosion continues to occur because of site drainage effects, the gully appears to be stabilizing as its grade reaches equilibrium with surrounding topography. The gully is not impacting site features or access but will continue to be monitored. No maintenance needs were identified.

*PL-6. Gully Downgradient of Riprap-Armored Swale (Near Perimeter Sign P1)*

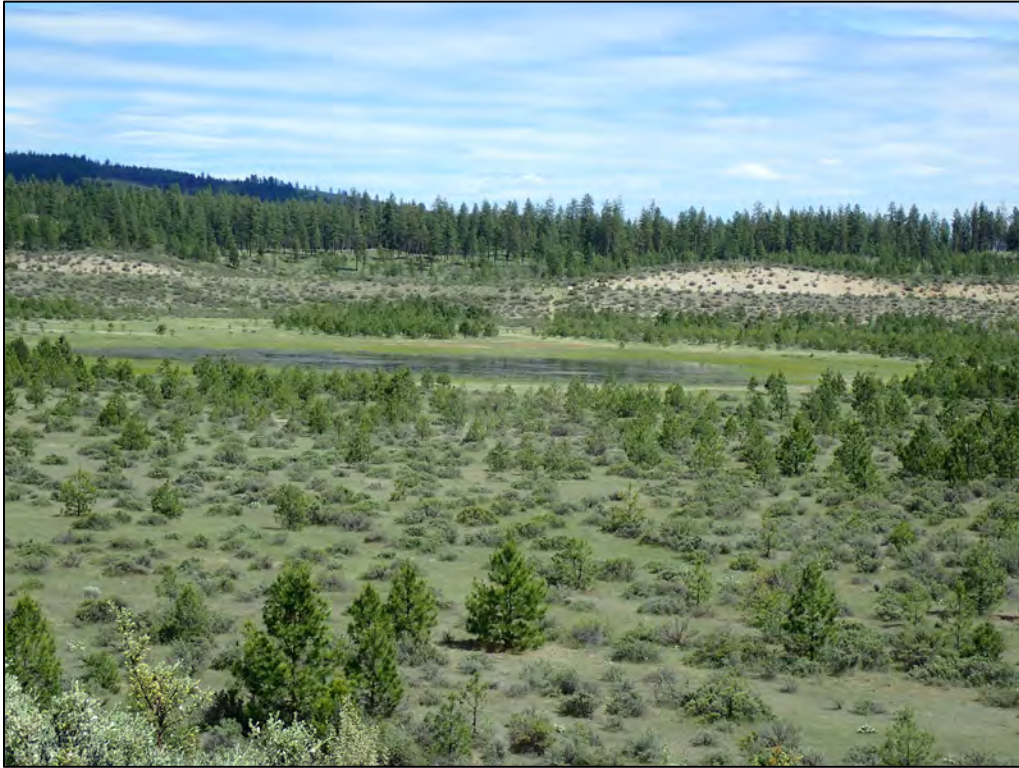
and settlement (DOE 2001). The largest area of settlement is referred to as Pond 1 (PL-7). The plant species present indicate the presence of year-round moisture below the surface of the pond area. Other minor depressions—designated as Ponds 2, 3, and 4—are often dry. An evaluation of topographic surveys conducted in 2016 and 2017 indicated that settlement up to 4.4 ft has occurred near the ponds since construction of the disposal cell. The cover was designed to withstand up to 10 ft of settlement (DOE 2018a). The shallow ponds are considered to be favorable features on the disposal cell cover, but LM will continue to monitor the surface for unusual settlement features to verify the cover’s integrity and ensure that the disposal cell is performing as designed. No maintenance needs were identified.

*PL-7. Pond 1 on Disposal Cell Top Slope*

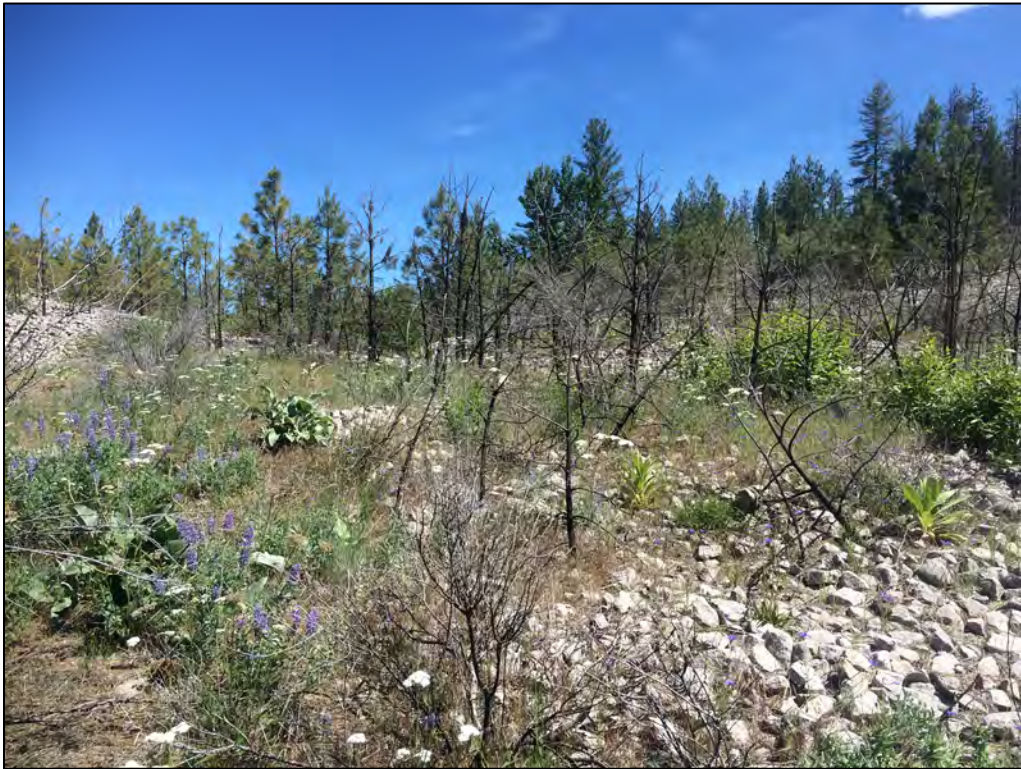
A riprap-armored diversion channel surrounds the disposal cell and diverts runoff away from the disposal cell surface. The diversion channel was designed to allow trees to grow and stabilize the surfaces, and the presence of trees in the diversion channel is not expected to hinder the diversion channel's ability to convey design flows. The intrusion of volunteer plants, including trees, is evident in most areas of the diversion channel (PL-9). Sediment deposition is found in places on the west leg of the diversion channel but does not interfere with the diversion channel's design function. Upslope areas that have contributed to the sedimentation have stabilized with vegetation. Wildlife trails cross the diversion channel at numerous locations and have displaced the diversion channel riprap in several places. These disturbances will be visually monitored for erosion but are not in areas that would impact the disposal cell. No evidence of erosion was observed downgradient of the diversion channel outlet (PL-10). No maintenance needs were identified.

*PL-10. Diversion Channel Outlet*

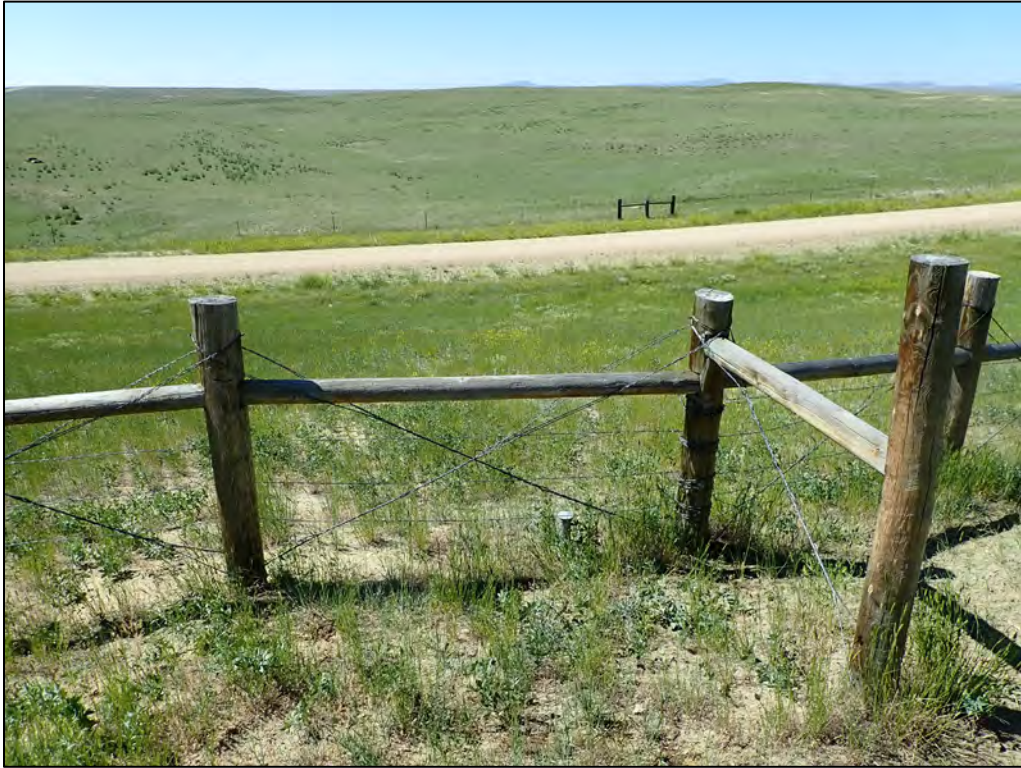
There are 27 boundary monuments delineating the site property boundary (PL-5). All boundary monuments were inspected. No maintenance needs were identified.

*PL-5. Boundary Monument BM-15*

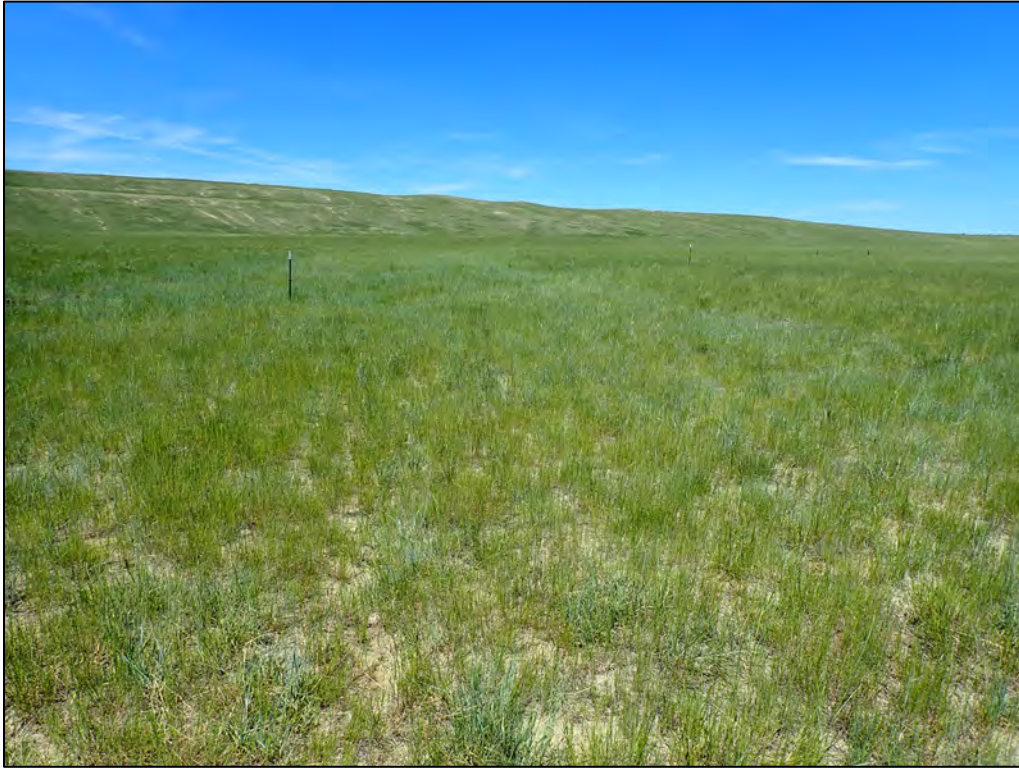
*PL-11. Upgradient View of North Channel*
