U.S. DEPARTMENT OF
ENERGY

Legacy
Management

2019 Annual Site Inspection and Monitoring Report for Uranium Mill Tailings Radiation Control Act Title I Disposal Sites

March 2020

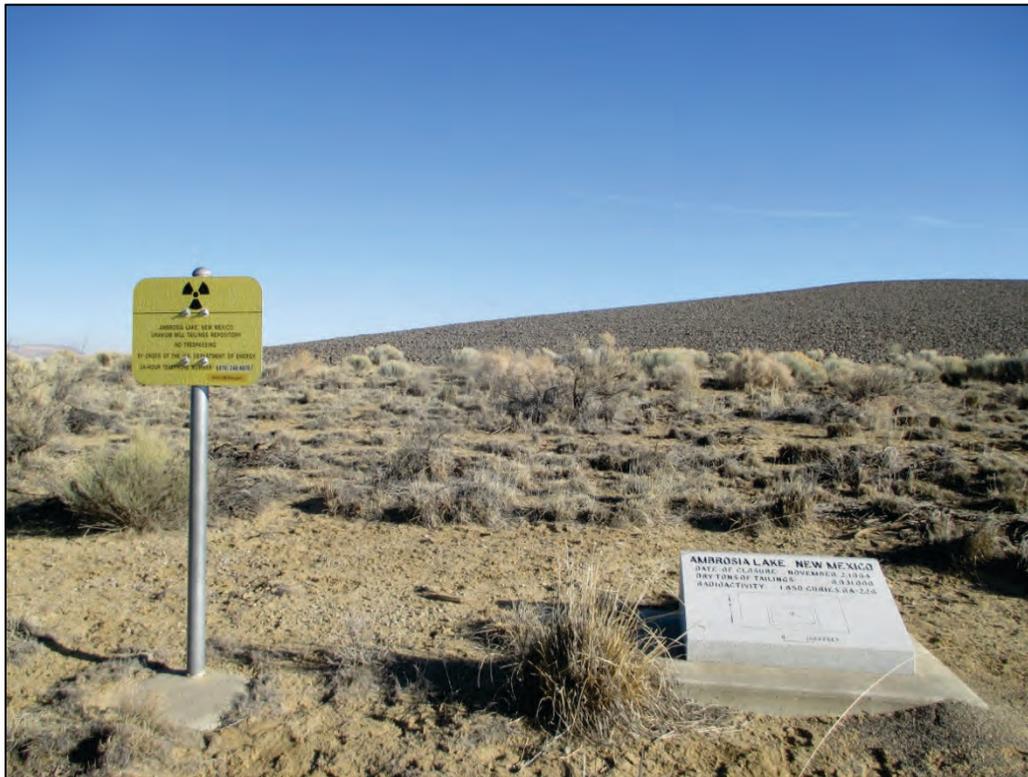
PL-1. Entrance Sign and Site Marker SMK-1

- Replacing the cracked entrance sign
- Replaced perimeter signs P1 through P15 and associated mining restriction signs

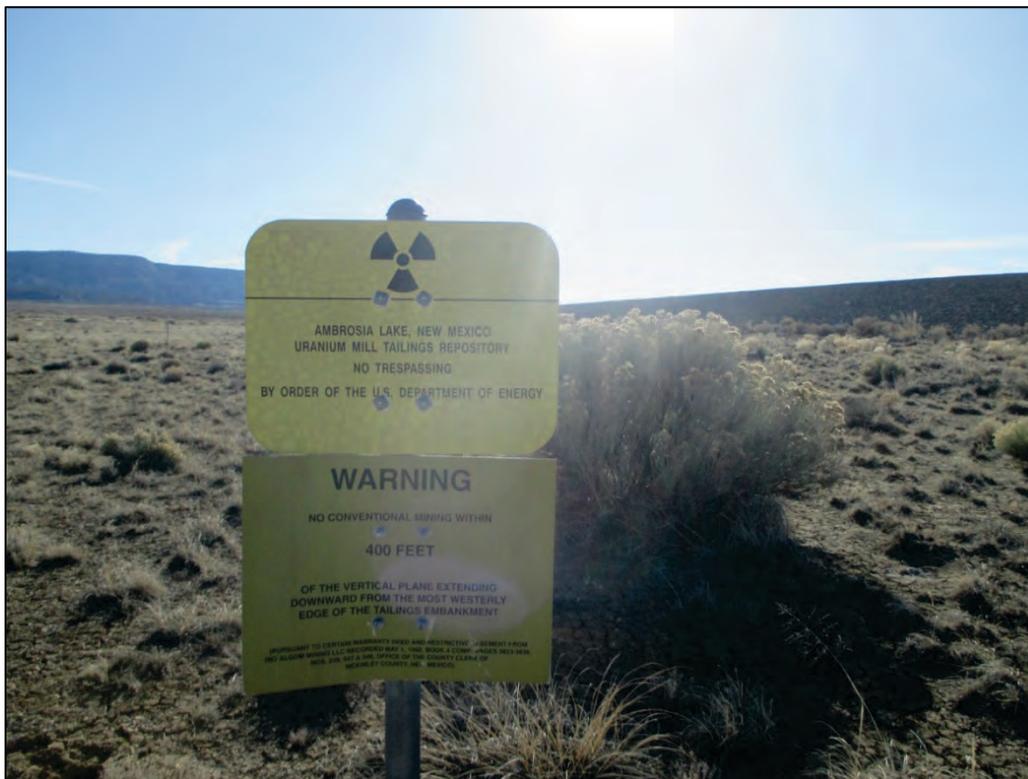
PL-2. Perimeter Sign P10 and Mining Restriction Sign (Replaced Following Inspection)

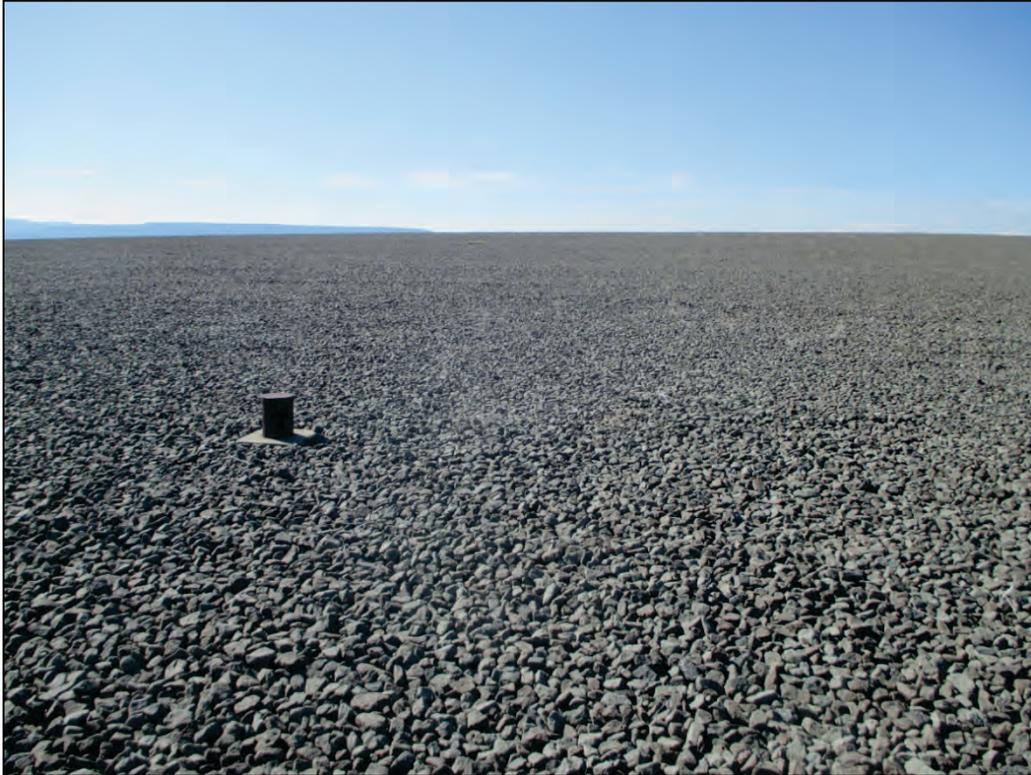
PL-7. Minor Settlement near Settlement Plate SP-4

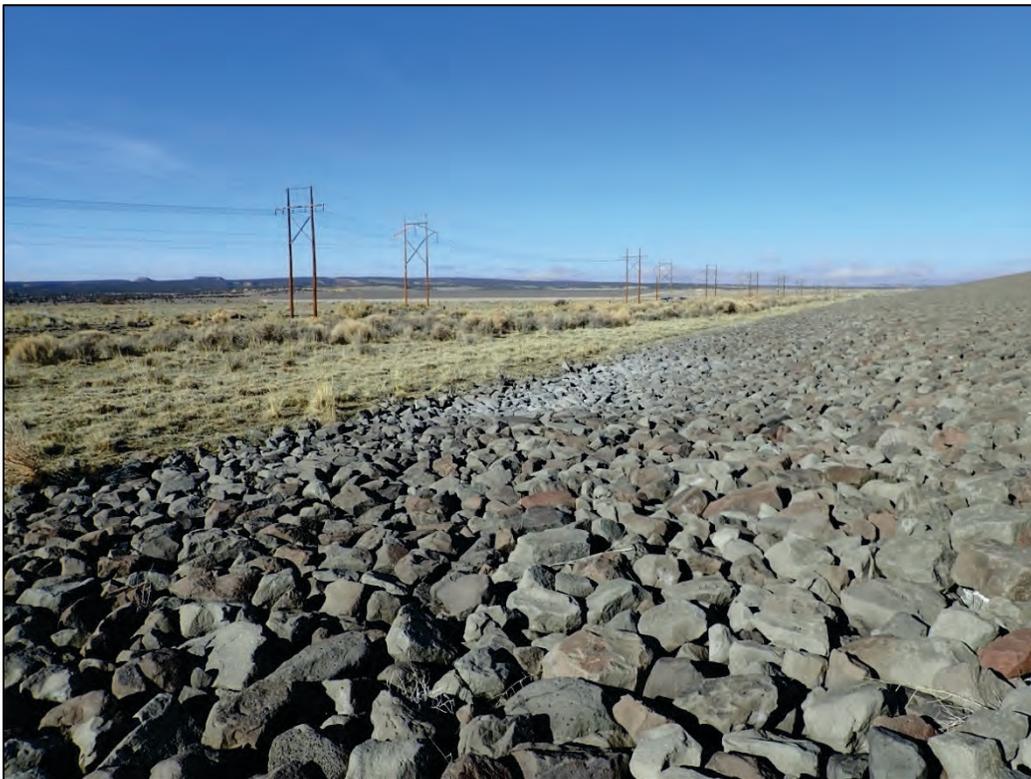
PL-8. South Side Slope of Disposal Cell and Area That Ponds (Dry)

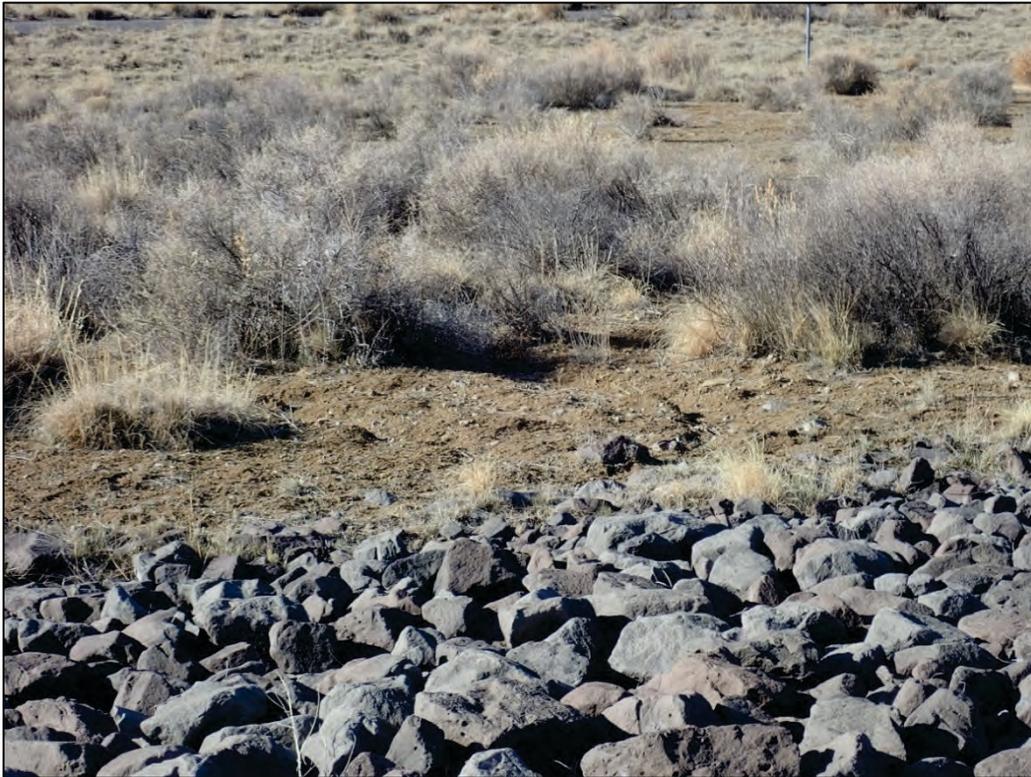
PL-9. Rills at Southern Base of Disposal Cell

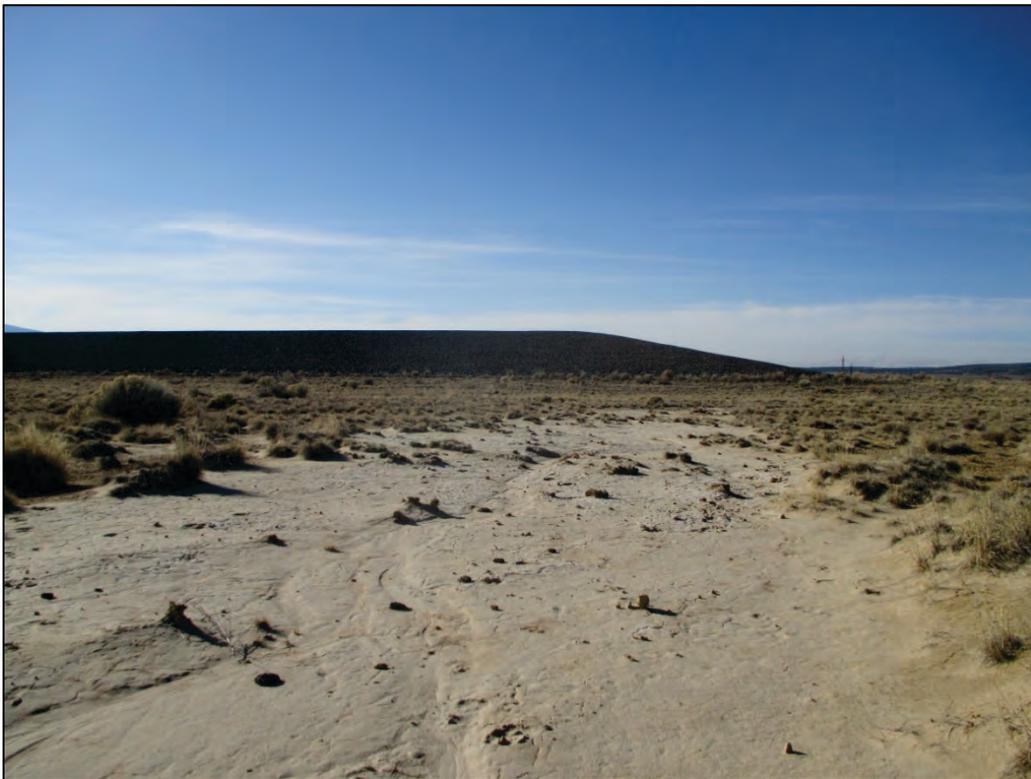
PL-10. Bare Spot North of Disposal Cell with Minor Rills

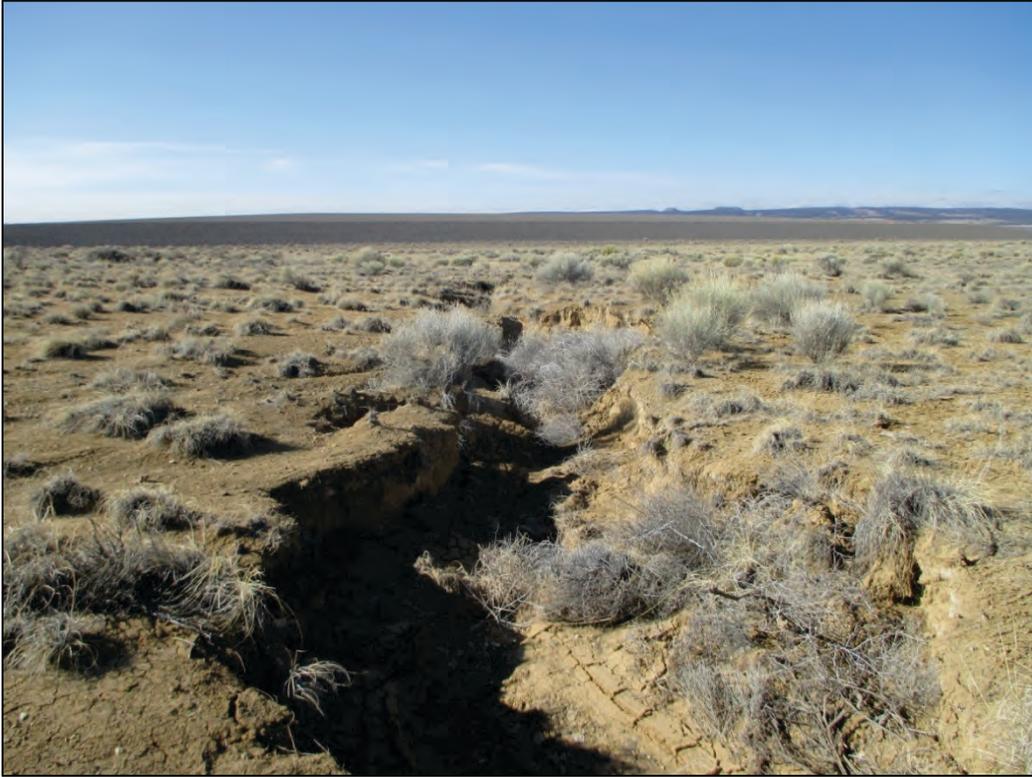
PL-11. Erosion North of Disposal Cell

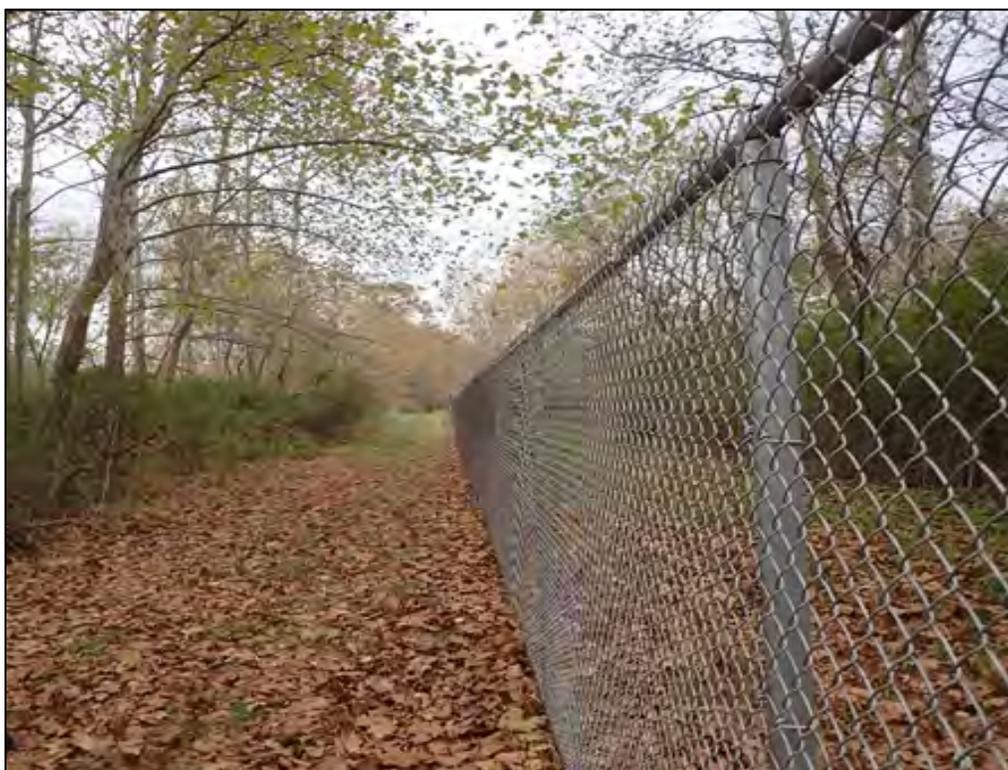
A chainlink security fence encloses the disposal cell and drainage features. The site herbicide subcontractor keeps the fence line clear of vegetation, which should prolong the life of the security fence (PL-2). Tree limbs growing toward, or hanging over, the security fence tagged during the 2018 inspection were removed in 2019 before the inspection. An information sign that was posted on the personnel gate at the west end of the site was identified as missing during the 2018 inspection and was replaced in 2019 before the inspection.

PL-2. Southeast Fence Line

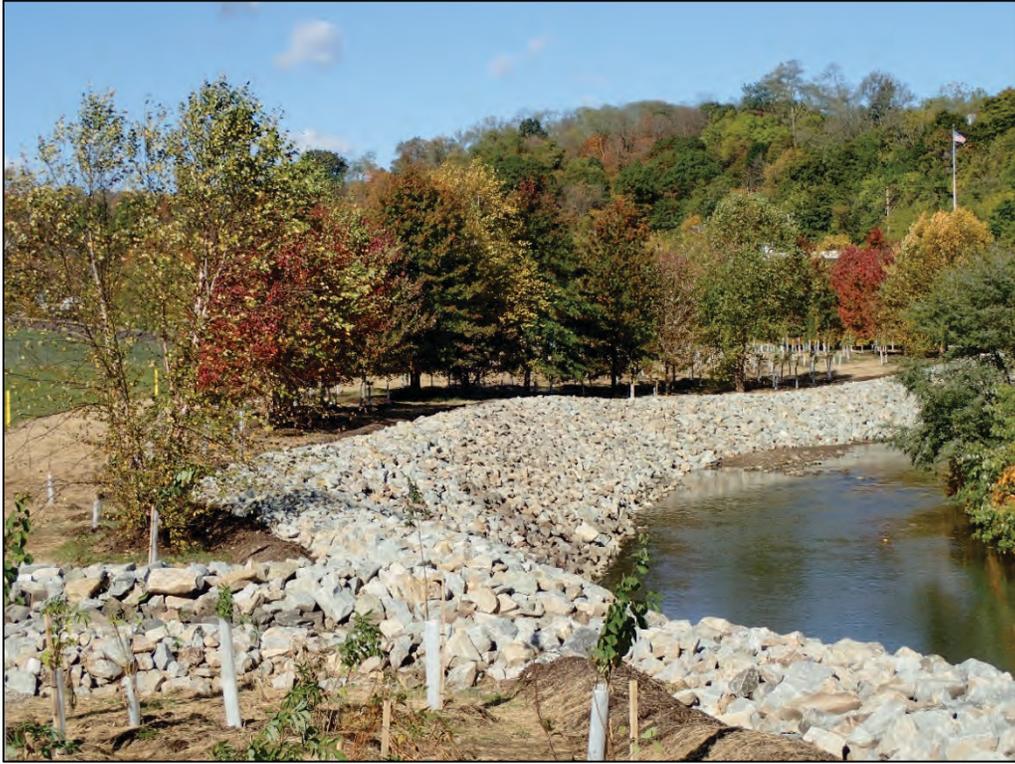
PL-5. Newly Repaired Riprap Embankment

- **Canonsburg, Pennsylvania, Disposal Site:** Engineered repairs to the riprap-armored embankment of Chartiers Creek north of the disposal cell were completed. A riparian forest buffer was planted above and along the embankment to further stabilize the area against future stream flooding events and to reduce erosion upgradient of the riprap embankment. Disturbed areas were seeded with a pollinator-friendly native grass and wildflower mix.

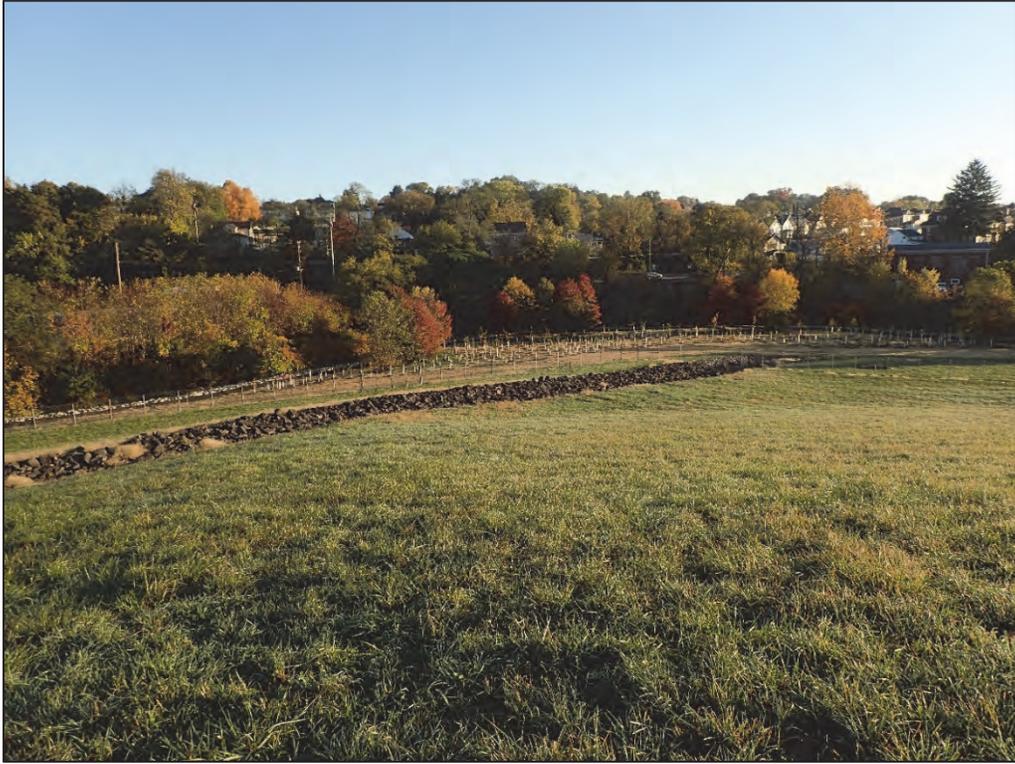
PL-7. Newly Planted Riparian Area

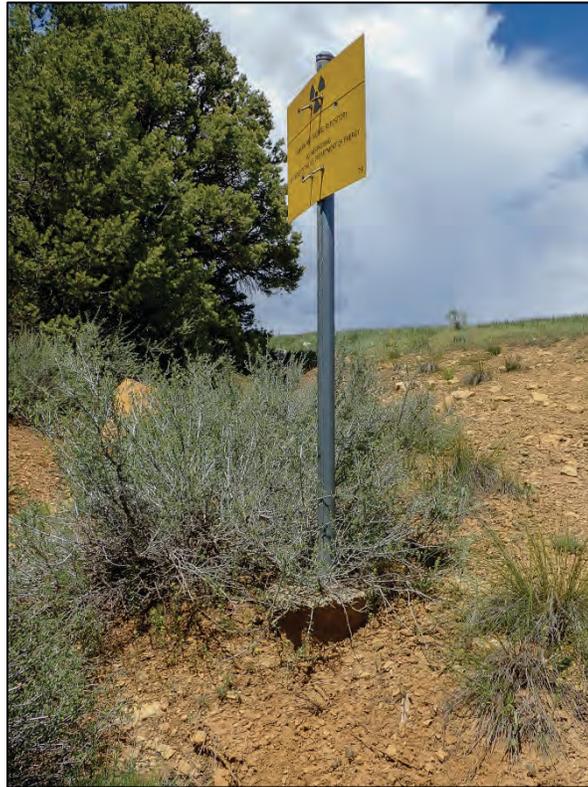
The concrete bases of several perimeter signs have been and continue to be undercut, but the positions of the signs remain uncompromised (PL-1). Following the 2018 inspection, perimeter sign P45 was moved approximately 25 feet (ft) to the east, a location less prone to erosion. Vegetation was encroaching on perimeter sign P4 (PL-2) and P18 and was removed in 2019 following the inspection. Perimeter sign P64 was a plastic sign and had faded and curled and was replaced in 2019 following the inspection. Perimeter signs P62 and P63 are also plastic and somewhat curled but still legible at this time. No other maintenance needs were identified.

PL-1. Concrete Base of Perimeter Sign P79 (Undercut by Erosion)

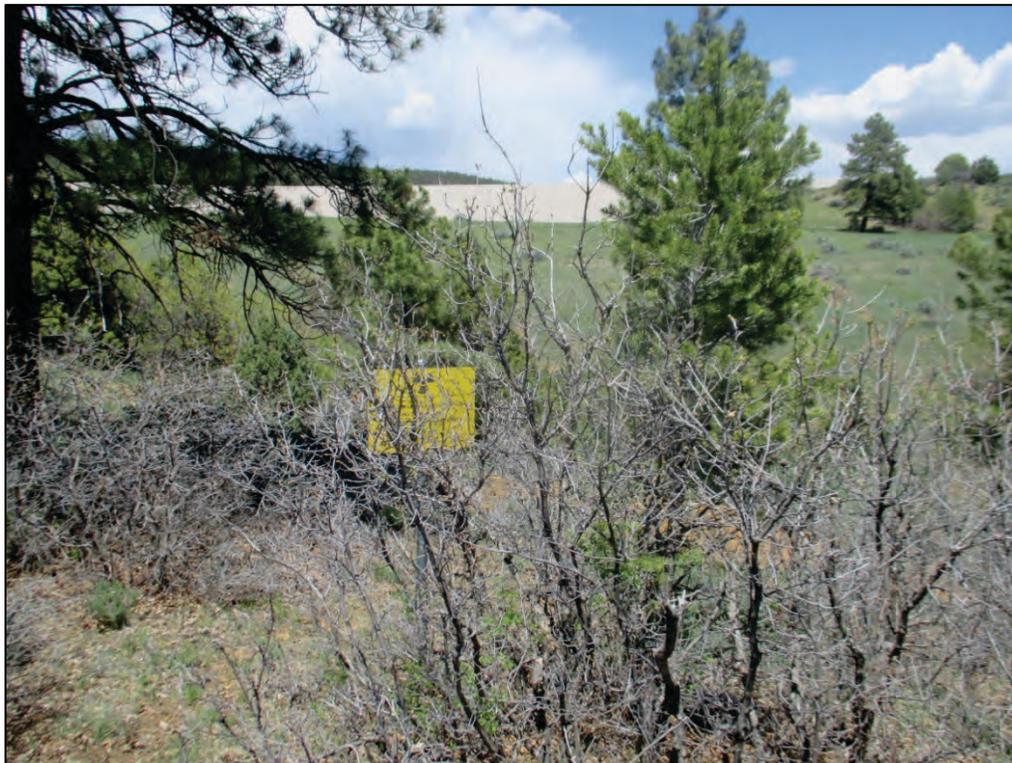
PL-2. Vegetation Blocking Perimeter Sign P4 (Removed Following Inspection)

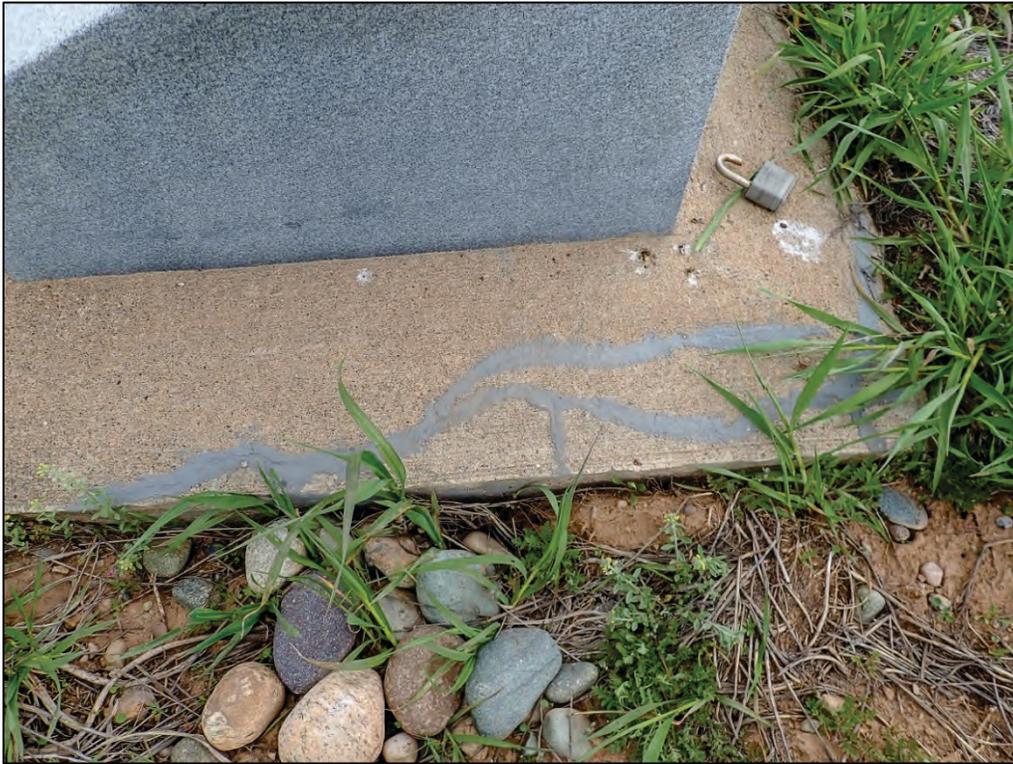
The site has two site markers. Site marker SMK-1 is just inside the original entrance gate; a deep depression to the side of SMK-1 was filled in after the inspection. Site marker SMK-2 is on the top slope of the disposal cell; minor cracking and spalling along the concrete base edges was repaired in 2018 (PL-3). No other maintenance needs were identified.

PL-3. 2018 Repairs to Base of Site Marker SMK-2

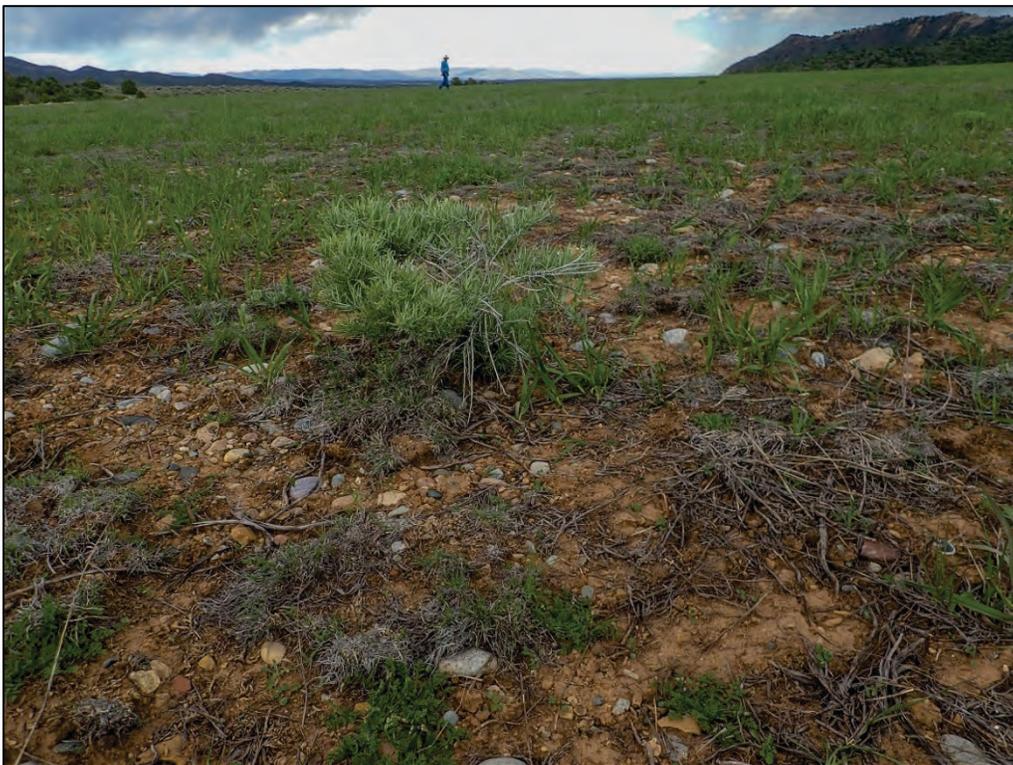
observed in 2019. A single volunteer rabbitbrush shoot (a woody species) (PL-6) was observed growing on the disposal cell top and was treated with herbicide in 2019. No other maintenance needs were identified.

PL-6. Rabbitbrush on Disposal Cell Top

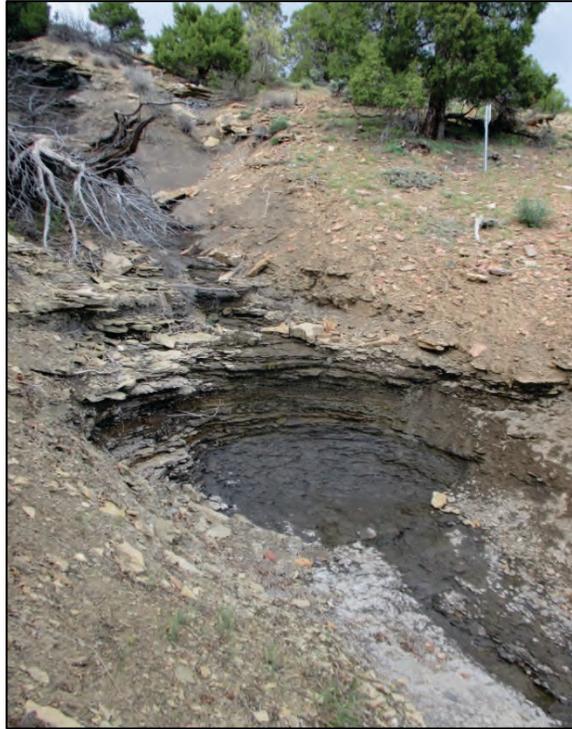
PL-7. Water Flowing in Natural Drainage Near Perimeter Sign P23

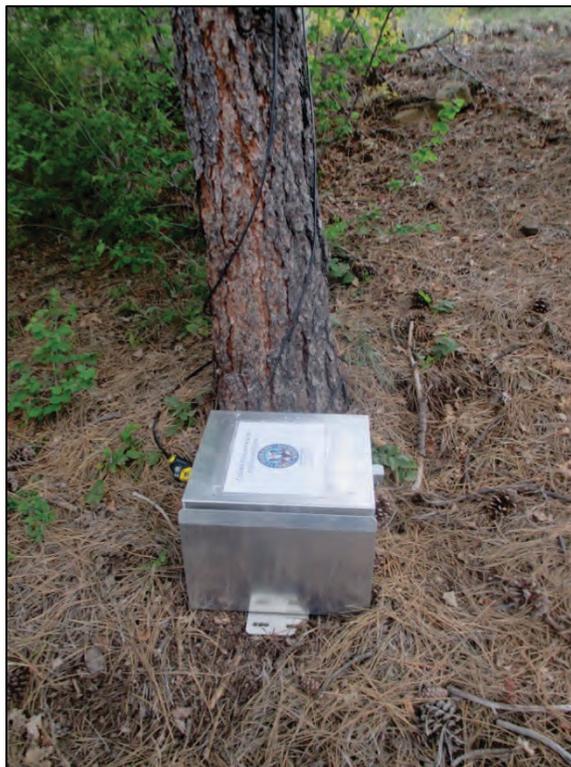
Boundary monuments and perimeter signs delineate the site boundary (property boundary) with one exception; the site boundary marked by boundary monument BM-6 is not delineated with perimeter signs because the signs cut across the corner of the site (perimeter signs P82, P1, P2, and P3). Inspectors noted no new activities or changes to the site boundary area, with the exception of a Colorado Parks and Wildlife (CPW) sound recording device placed near the road along the north side of the disposal cell (PL-8). The device was placed onsite without the

PL-8. Colorado Parks and Wildlife Sound Recorder near Small Pull-out in Road

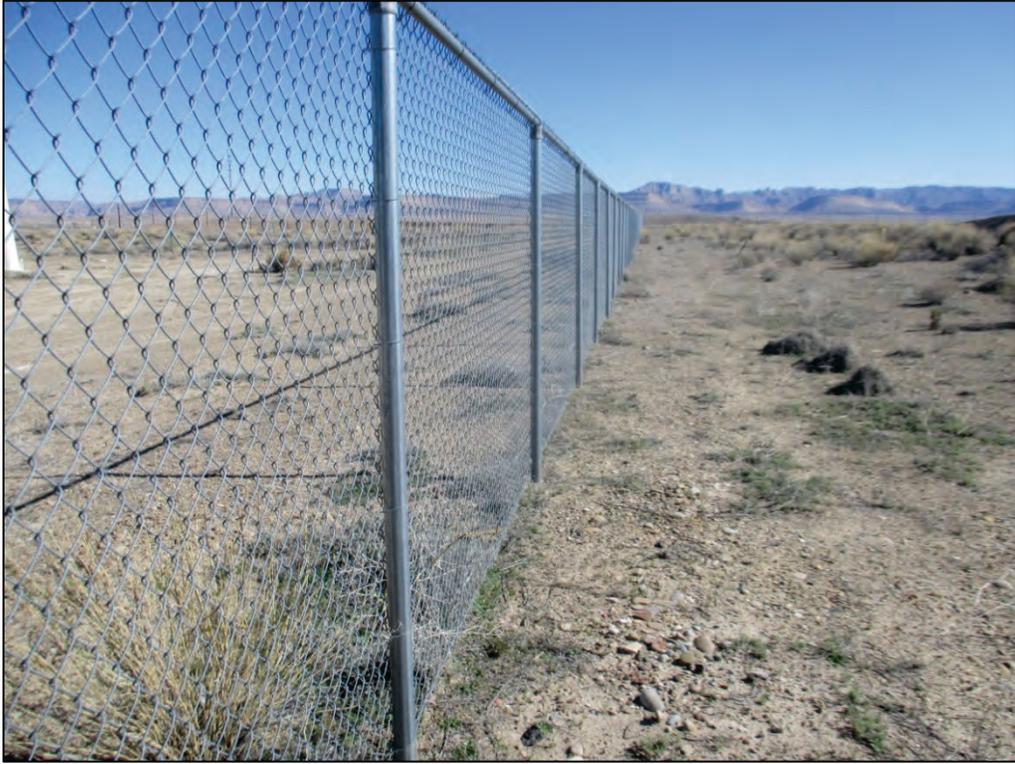
PL-1. Northwest Security Fence Line

A chainlink security fence encloses the portion of the site that contains the disposal cell. Two vehicle gates are at the south and east corners of the security fence line, and a personnel gate is at the north corner of the security fence line. The security fence (PL-1) was intact, and the gates were locked. Minor erosion was identified under the southeast fence line (PL-2), but it does not compromise the integrity of the fence at this time. The erosion was repaired at the time of the inspection.

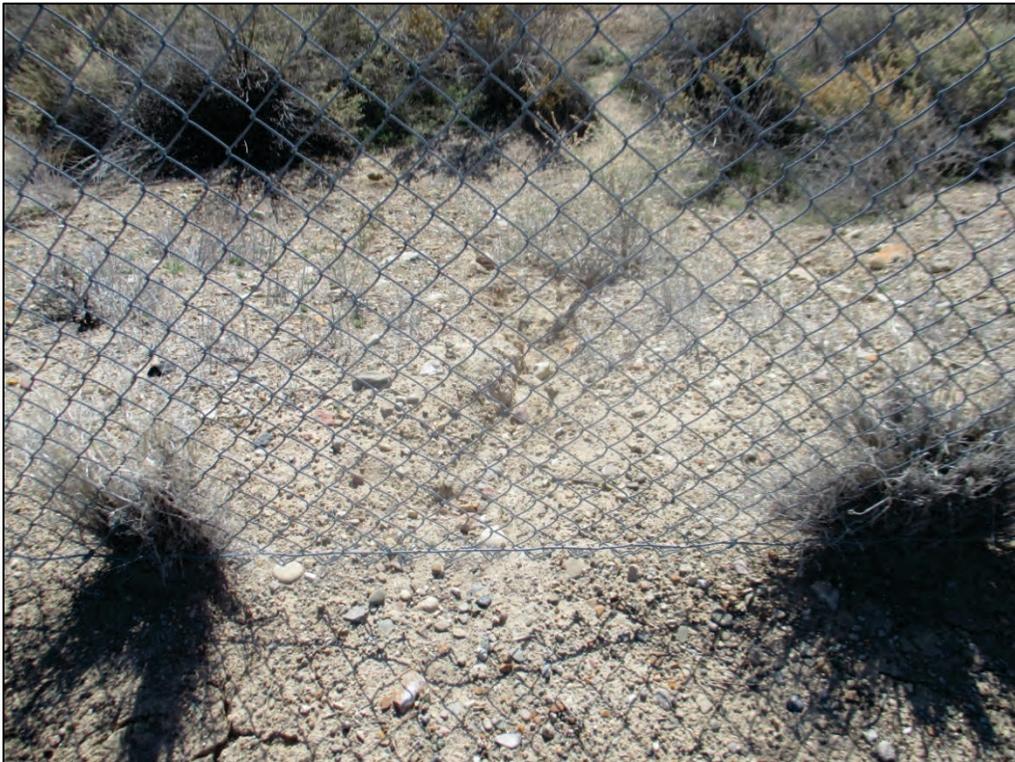
PL-2. Minor Erosion Under Southeast Security Fence Line (Repaired)

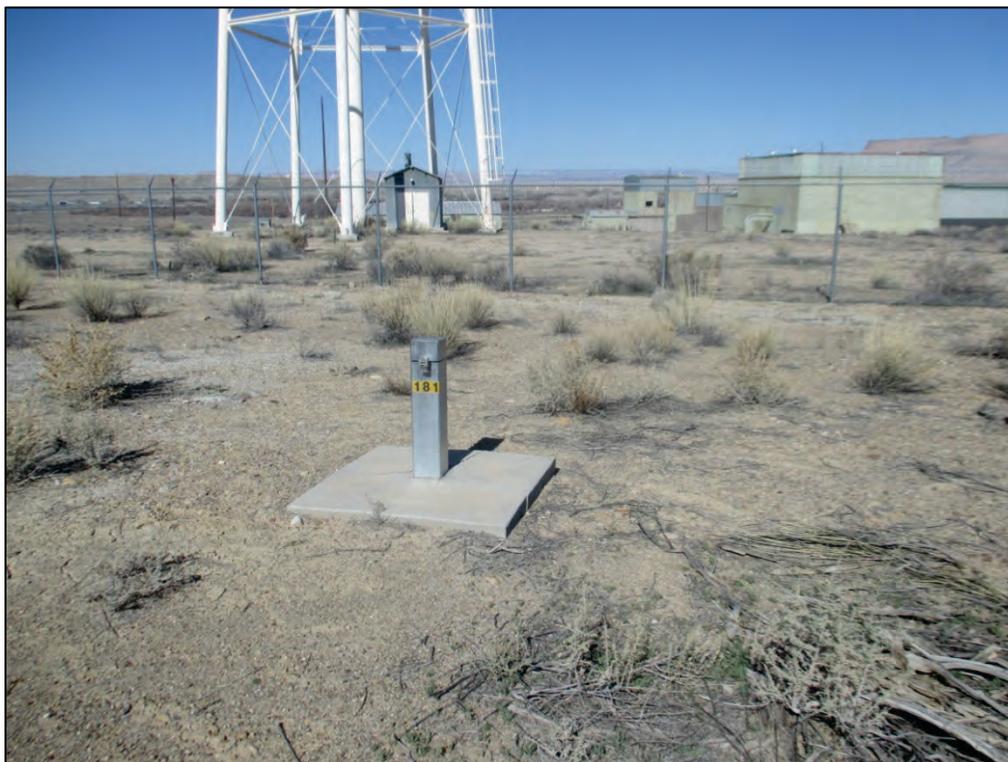
There are 22 monitoring wells on or near the site. Monitoring wells were inspected during the June 2019 sampling event. All wellhead protectors observed during the inspection were undamaged and locked (PL-4). Some of the concrete monitoring well collars are cracked, but the wellhead protectors are stable and repairs are not necessary. No maintenance needs were identified.

PL-4. Monitoring Well 0181 (Abandoned Mill Buildings in Background)

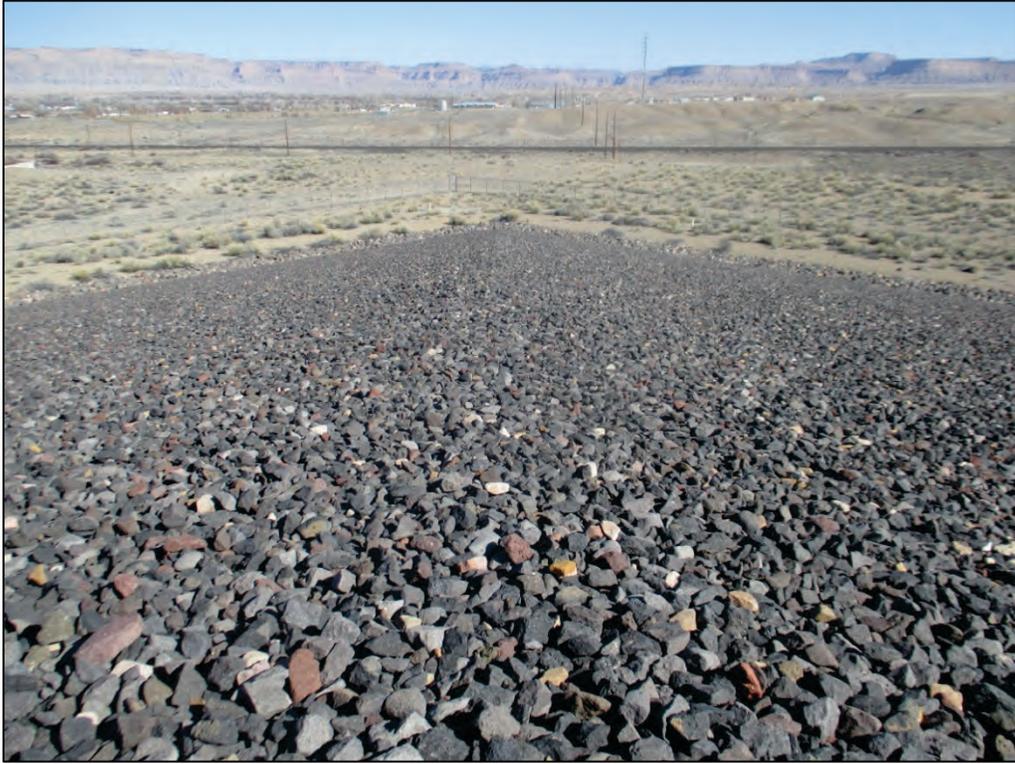
The disposal cell, completed in 1989, occupies 6 acres. The slopes of the disposal cell cover are armored with riprap, consisting primarily of competent basalt with a small fraction of sedimentary rocks, to control erosion (PL-5). A small percentage of the rock, including basalt and sedimentary rock, has degraded, but the riprap cover is functioning as designed (PL-6). There was no evidence of settling, slumping, erosion, or any other modifying process that might affect the integrity of the disposal cell.

PL-5. North Corner of Disposal Cell

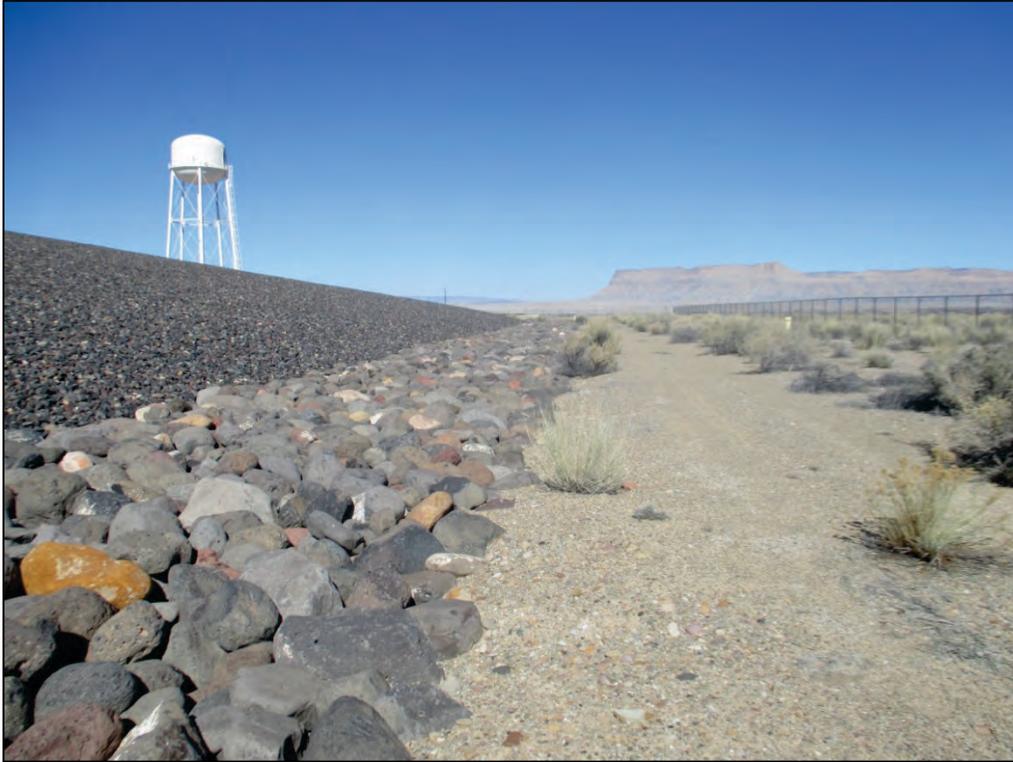
A boulder-filled trench, known as an apron, surrounds the disposal cell (PL-7). The apron was intact and stable, with no observed erosion along the base of the side slopes. Small erosion rills are present along portions of the outside edge of the apron. The rills form as storm water runoff along the disposal cell perimeter road drains into the disposal cell apron. This occurrence is not a concern because the erosion is minor and sedimentation in the apron has not adversely affected the performance of the apron (the sediment has not filled the apron or become visible in the apron). Inspectors will continue to monitor the area.

PL-7. Apron Along Northeast Side of Disposal Cell

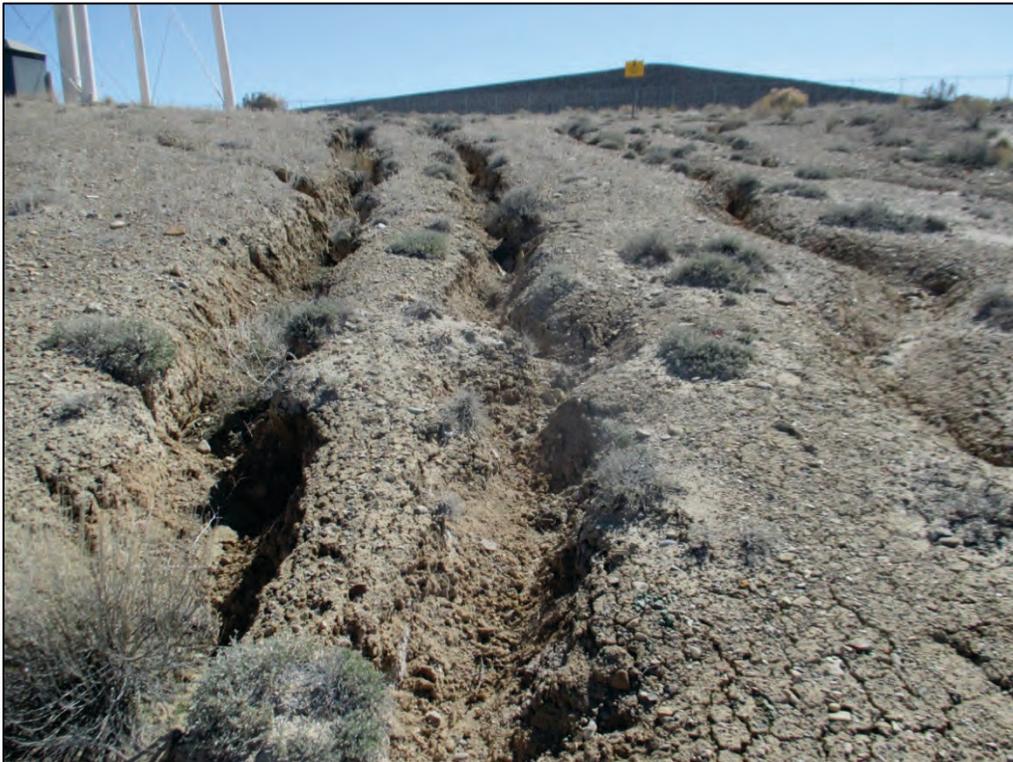
Areas of erosion noted during previous inspections include the natural drainage near the southwest side of the site and rills and gullies northwest of the water tower (PL-8). Evidence of continued erosion in these areas was apparent but currently does not threaten the integrity of the disposal cell or site surveillance features. Inspectors will continue to monitor these erosional features. No maintenance needs were identified.

PL-8. Gullies Near Water Tower and Boundary Monument BM-3

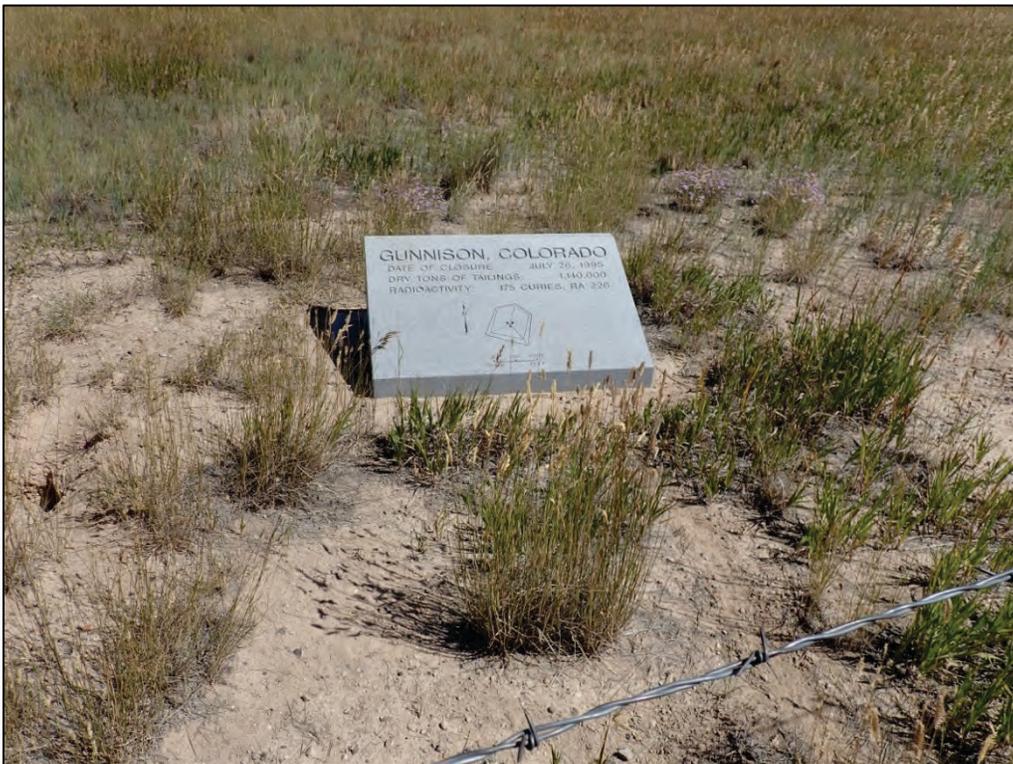
PL-2. Site Marker SMK-1

The site has two granite site markers. Site marker SMK-1 is just inside the entrance gate (PL-2), and site marker SMK-2 is on the top slope of the disposal cell. The base of SMK-2 has a small, insignificant crack and remains stable (PL-3). No maintenance needs were identified.

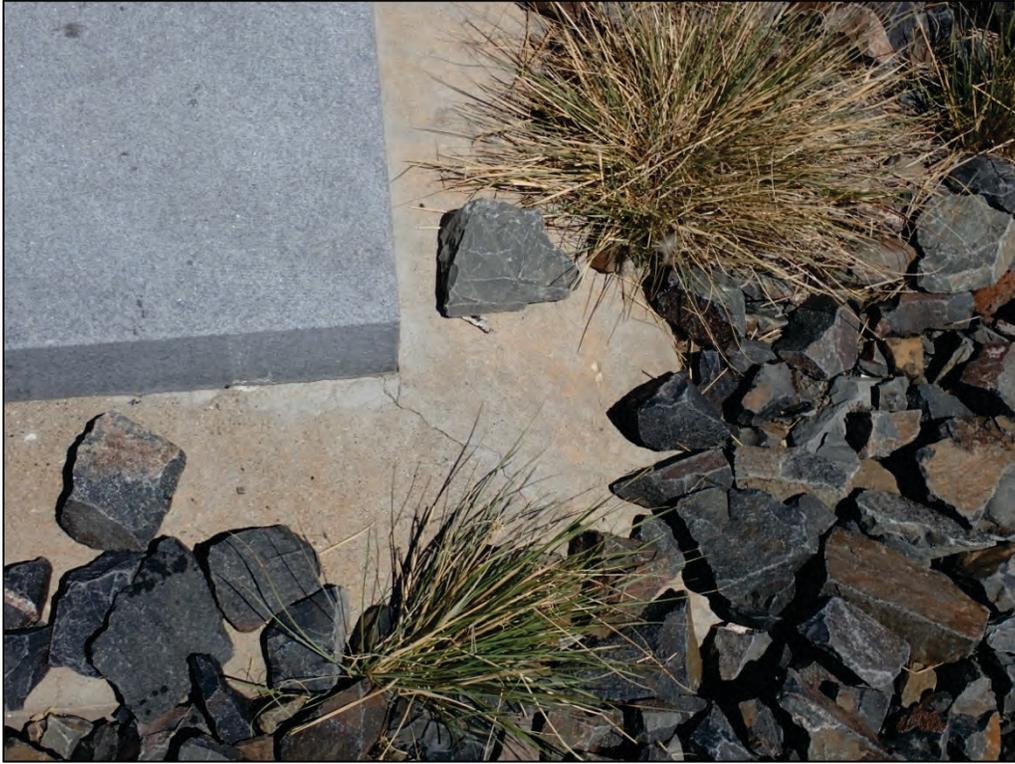
PL-3. Small Crack in Base of Site Marker SMK-2

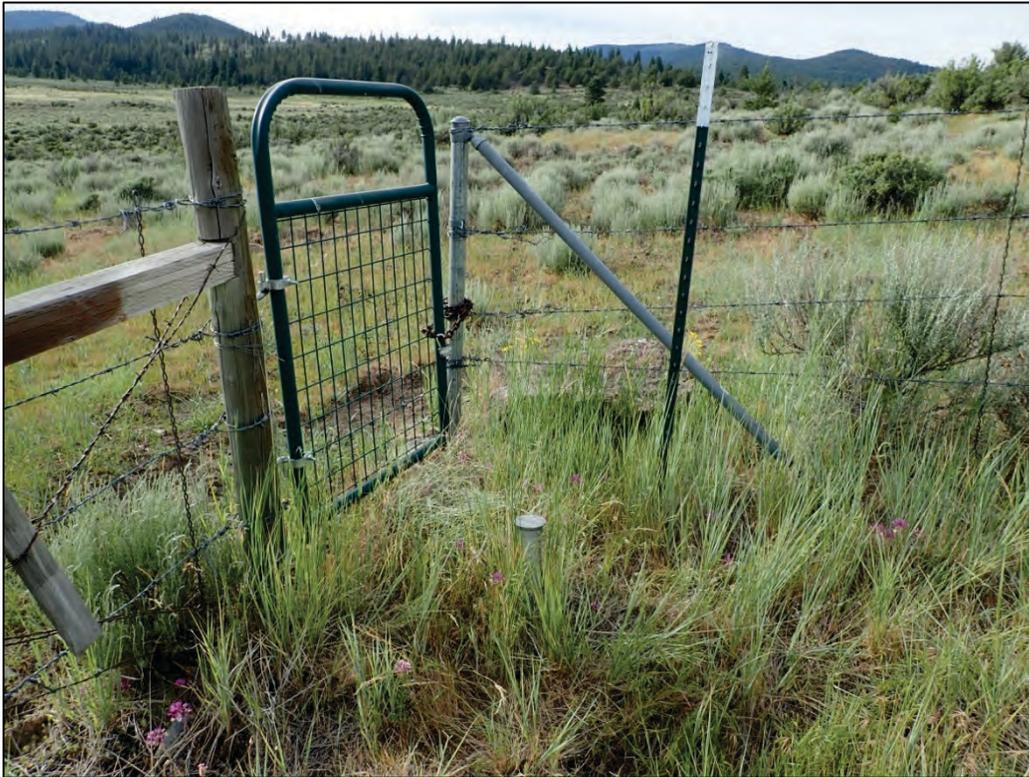
PL-3. Boundary Monument BM-1 and Pedestrian Gate

Access to the site is from a gravel road that heads west from Lake County Road 2-16B. DOE was granted a perpetual easement on the approximately 1.2-mile access road between the county road and the property boundary. A lockable gate across the access road on the adjacent privately owned land limits access to the site. The entrance gate to the site is in the southeast corner of the perimeter fence (PL-1). The entrance gate was locked and undamaged. The entrance sign is attached to a steel post set in concrete along the access road and was undamaged (PL-2). A pedestrian gate in the northwest corner of the site was locked and undamaged (PL-3). No maintenance needs were identified.

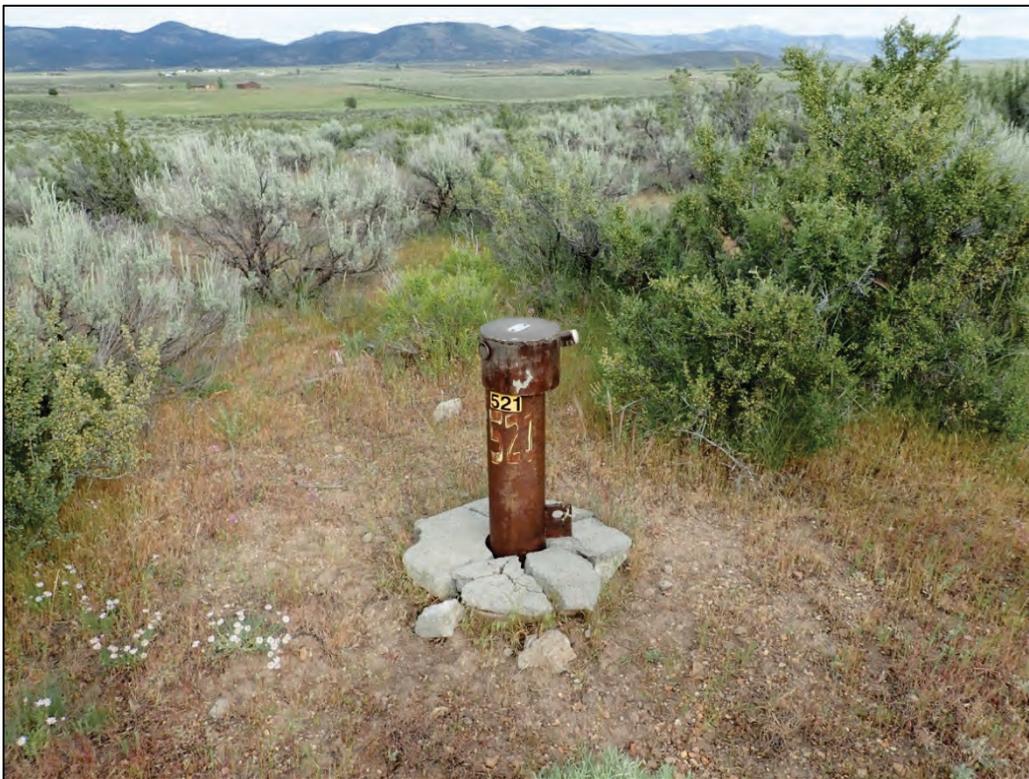
PL-8. Monitoring Well 0521 with Cracked Concrete Base

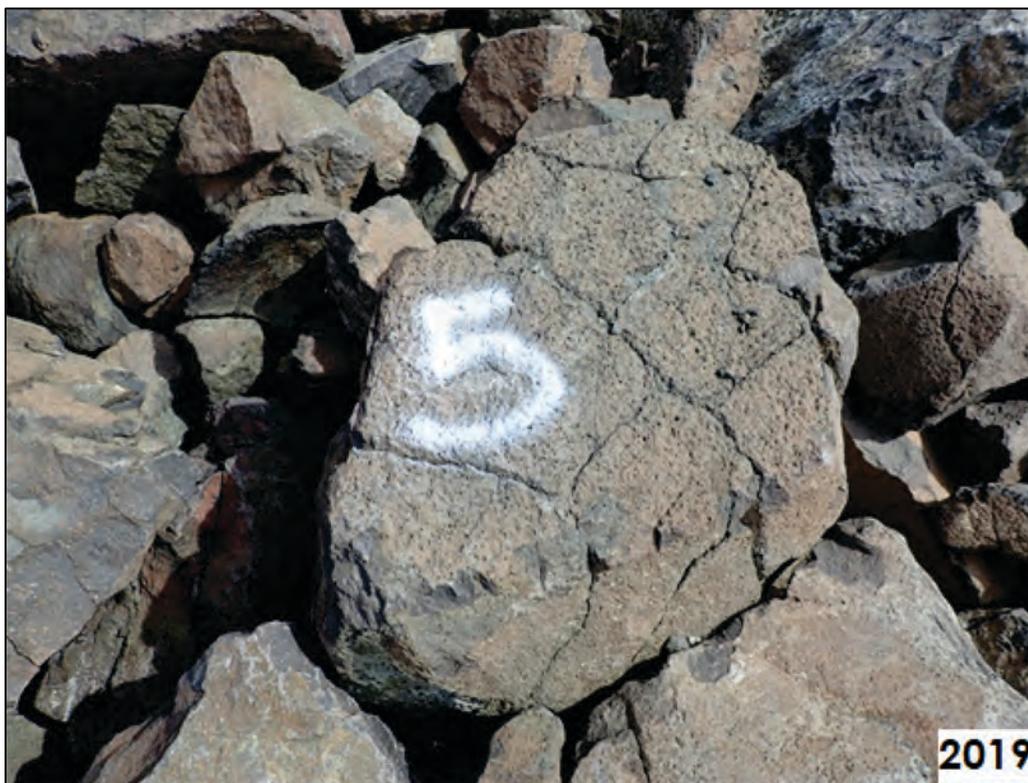
PL-12. (a) Riprap Monitoring Location Number 5 in Energy Dissipation Area—2019

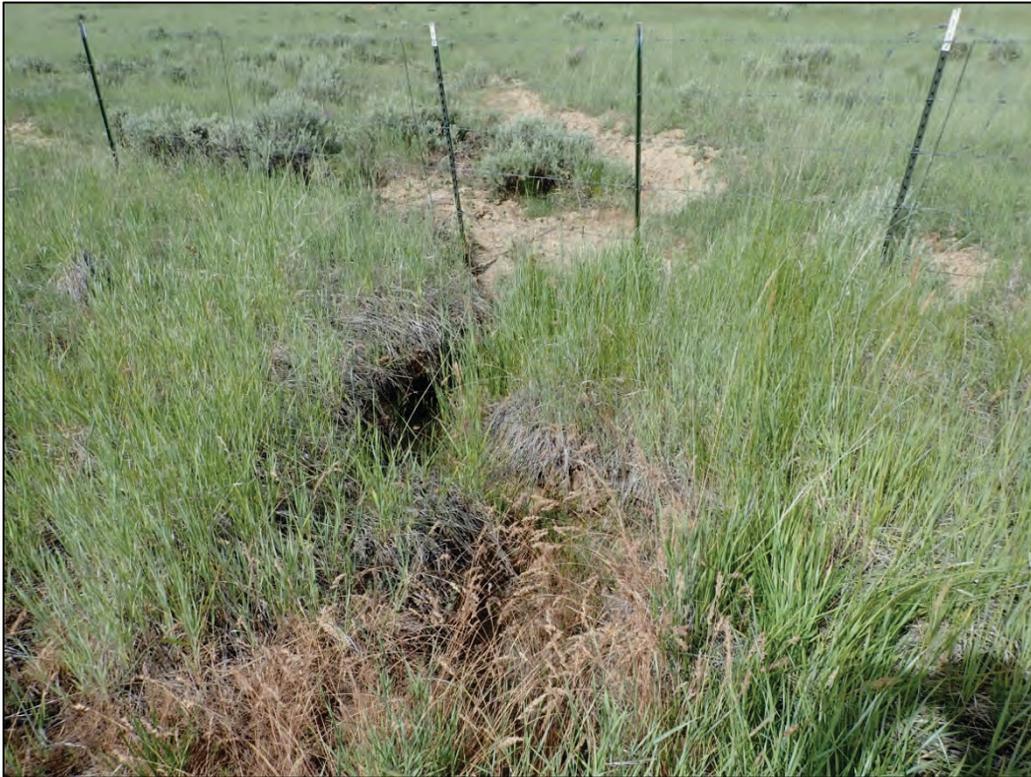
PL-13. Gully Downgradient of Toe Drain 3
