U.S. DEPARTMENT OF
ENERGY

Legacy
Management

2019 Annual Site Inspection and Monitoring Report for Uranium Mill Tailings Radiation Control Act Title I Disposal Sites

March 2020

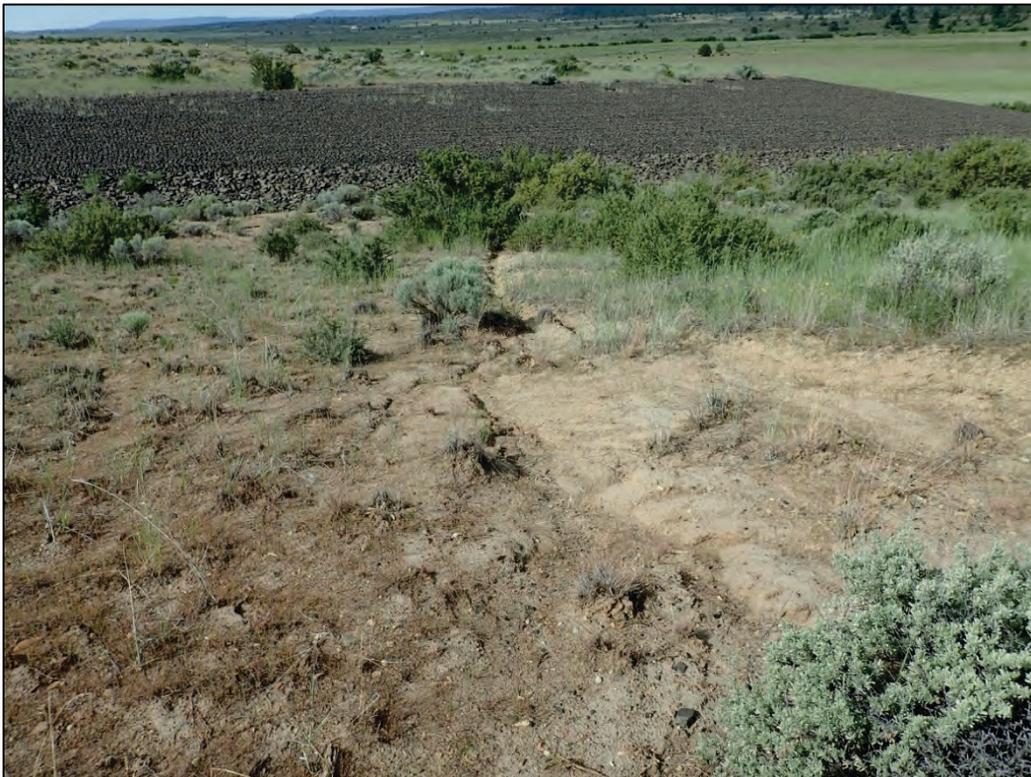
PL-14. Erosion Rills North of Disposal Cell

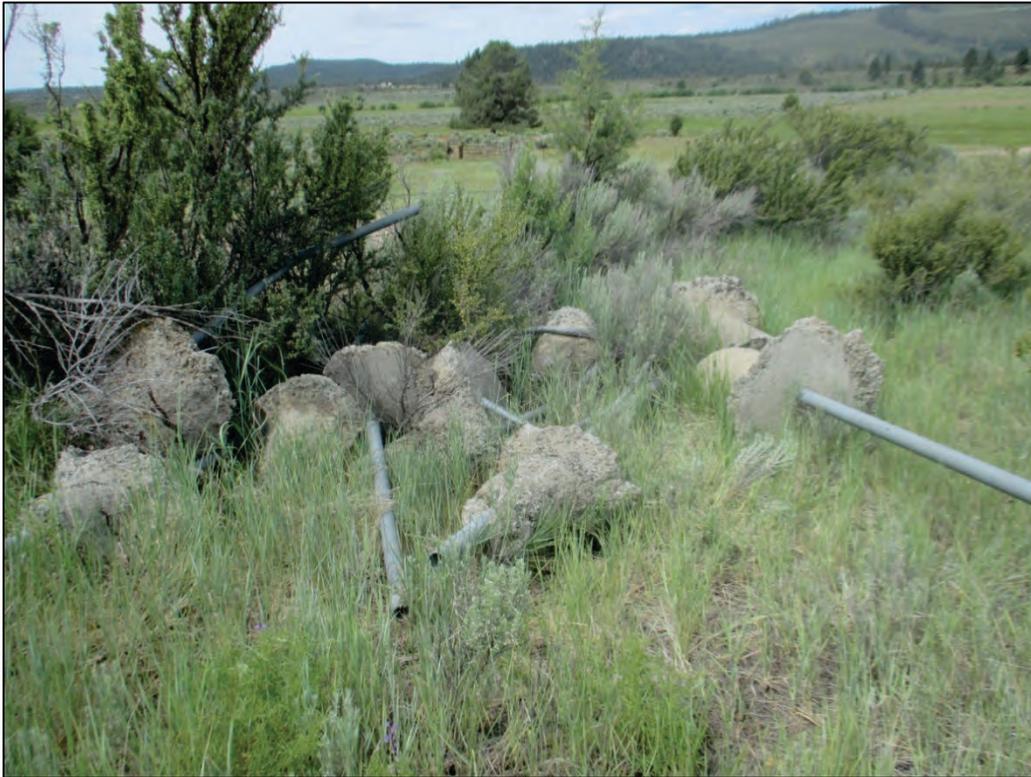
PL-15. Abandoned Metal Signposts with Concrete Bases

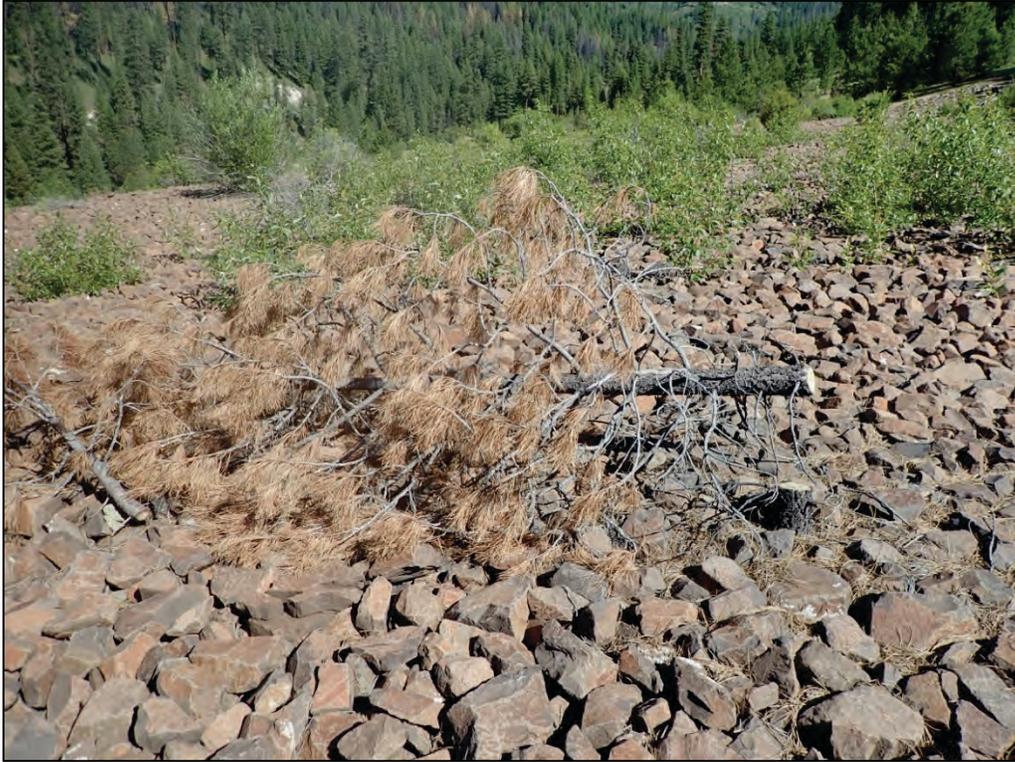
Natural vegetation continues to encroach on the top and side slopes of the disposal cell. Although the LTSP states that control of vegetation growth on the cell is not needed, LM concluded that controlling the growth of conifers—primarily ponderosa pine—would be a best management practice. Unlike the shrubs and other vegetation growing on the disposal cell, mature conifers could potentially become uprooted during windstorms and damage the surface of the disposal cell. Numerous ponderosa pine trees were observed on the disposal cell top and side slopes and were cut down and left in place in September 2018 following the inspection (PL-5). Other plants growing on the disposal cell were not removed, as they do not present a physical threat to the integrity of the disposal cell. Additional ponderosa pine seedlings that were not eradicated in 2018 were identified during the inspection and treated in 2019 following the inspection. No other maintenance needs were identified.

PL-5. Treated and Fallen Ponderosa Pine

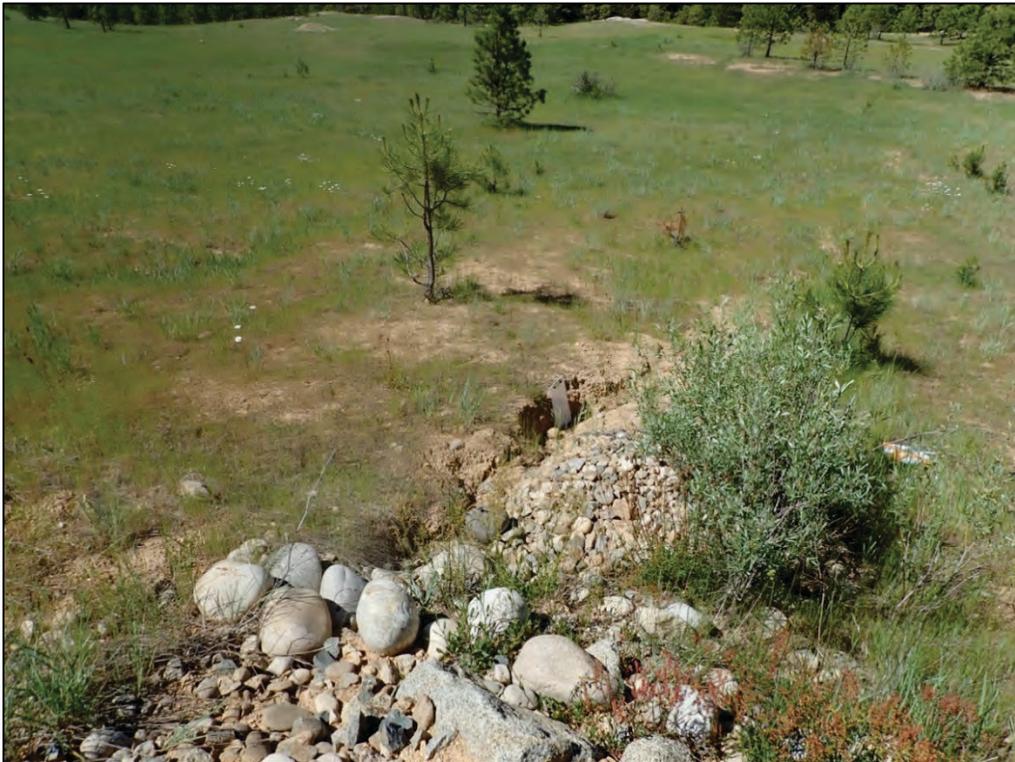
revegetated. LM installed three interceptor benches across the steep slope in this area in 1998 to intercept runoff, collect it in an armored collection ditch, and route it offsite into Clear Creek. Over the years, minor erosion has breached the benches in several locations, and LM has conducted repairs on numerous occasions, most recently in October 2016. The three interceptor benches (PL-6) and a collection ditch are inspected annually to ensure that erosion in this area does not affect overall site stability. In 2019, inspection of the 2016 repairs showed they remain intact, and LM will continue to inspect as the vegetation continues to establish.

PL-6. Bench 1 Erosion

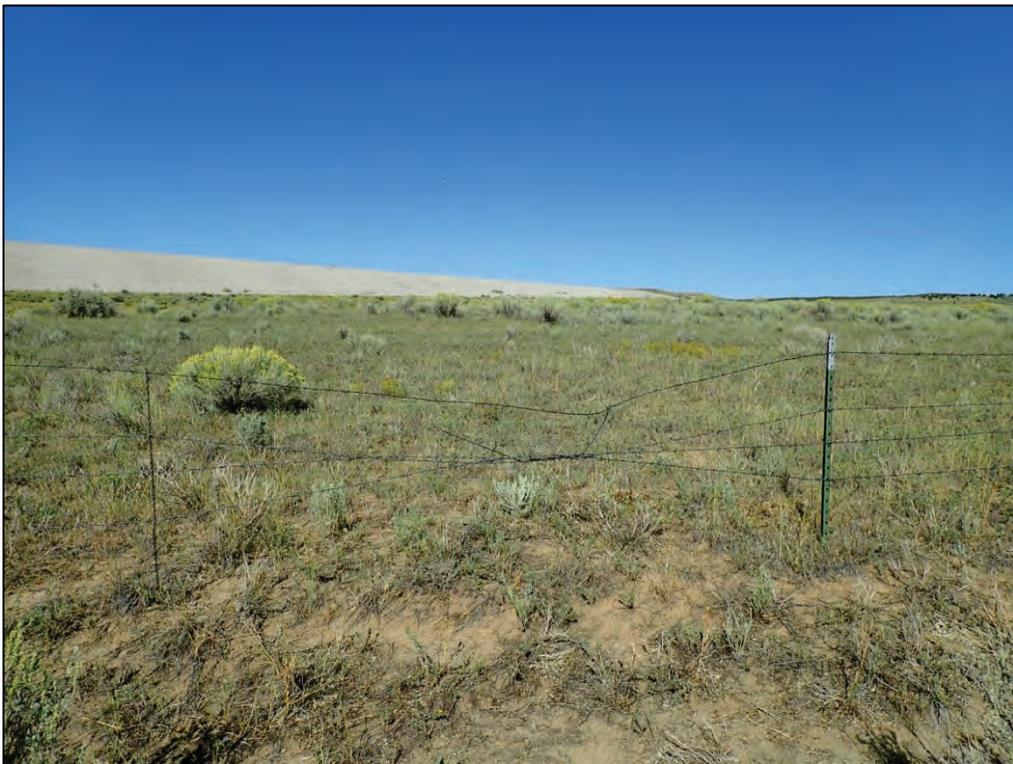
To facilitate land management by LM, a four-strand barbed-wire perimeter fence encloses the disposal cell, drainage structures, and much of the site. The site is in wintering grounds frequented by big-game animals (primarily pronghorn, deer, and elk) and is also surrounded by open range used to graze cattle. As a result, minor damage to the perimeter fence periodically occurs. Perimeter fence strands were twisted in one location (PL-2) and were repaired following the inspection.

PL-2. Twisted Perimeter Fence Strands (Repaired)

- Spraying noxious weeds and deep-rooted plants on the disposal cell
- Minor repairs to the perimeter fence (twisted fence strand)

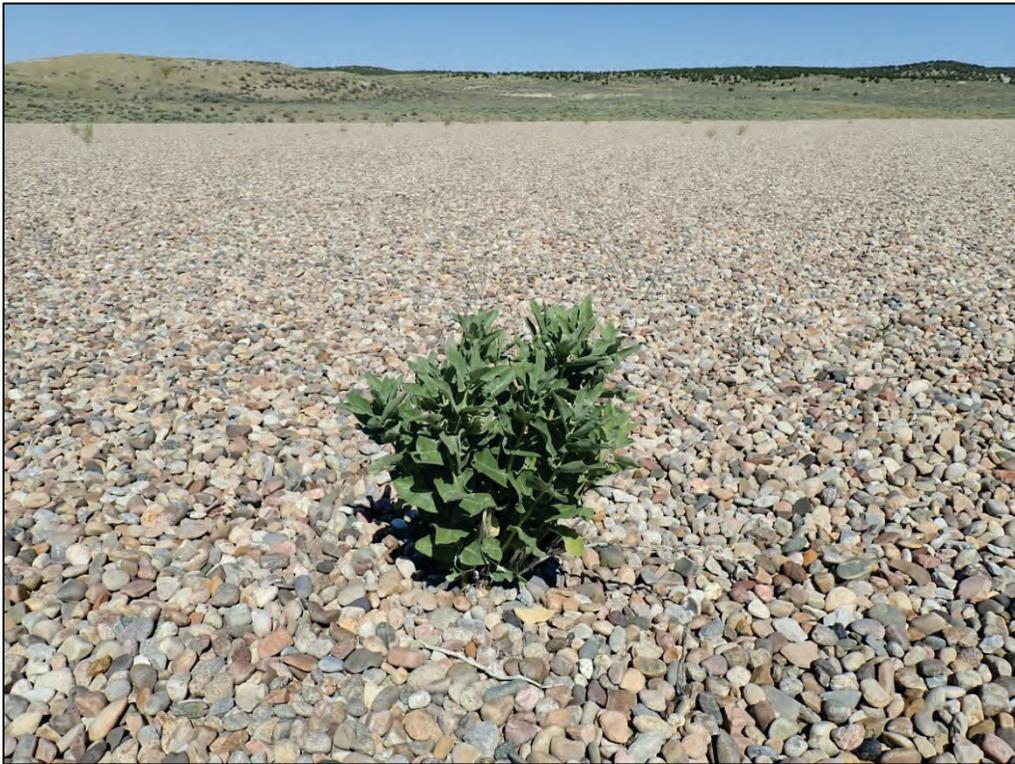
PL-8. Milkweed Plant on Top Slope of Disposal Cell

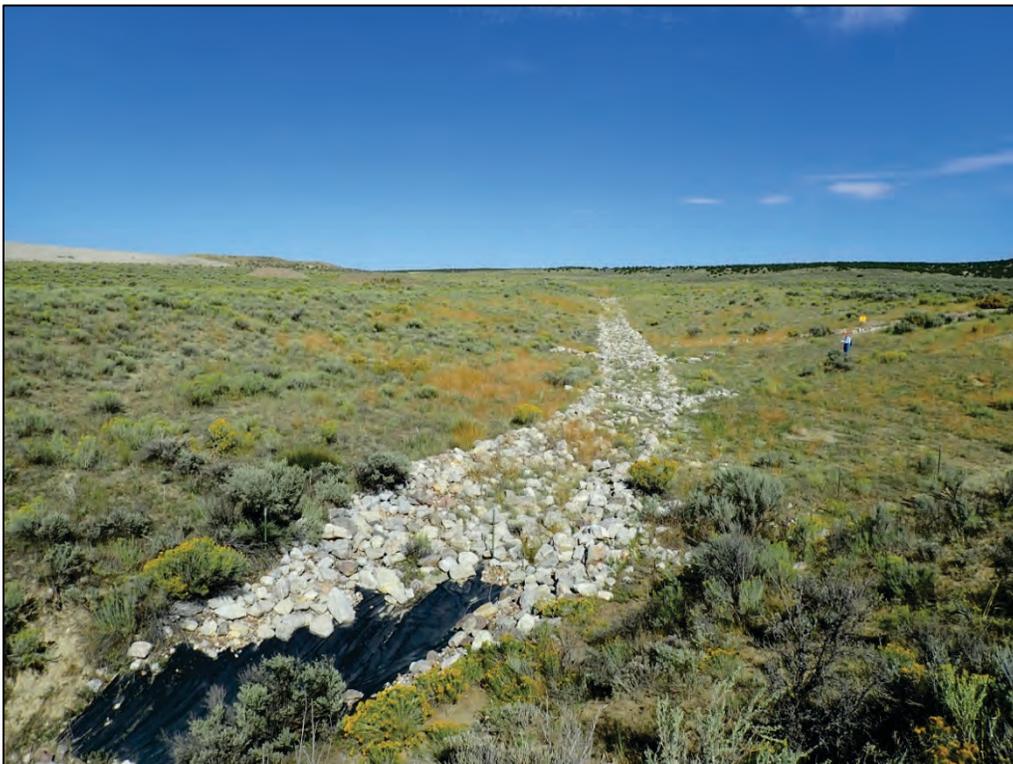
PL-10. Exposed Geotextile at Outlet to Swale No. 1

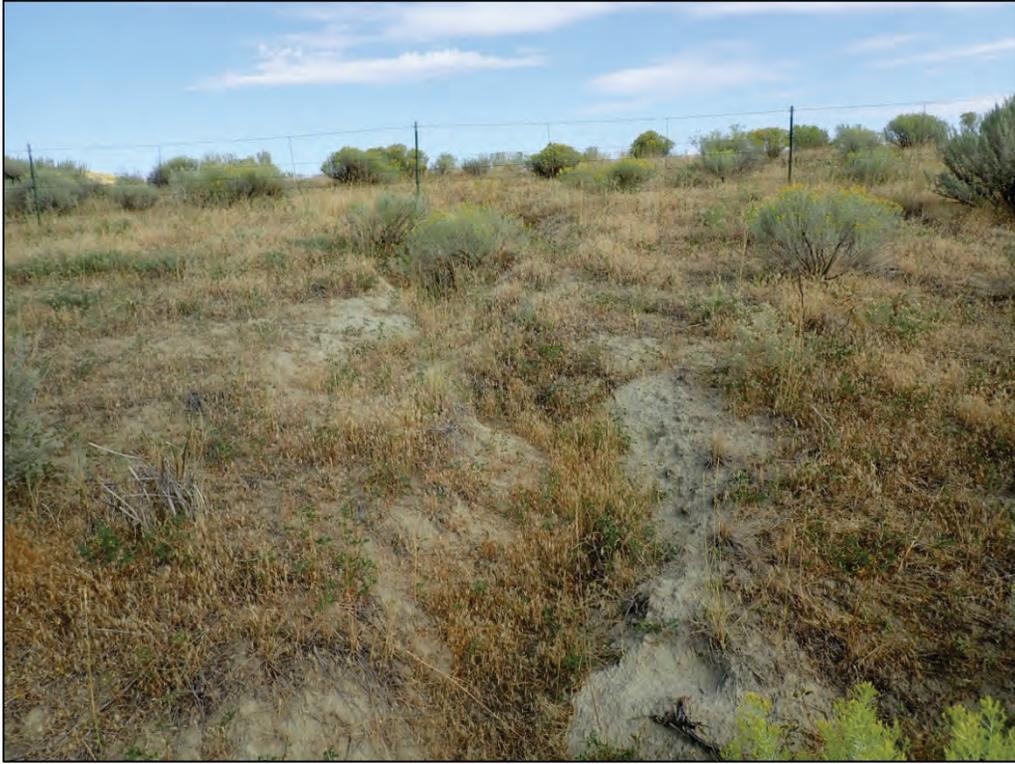
PL-13. Minor Erosion Along Northern Perimeter Fence

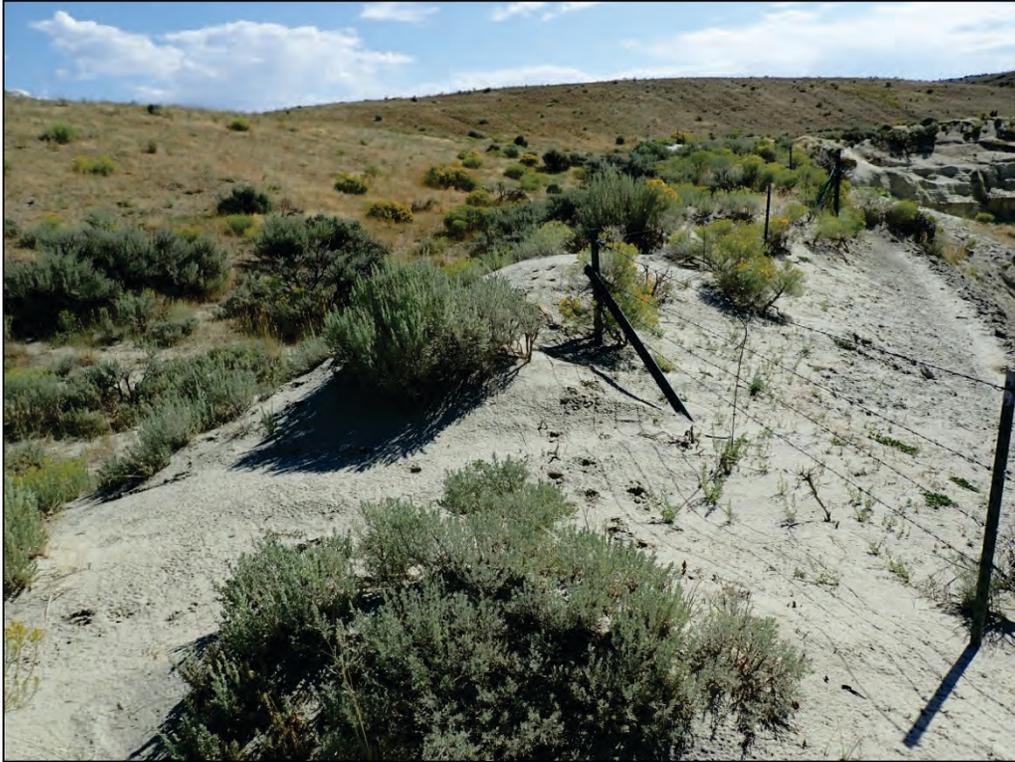
PL-15. Sand Buildup Around Perimeter Fence near Johnson Pit

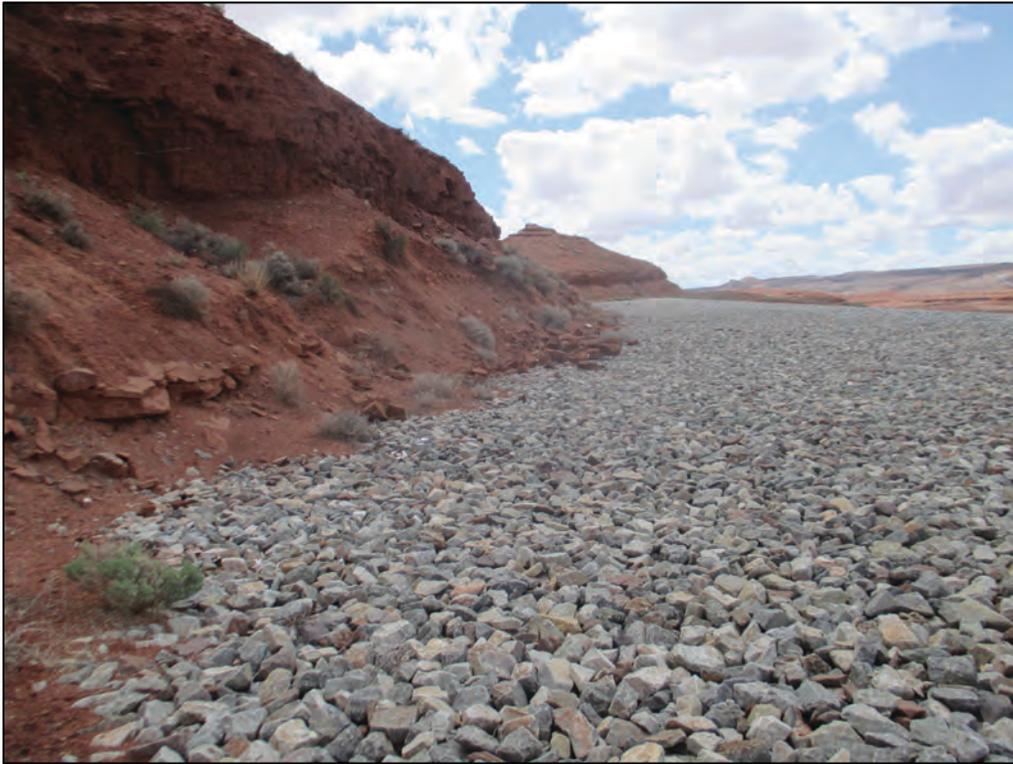
PL-5. Sloughed Rock on South Apron of Disposal Cell

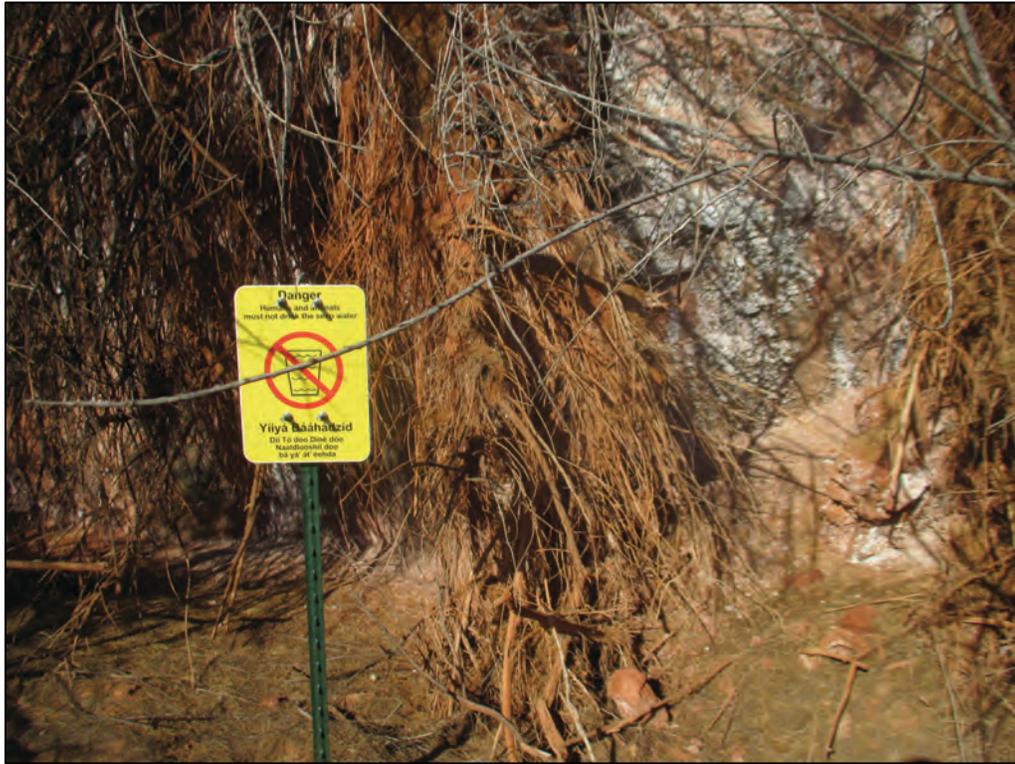
Since 2010, groundwater discharge from seeps had only been observed at cross-gradient Seep 0248, which typically exhibits dripping conditions. During the inspection, Seep 0248 was observed dripping; since the seep was only dripping and did not exhibit steady flow, an estimated flow rate was not evaluated. Additionally, Seeps 0251 and 0264 were damp, and upgradient (background) Seep 0261 was observed to be flowing during the inspection. Seep 0261 is approximately 0.50 mile upstream of Seep 0248 in Gypsum Creek.

PL-7. Seep 0248 (Limited Dripping)

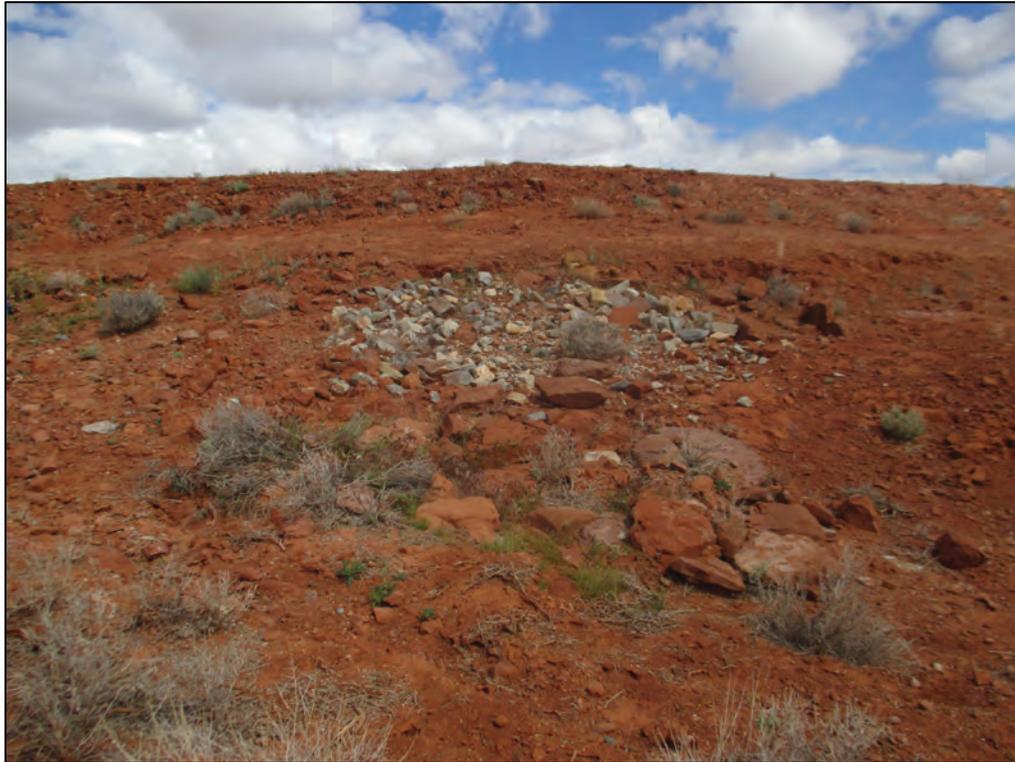
PL-8. Seep 0249 (Dry)

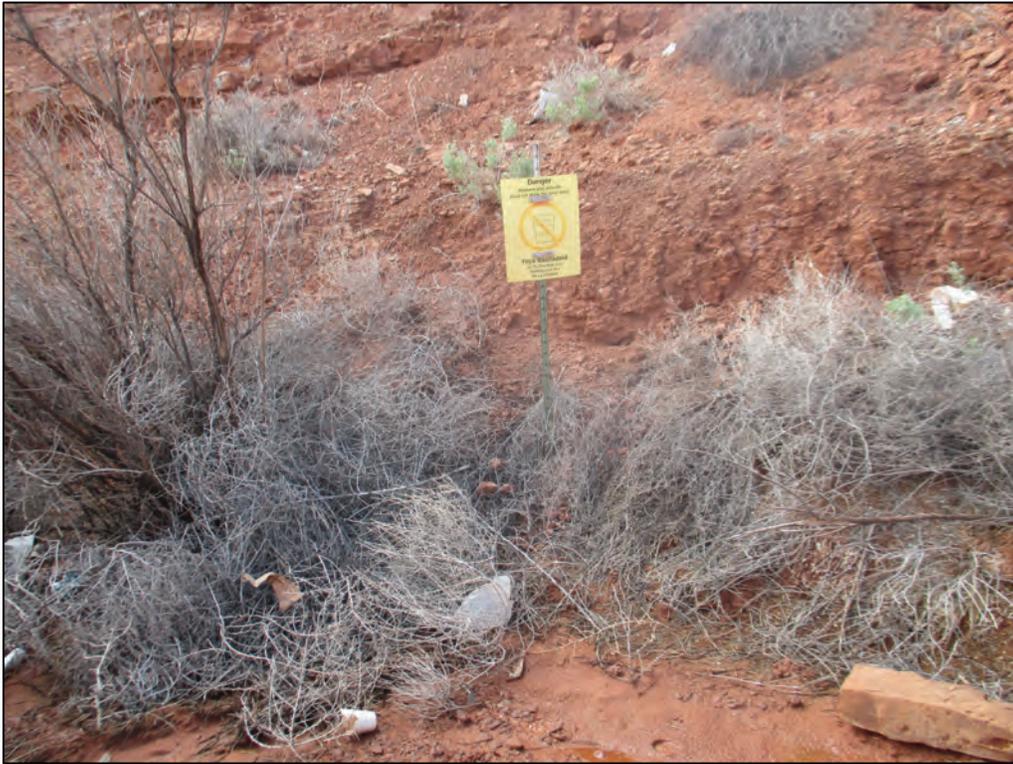
PL-9. Seep 0251 (Damp)

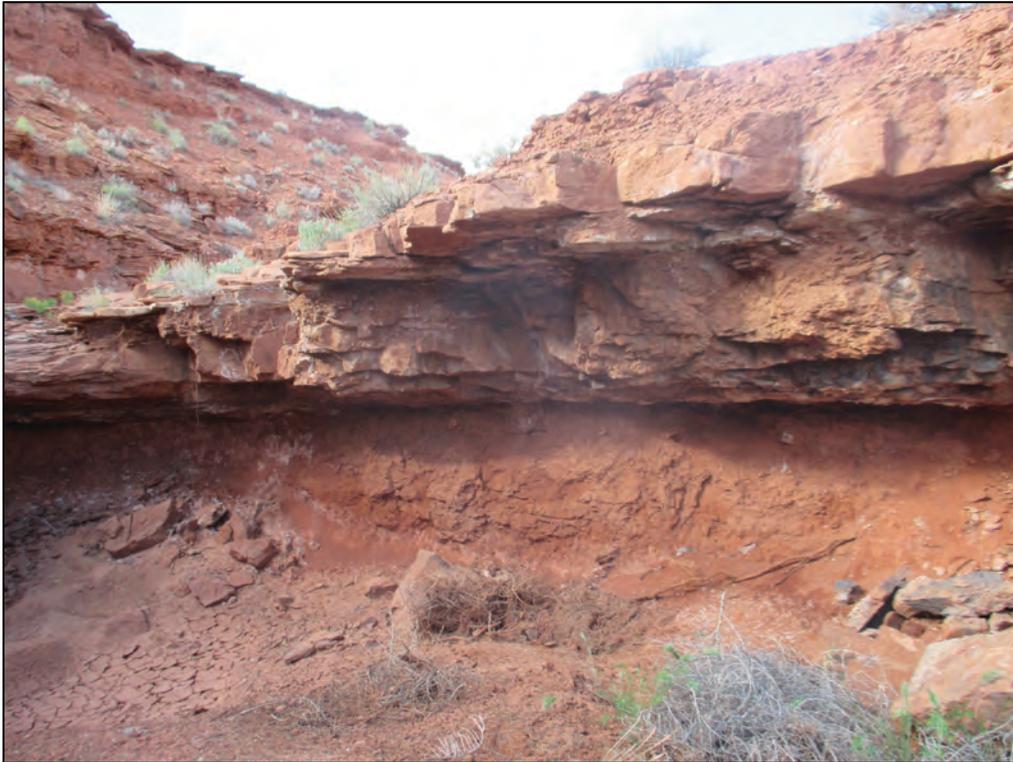
PL-10. Seep 0254 (Dry)

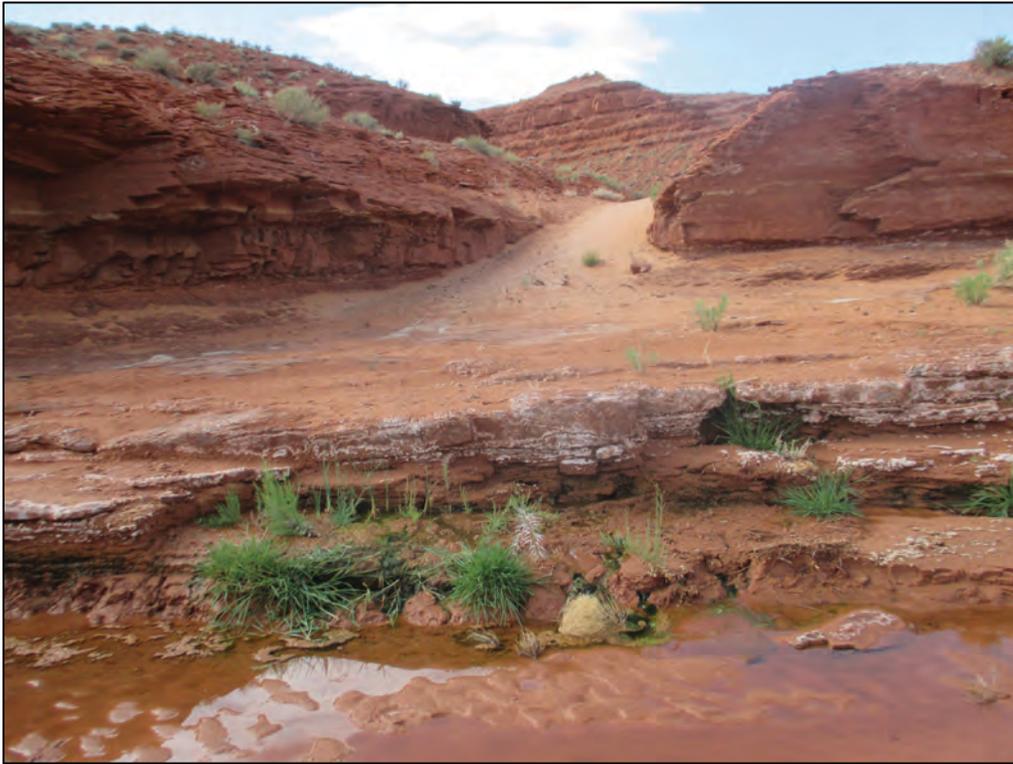
PL-11. Background Seep 0261 (Flowing)

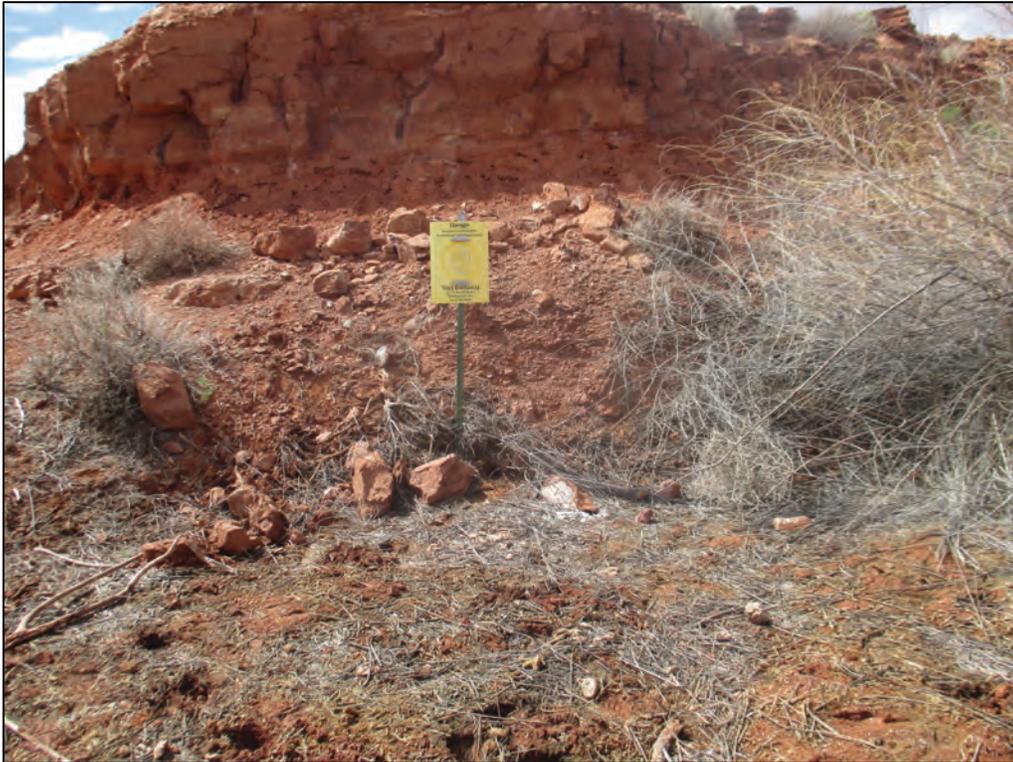
PL-12. Seep 0264 (Damp)

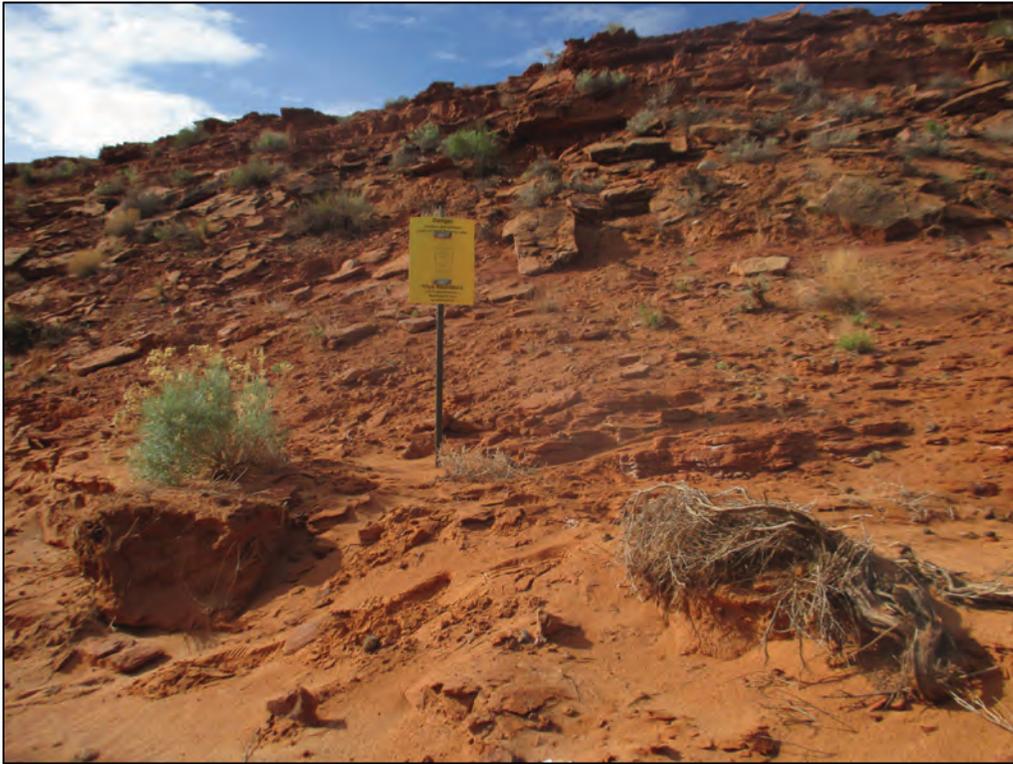
PL-13. Seep 0922 (Dry/Sandbar)

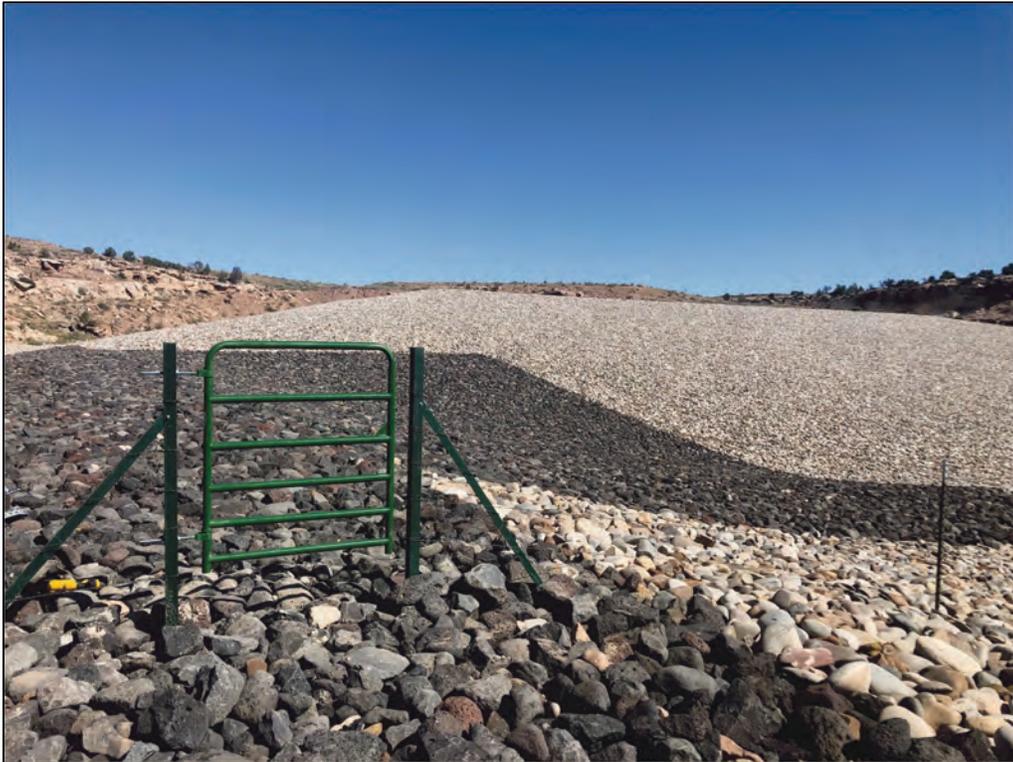
A barbed-wire perimeter fence encloses the site. Three aging wooden stiles identified in the 2018 inspection (DOE 2019a) were replaced with two pedestrian gates following the 2019 inspection (PL-1). A large bush growing in the western perimeter fence line was removed to prevent damage to the fence (PL-2). Inspectors identified a loose fence strand and a detached fence bracket; both were repaired following the inspection.

PL-1. New Pedestrian Gate on Disposal Cell

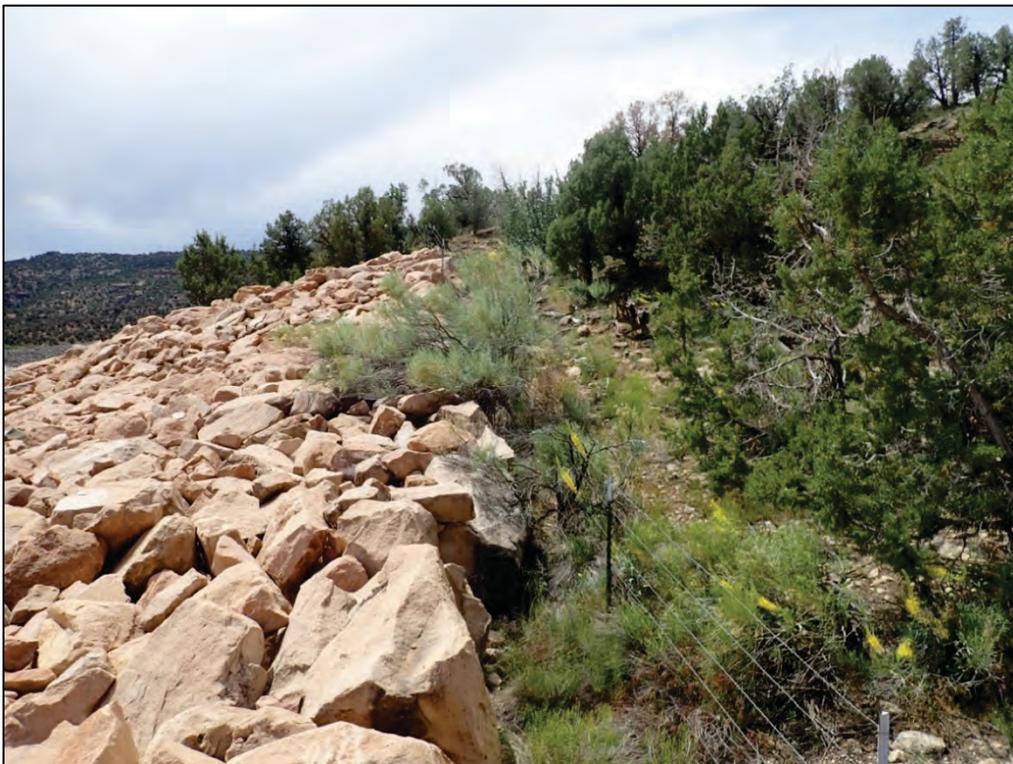
PL-2. Vegetation Growing in Fence Line

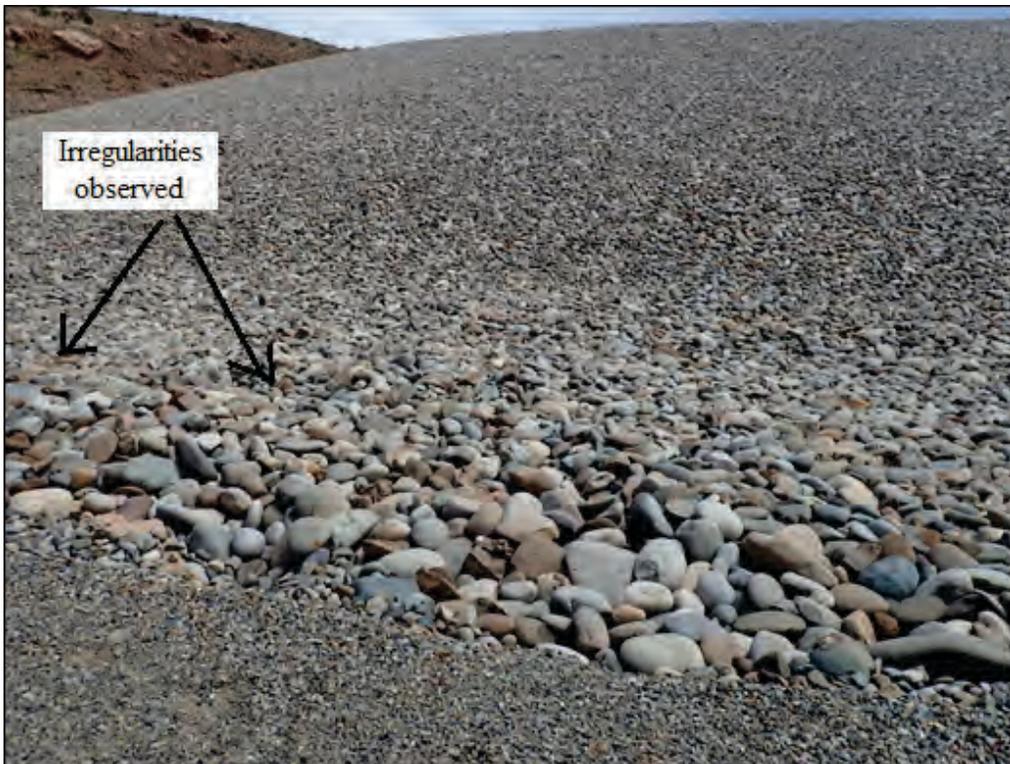
PL-8. Area of Irregularity on Disposal Cell Apron and Interface with Disposal Cell Access Road

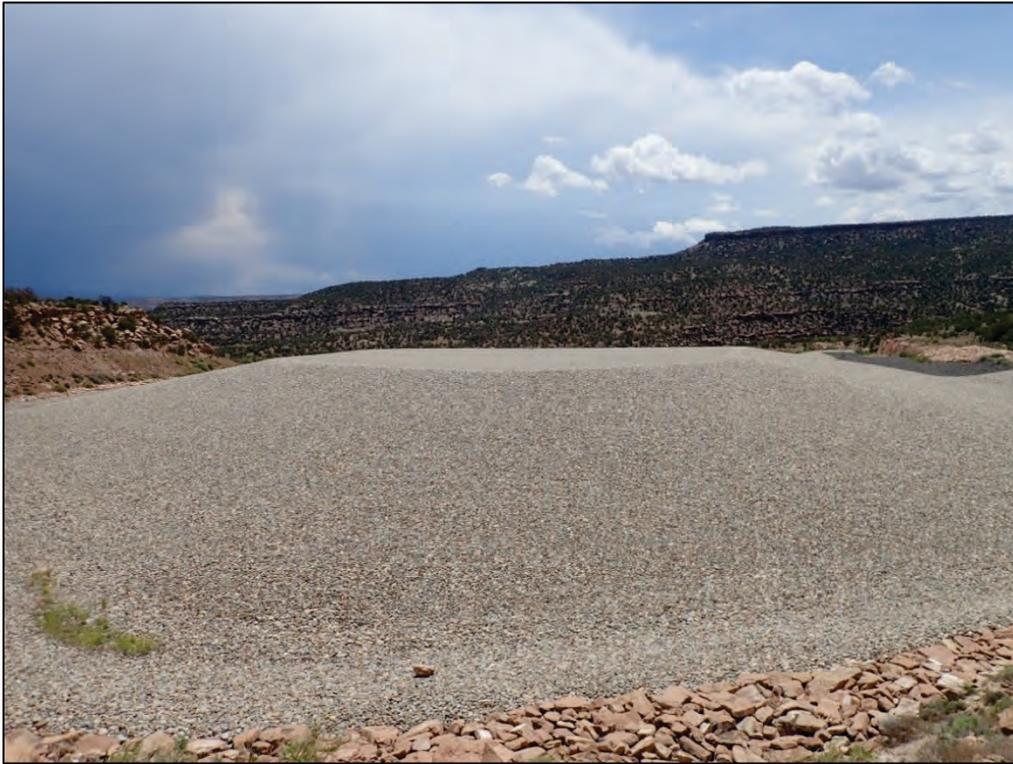
PL-9. Boulder on Disposal Cell Apron

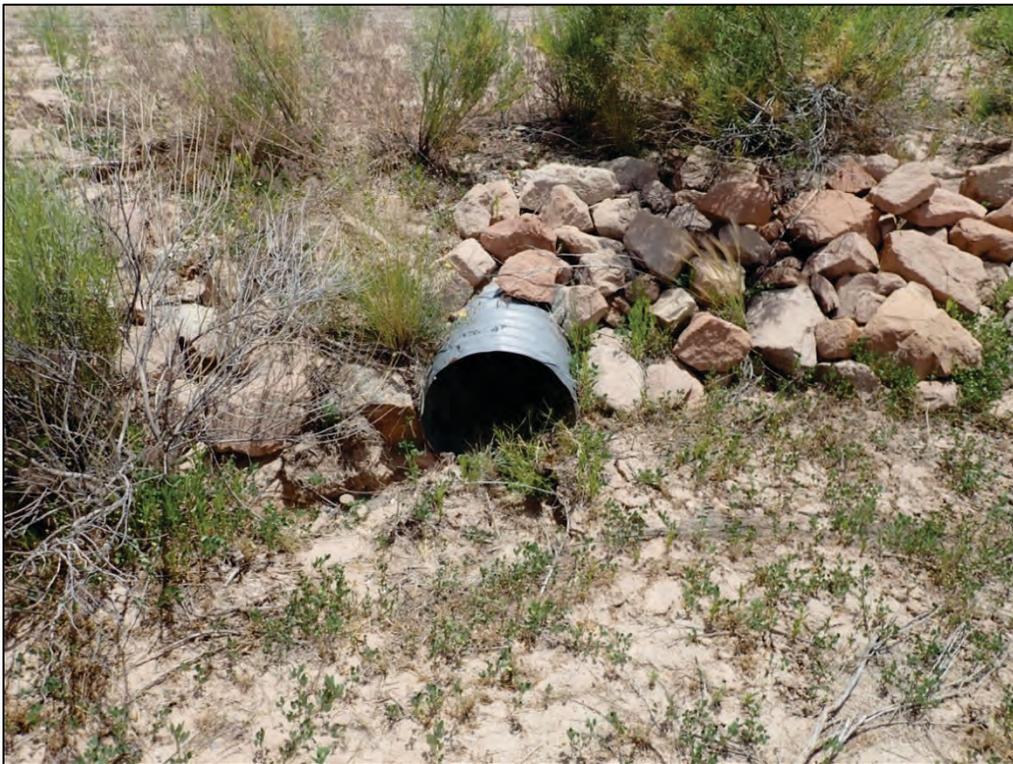
PL-10. Culvert Inlet Partially Blocked by Sediment

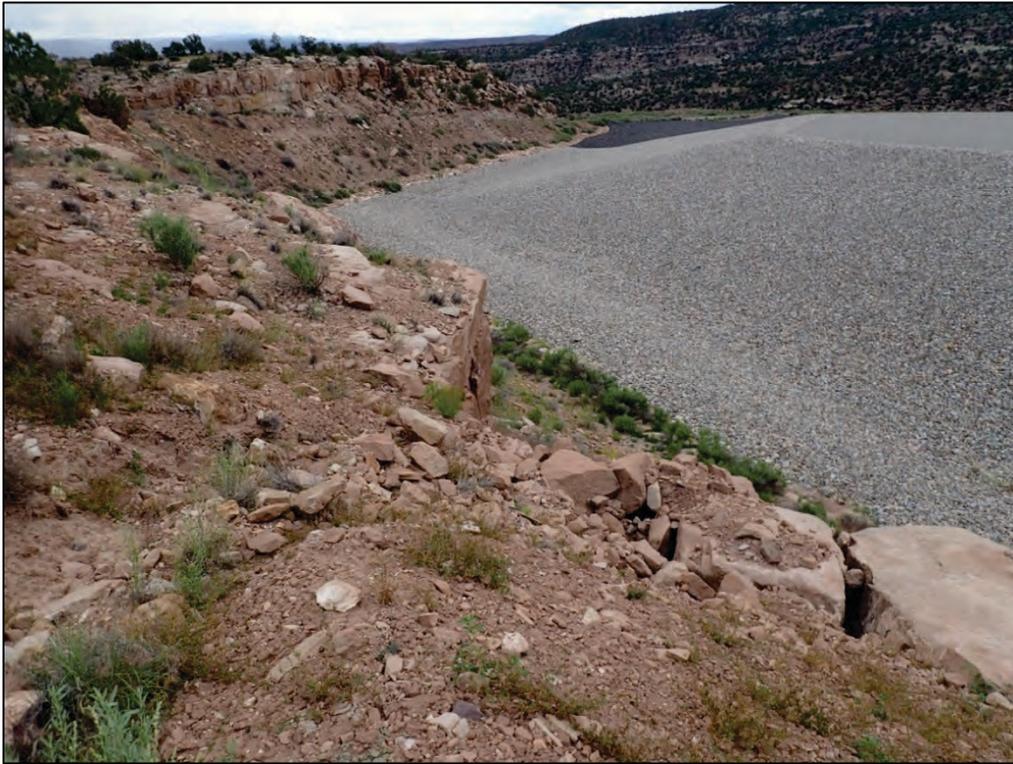
PL-11. Erosion Along Cliff Edge Above Disposal Cell

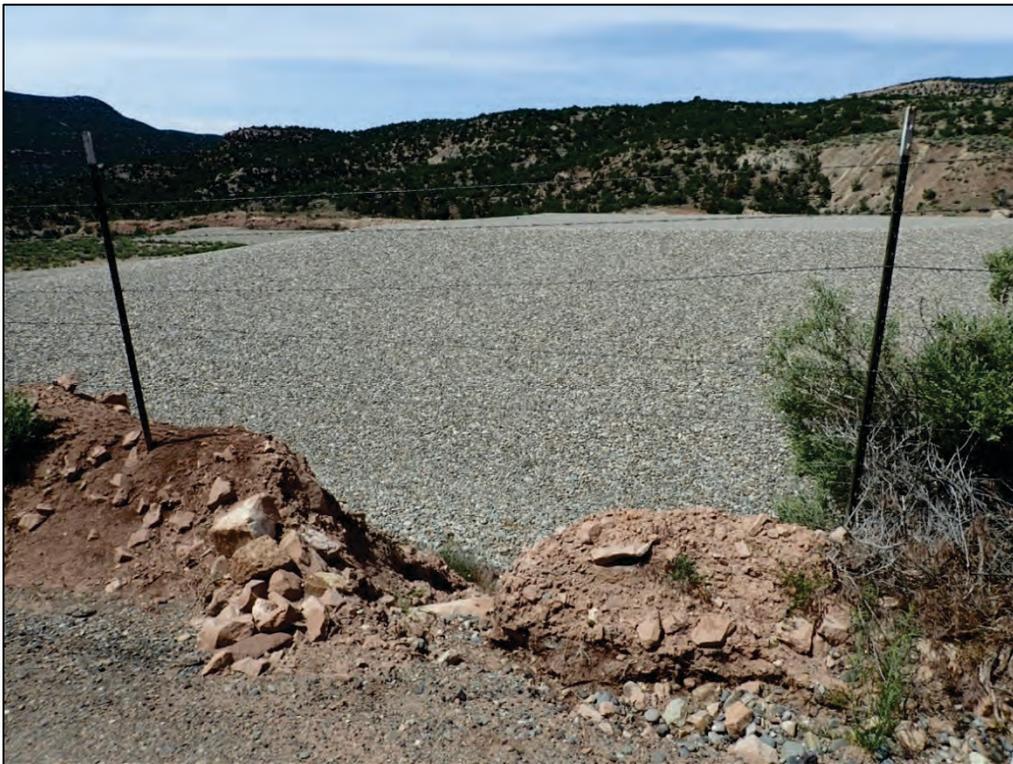
PL-12. Berm Cut off County Road EE22 (Repaired Following Inspection)

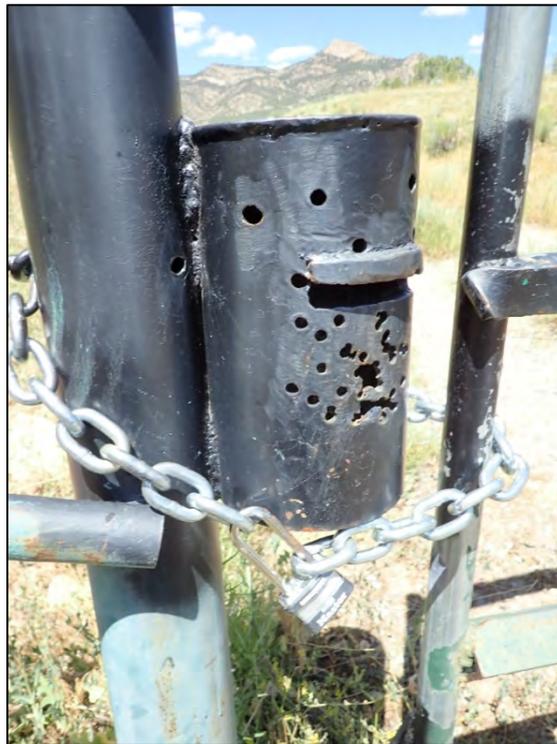
PL-2. Bullet Holes in Gate Cover at Outer Entrance Gate

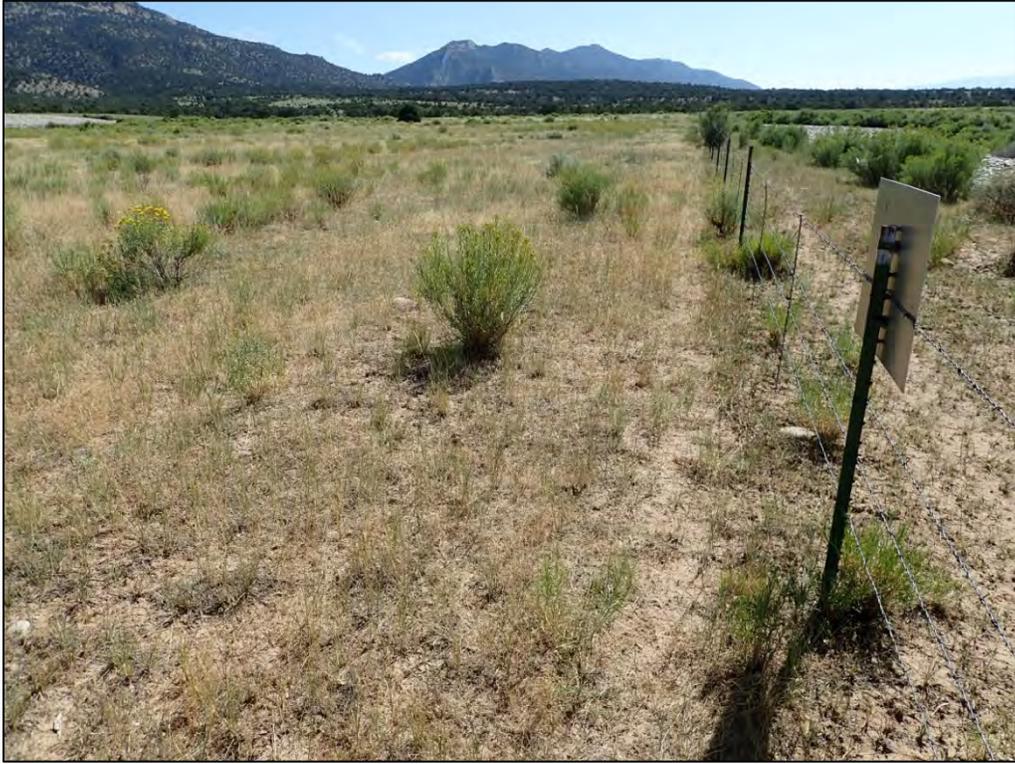
PL-3. Regrowth on Last Year's Livestock Trails on Both Sides of Fence East of Reclaimed Area

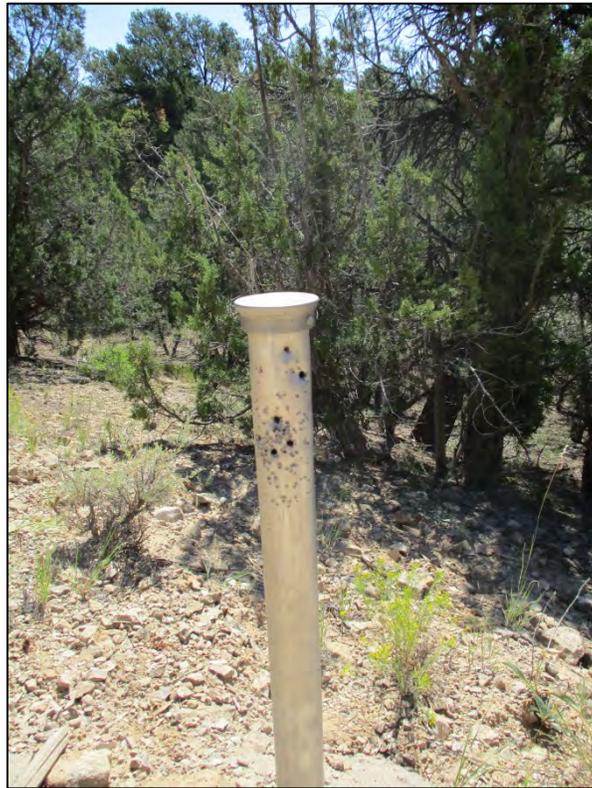
PL-4. Bullet Damage (Legible) in Boundary Monument BM-2

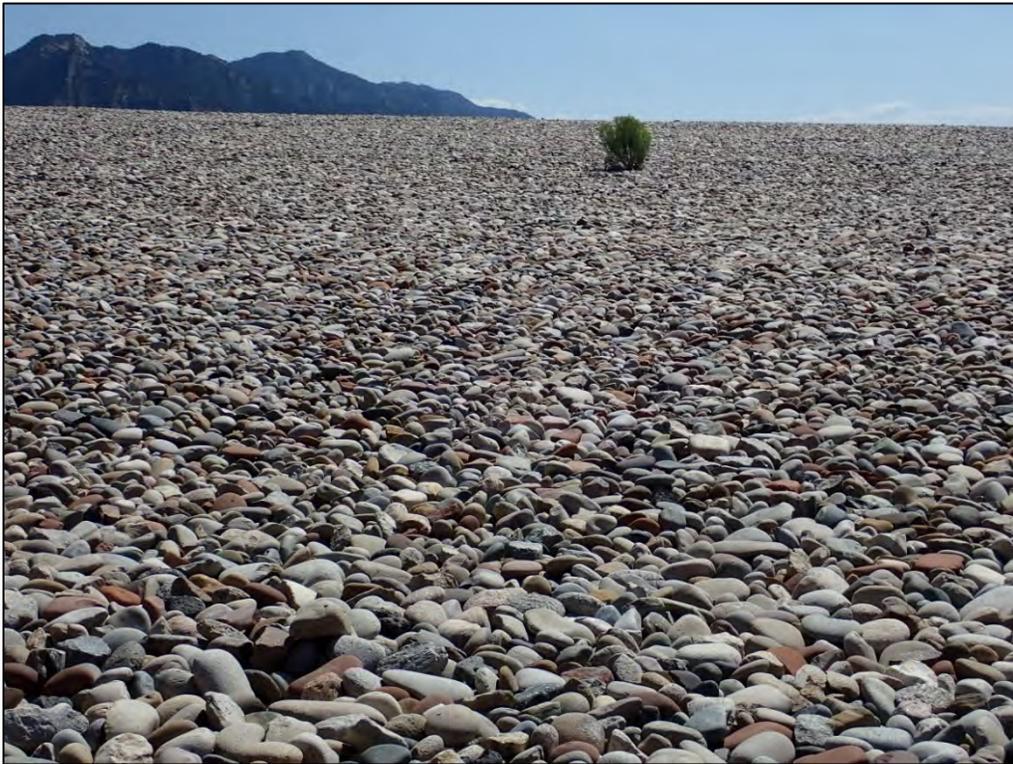
PL-8. One Deep-Rooted Woody Plant—Rubber Rabbitbrush—on Disposal Cell Top Slope

In August 2019, nine permanent quality control monuments were installed at the site in preparation for a baseline aerial survey of the disposal cell. The quality control monument locations are shown in Figure 14-1. The rabbitbrush on top of disposal cell will be treated with herbicide before the next inspection in 2020. No other maintenance needs were identified.

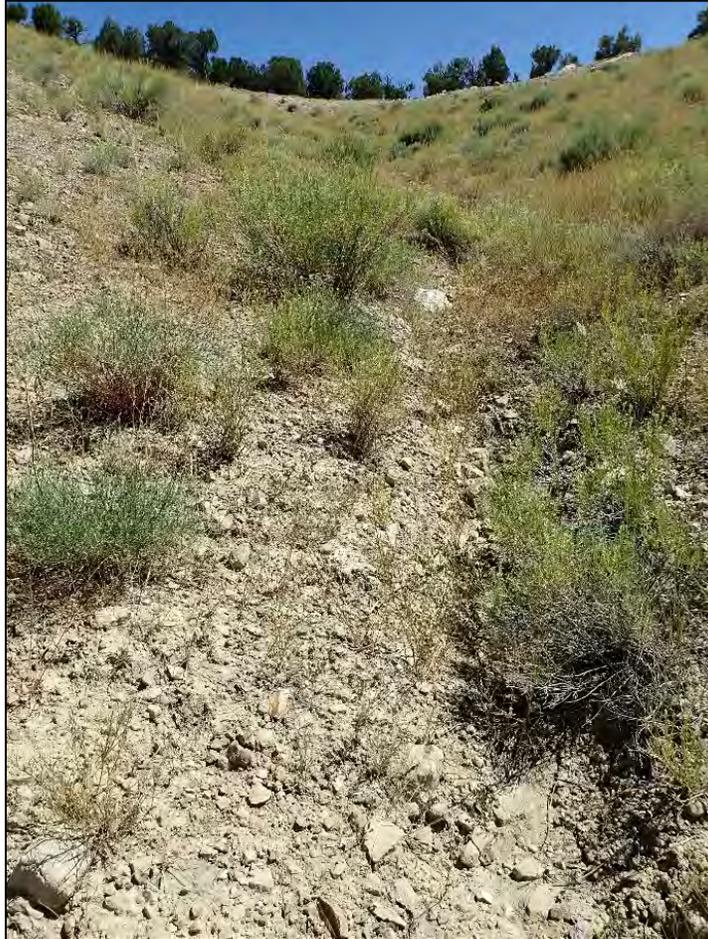
PL-9. Upslope of Interceptor Trench Erosion
