U.S. DEPARTMENT OF
ENERGY

Legacy
Management

2019 Annual Site Inspection and Monitoring Report for Uranium Mill Tailings Radiation Control Act Title I Disposal Sites

March 2020

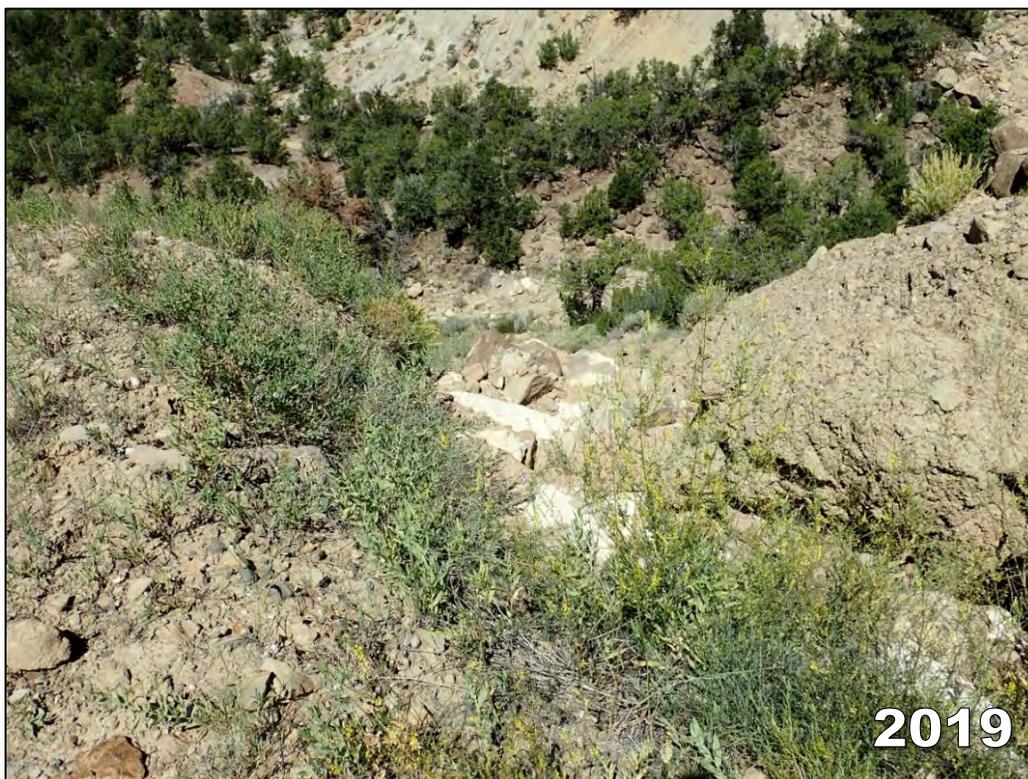
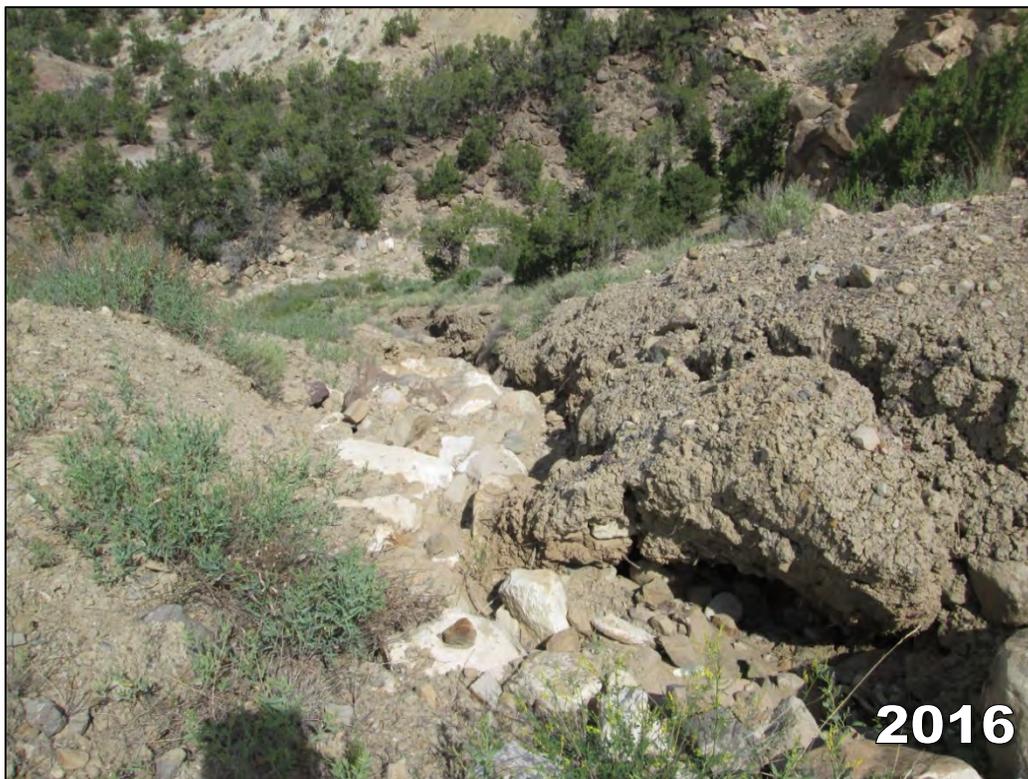
PL-10. (a) Erosion in Interceptor Trench Outfall Channel—2019

PL-10. (b) Erosion in Interceptor Trench Outfall Channel—2016 Photo for Comparison

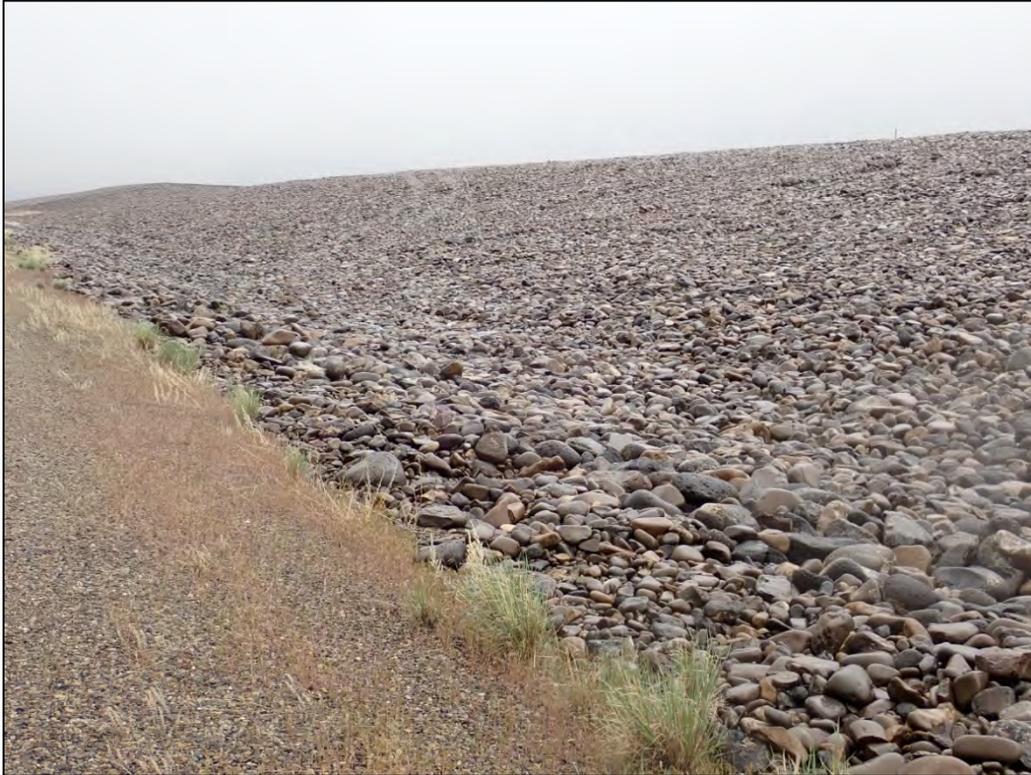
PL-3. Tracks Observed on East Side Slope of Disposal Cell

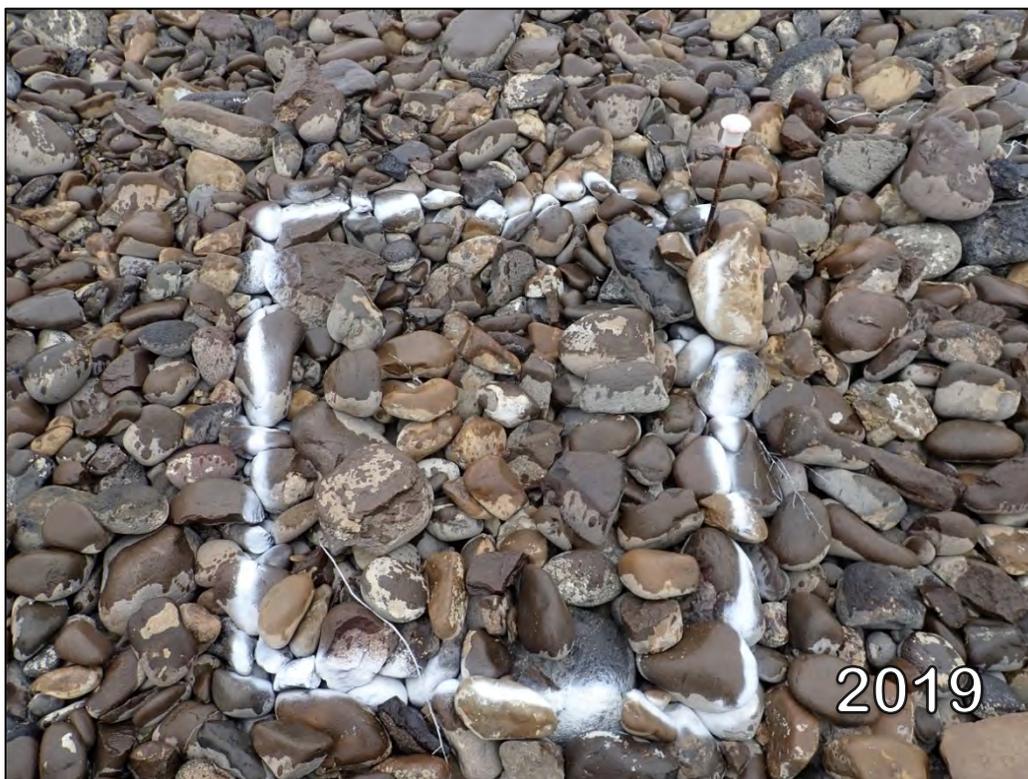
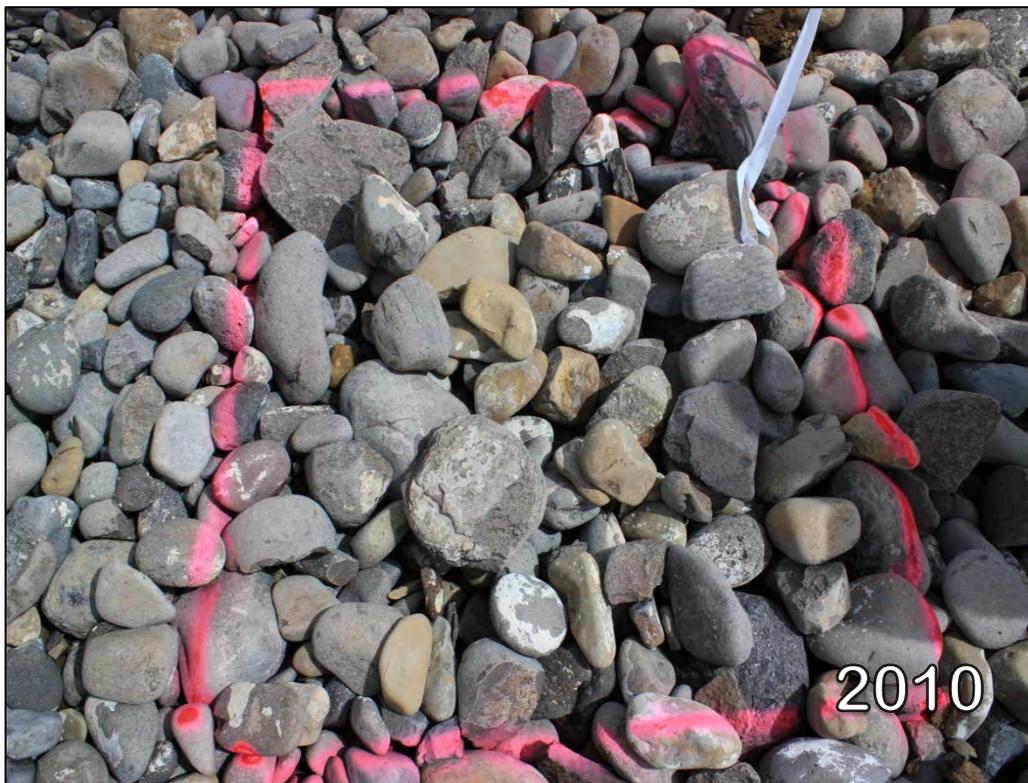
One of several types of rock used for the disposal cell erosion-protection riprap layer has exhibited minor degradation since the disposal cell was constructed. As a result, eight rock-quality monitoring plots, each measuring 1 square meter (indicated by Roman numerals I–VIII in Figure 15-1), were established in 2010 to monitor for continued rock degradation. The rock type exhibiting degradation constitutes approximately 1%–10% of the riprap material; degradation of this less competent rock is thought to result from freeze-thaw weathering. Rock-quality monitoring plots are visually monitored and documented annually with photographs.

PL-6. (a) Rock Quality Plot No. 1—2019

PL-6. (b) Rock Quality Plot No. 1—2010 Photo for Comparison

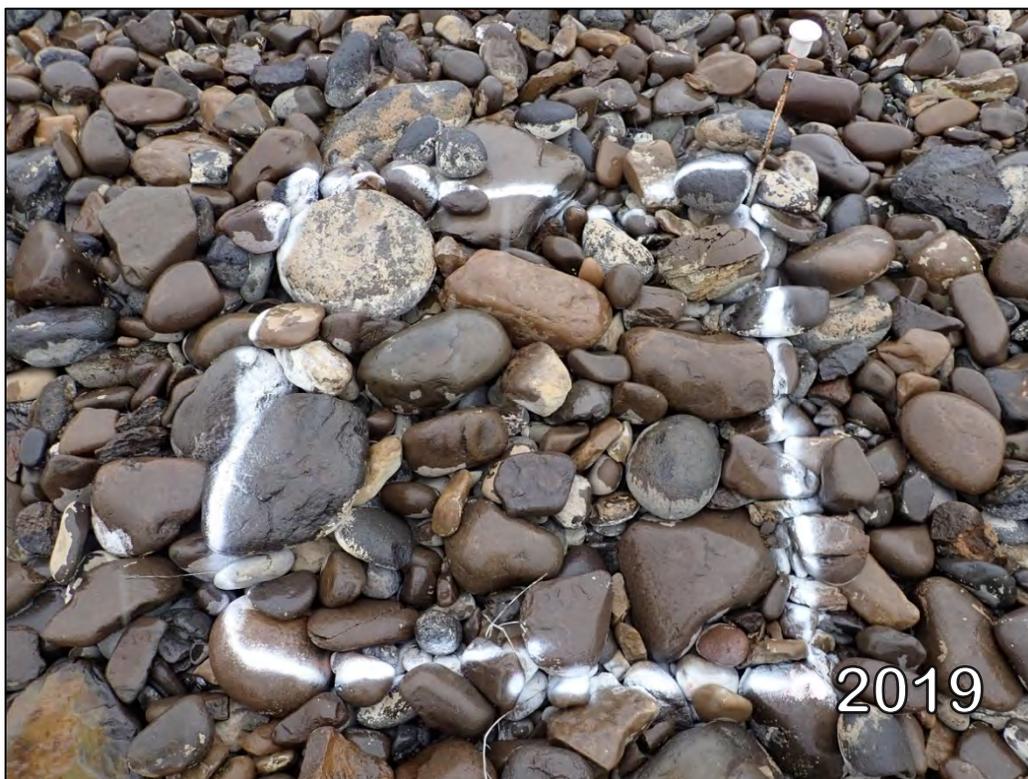
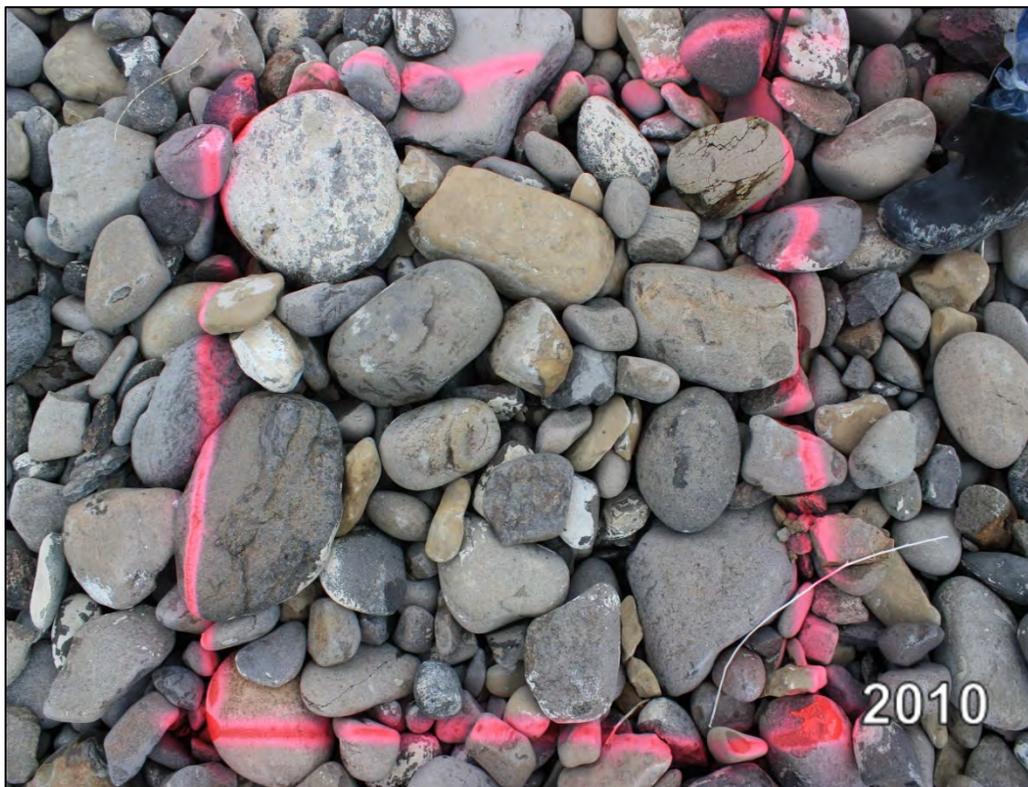
PL-7. (a) Rock Quality Plot No. II—2019

PL-7. (b) Rock Quality Plot No. II—2010 Photo for Comparison

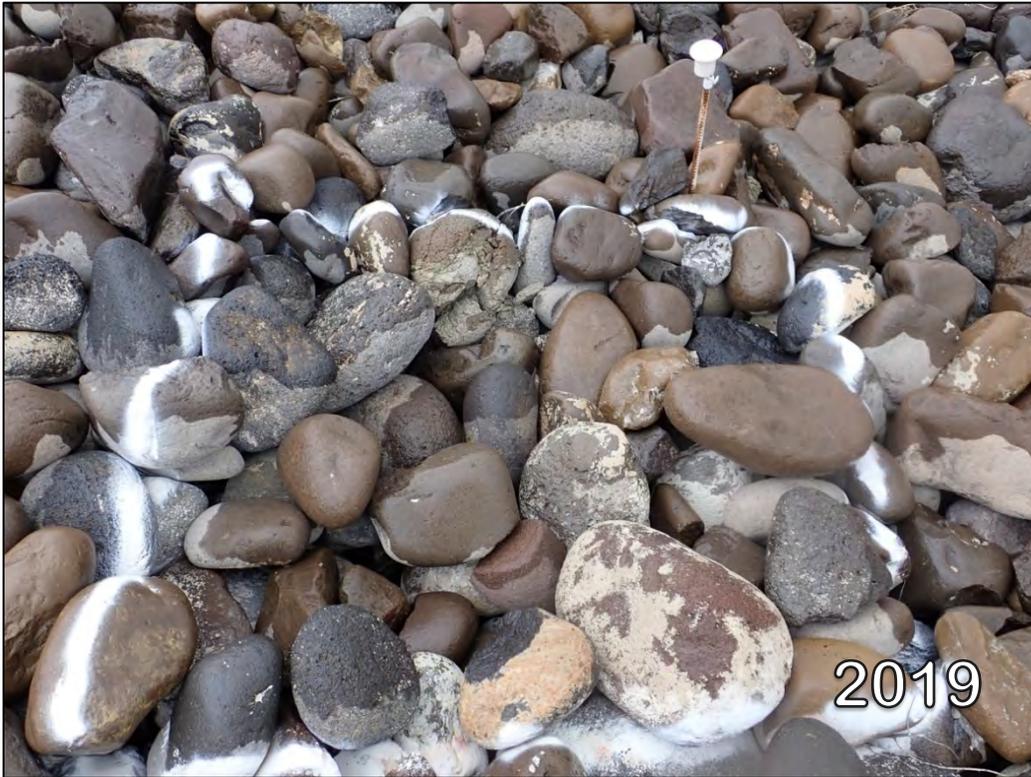
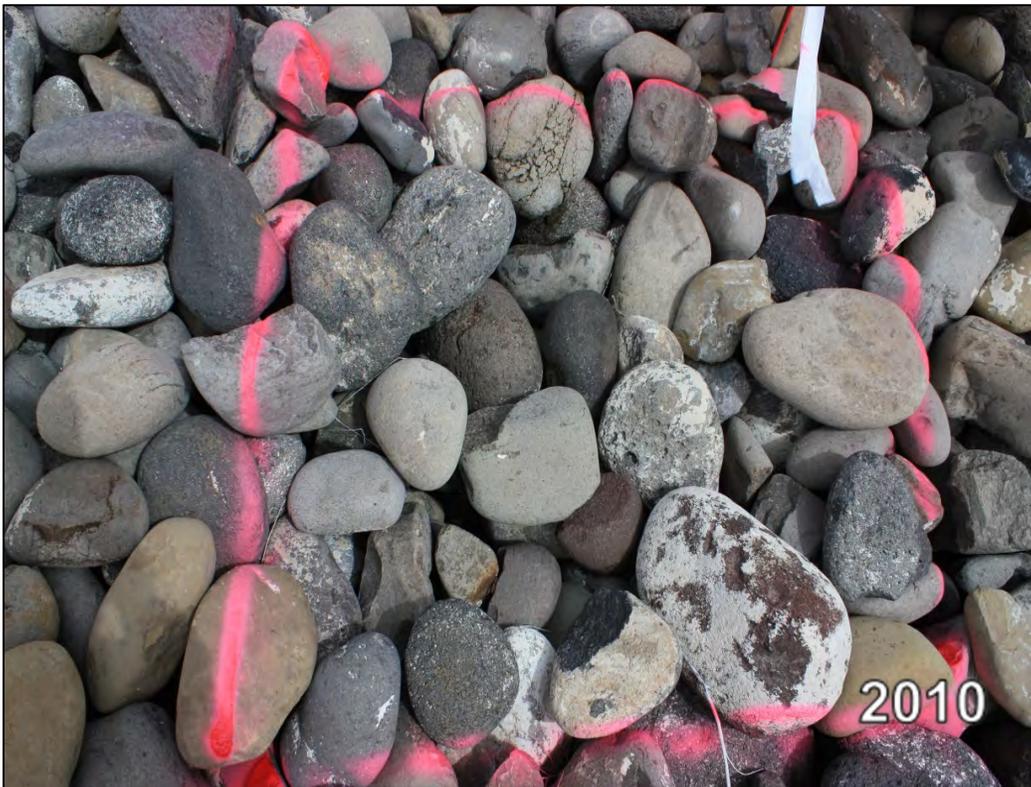
PL-8. (a) Rock Quality Plot No. III—2019

PL-8. (b) Rock Quality Plot No. III—2010 Photo for Comparison

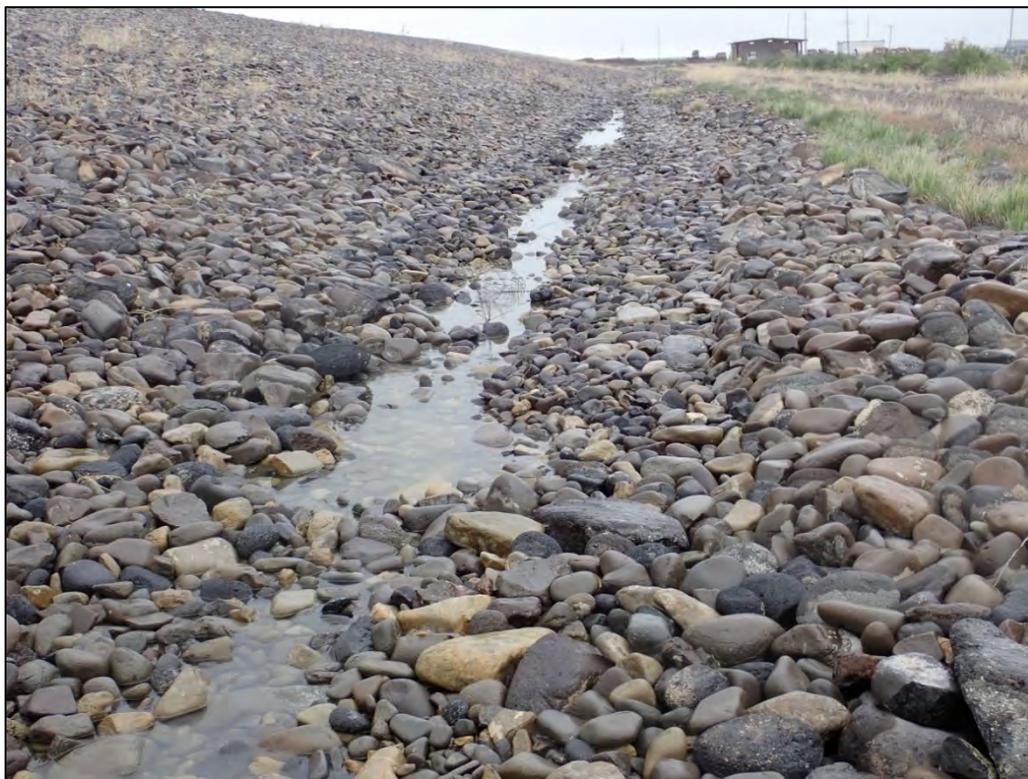
PL-14. Settlement Plate 8

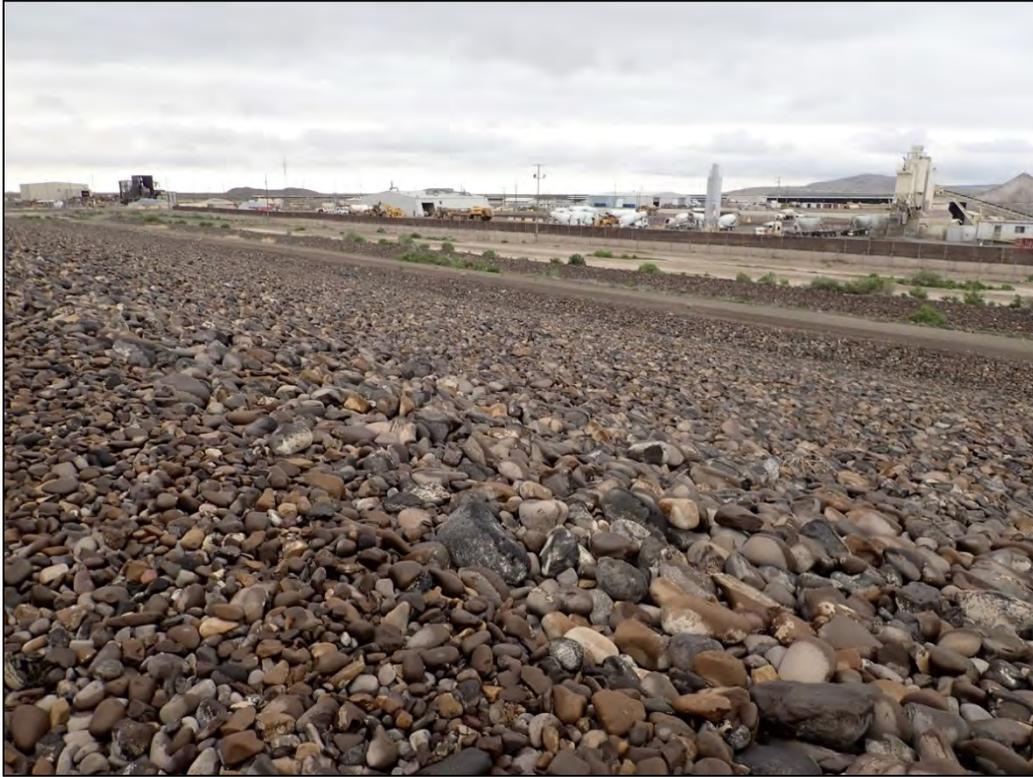
*PL-17. Intersection of Disposal Cell Top with West Side Slope of Disposal Cell;
EnergySolutions Disposal Cell in Background*

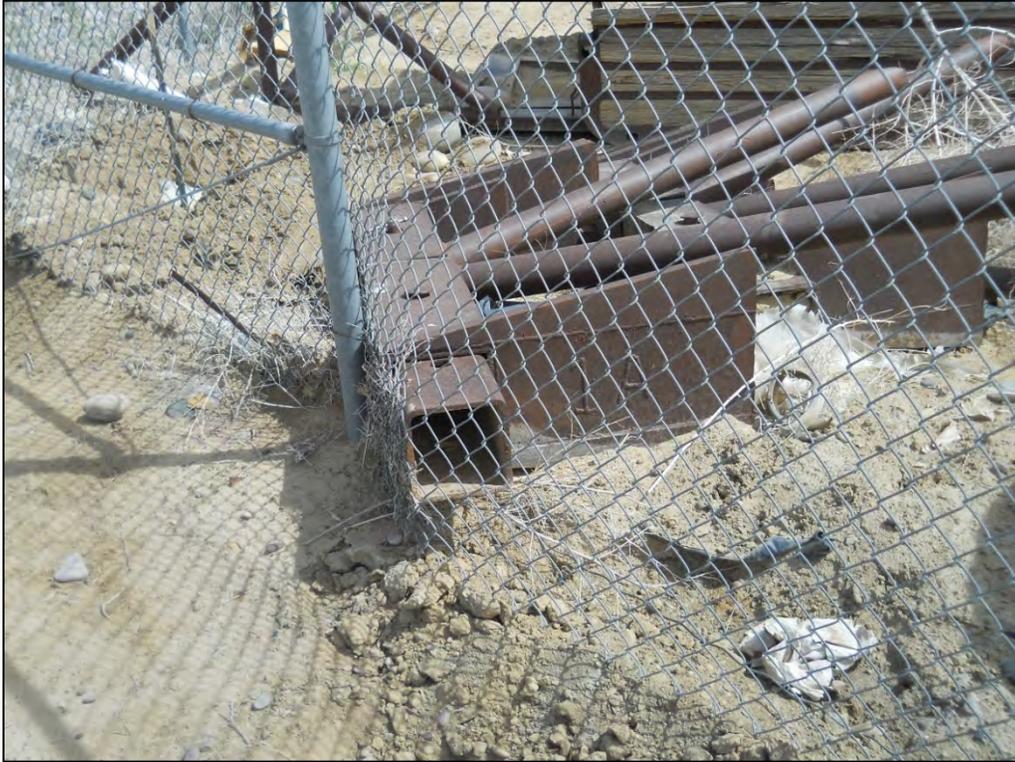
PL-1. NECA Equipment Against Perimeter Fence Between Perimeter Signs P14 and P15

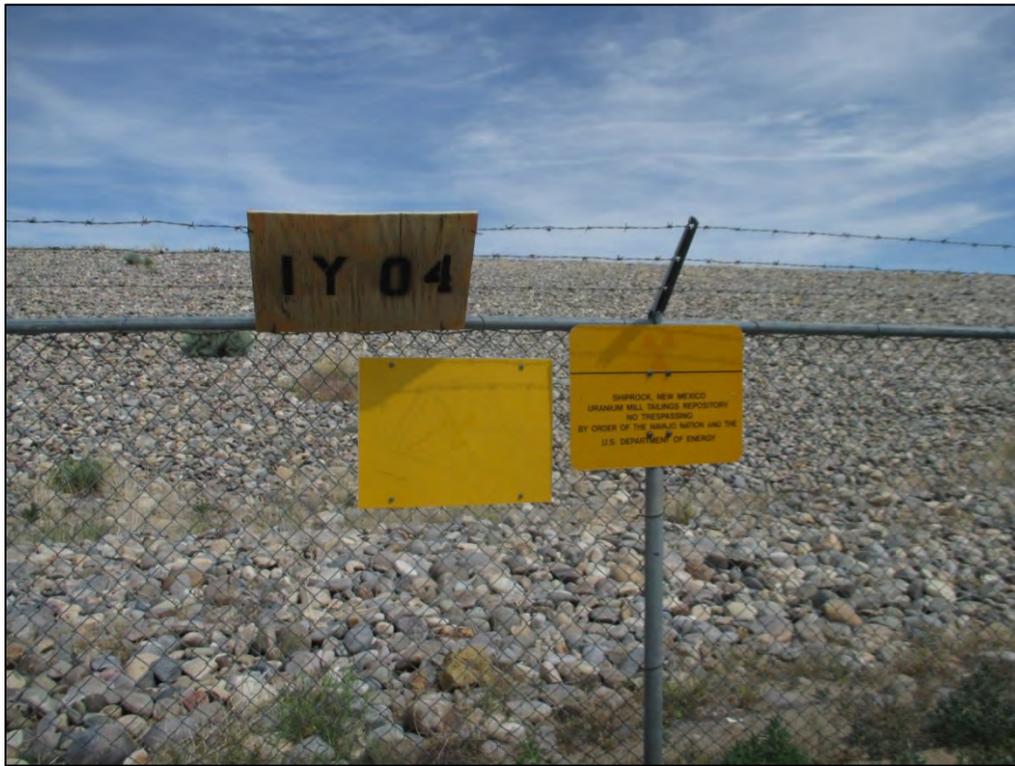
PL-3. Faded Pictorial Perimeter Sign P11 at NECA Yard

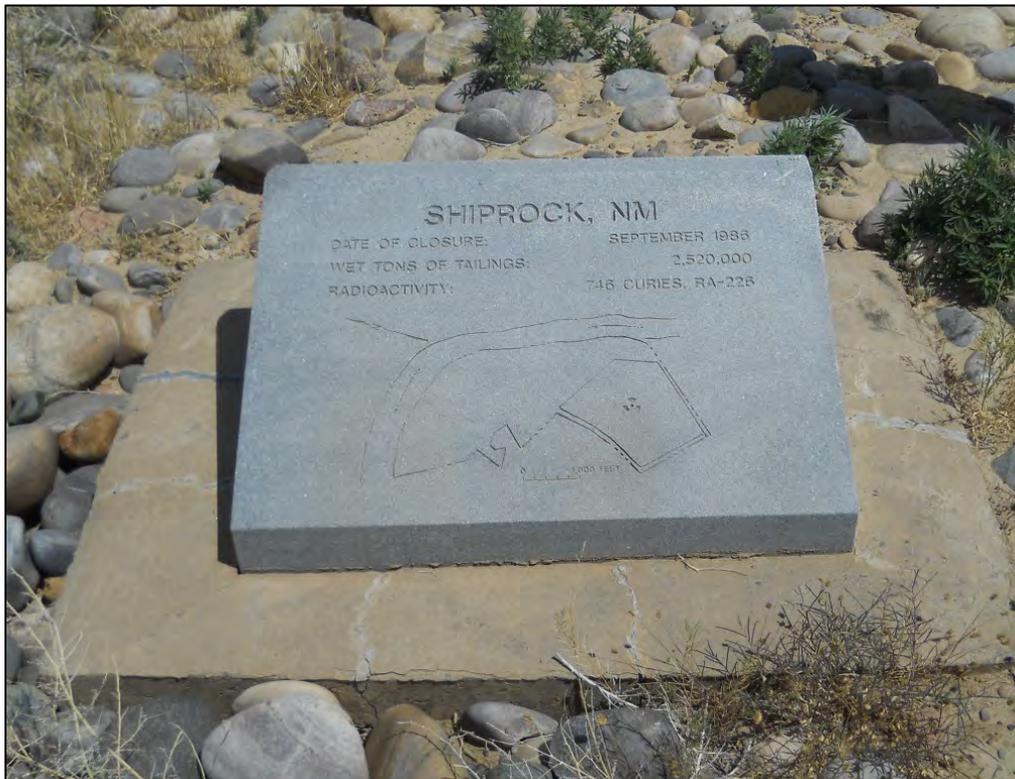
PL-4. Site Marker SMK-1

The site has two granite site markers. Site marker SMK-1 is just inside the west gate; minor cracks in its concrete base were resealed in 2018 (PL-4). Site marker SMK-2 is on the top slope of the disposal cell. No maintenance needs were identified.

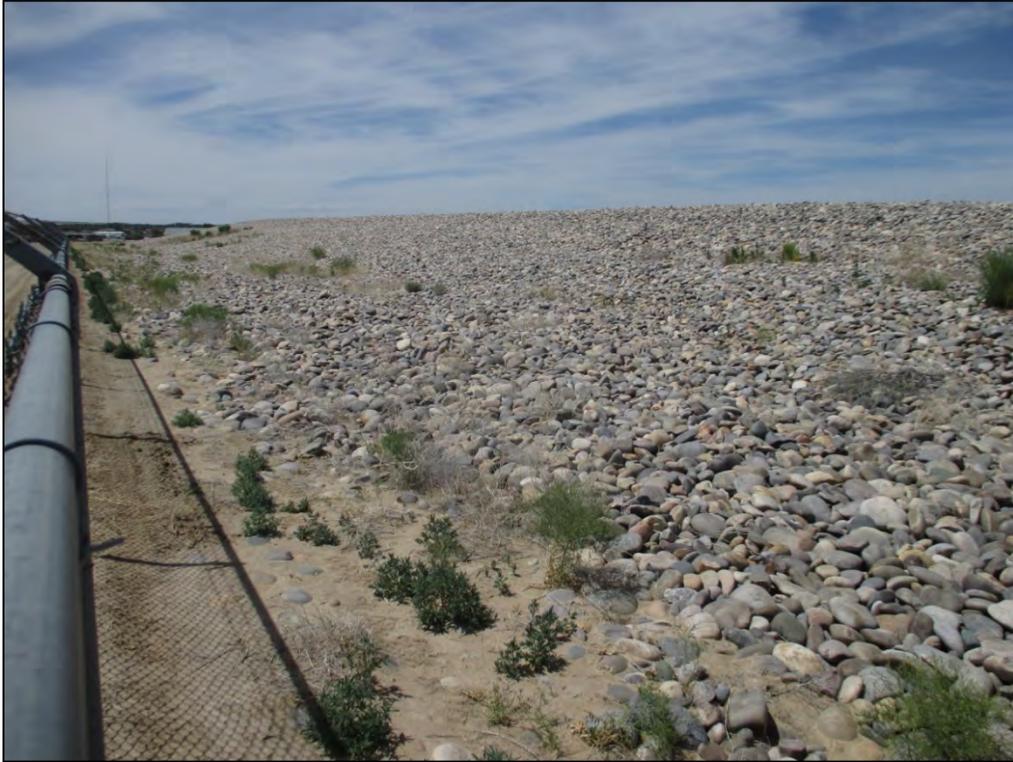
PL-7. Sediment Accumulation in Diversion Channel Along Southwest Slope of Disposal Cell

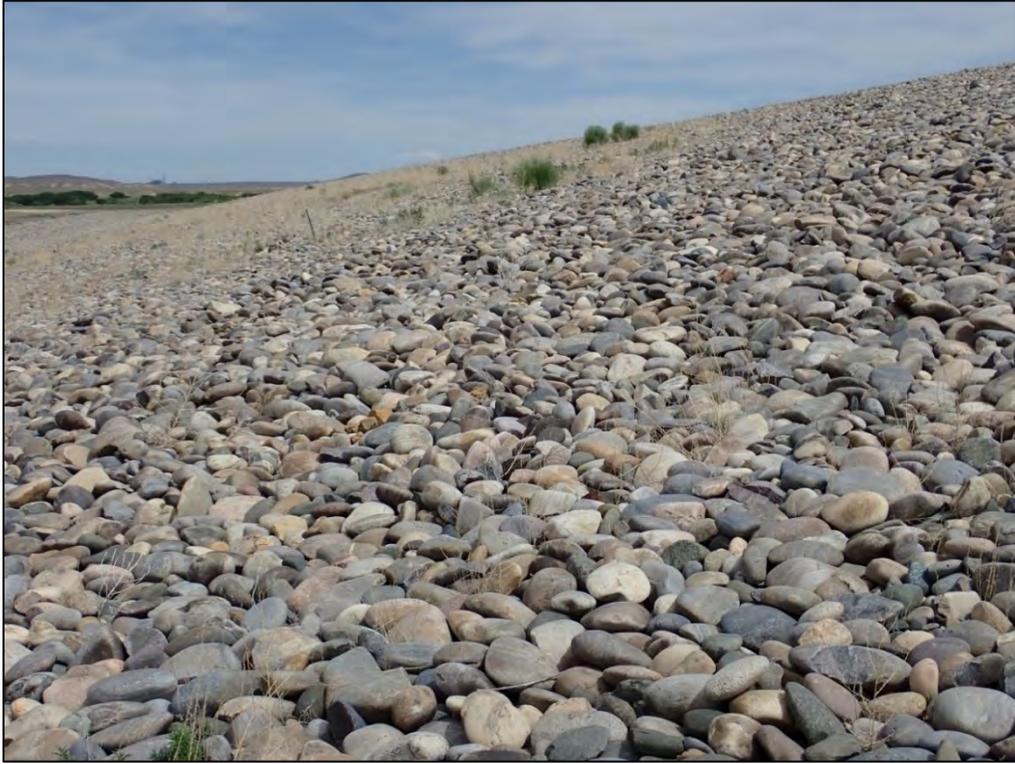
PL-9. Vegetation on Northeast Side Slope of Disposal Cell (Treated)

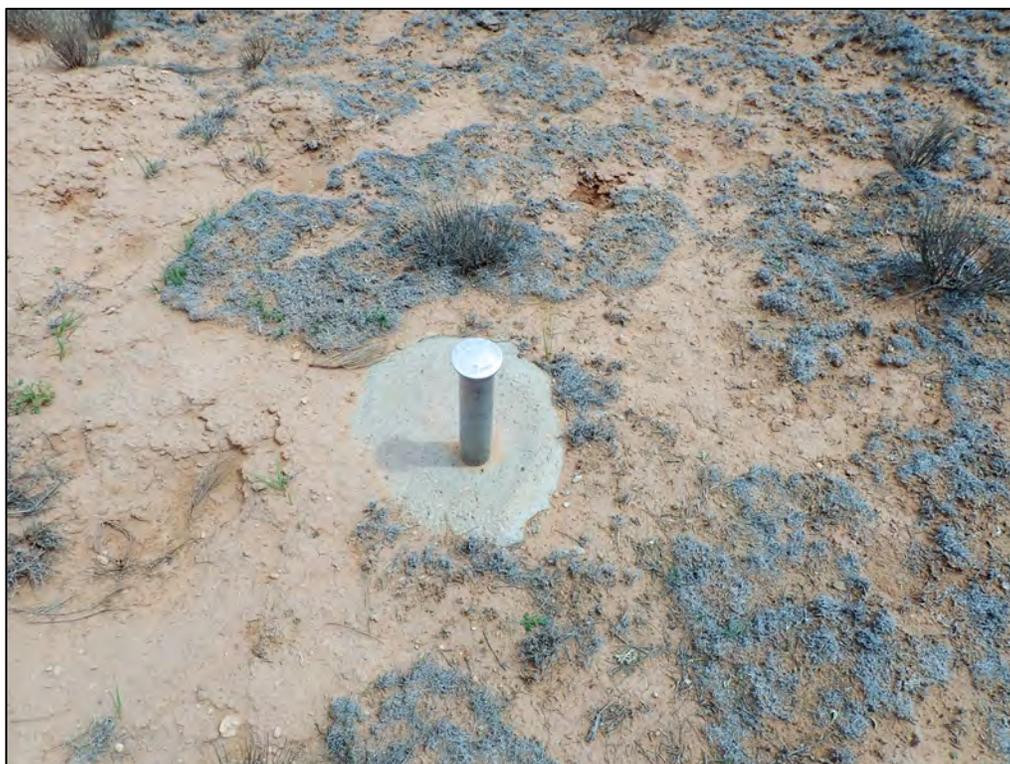
PL-2. Boundary Monument BM-5

The site has three survey monuments. Survey monument SM-2 was set in a low area and is frequently covered by several inches of soil. A T-post and rocks have been placed next to the monument to assist in locating this feature. Six boundary monuments delineate the corners of the site boundary (PL-2). No maintenance needs were identified.

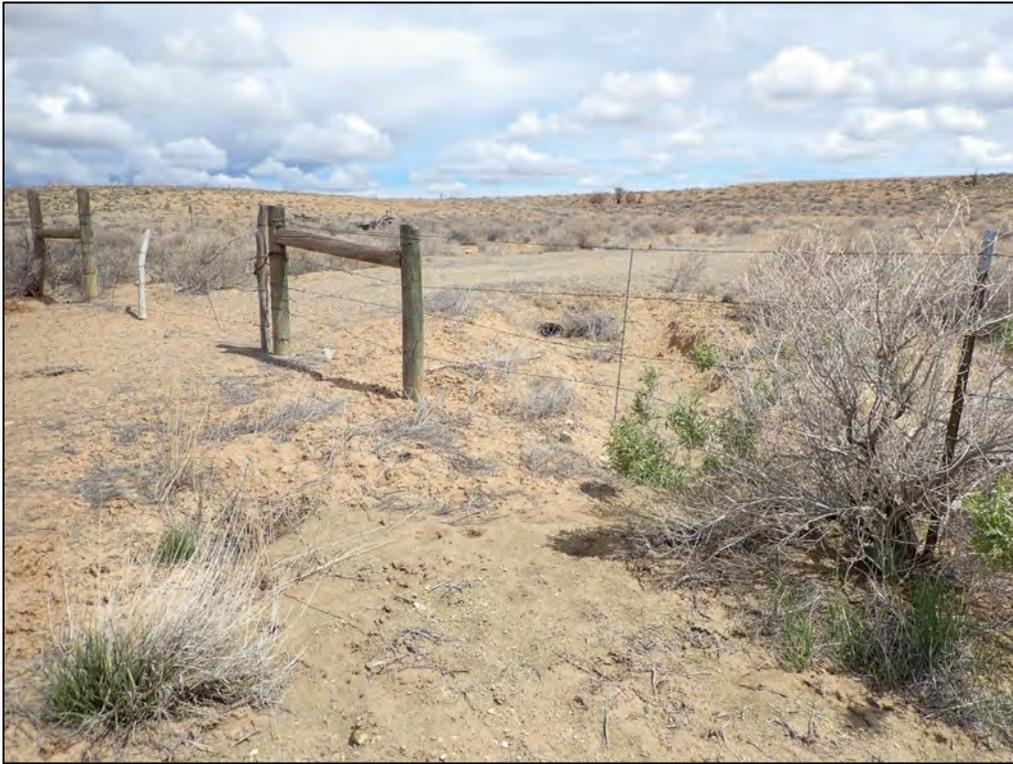
PL-7. Woody Vegetation Next to Fence Post with Culvert at Gate Entrance

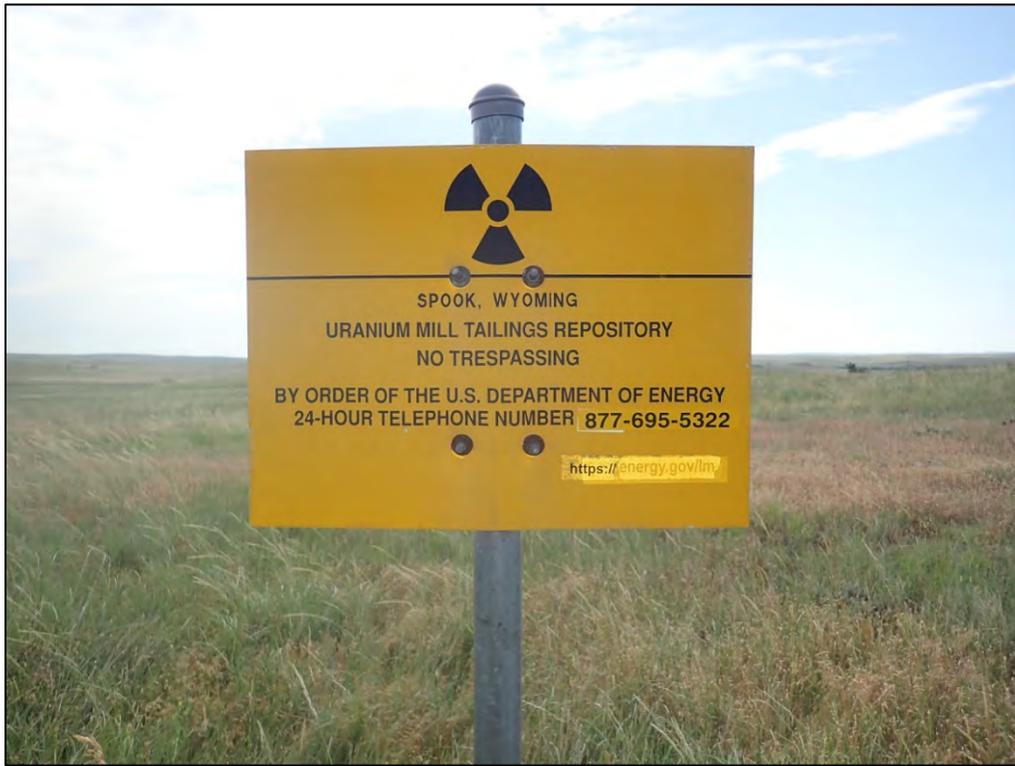
PL-1. Entrance Sign Before Update

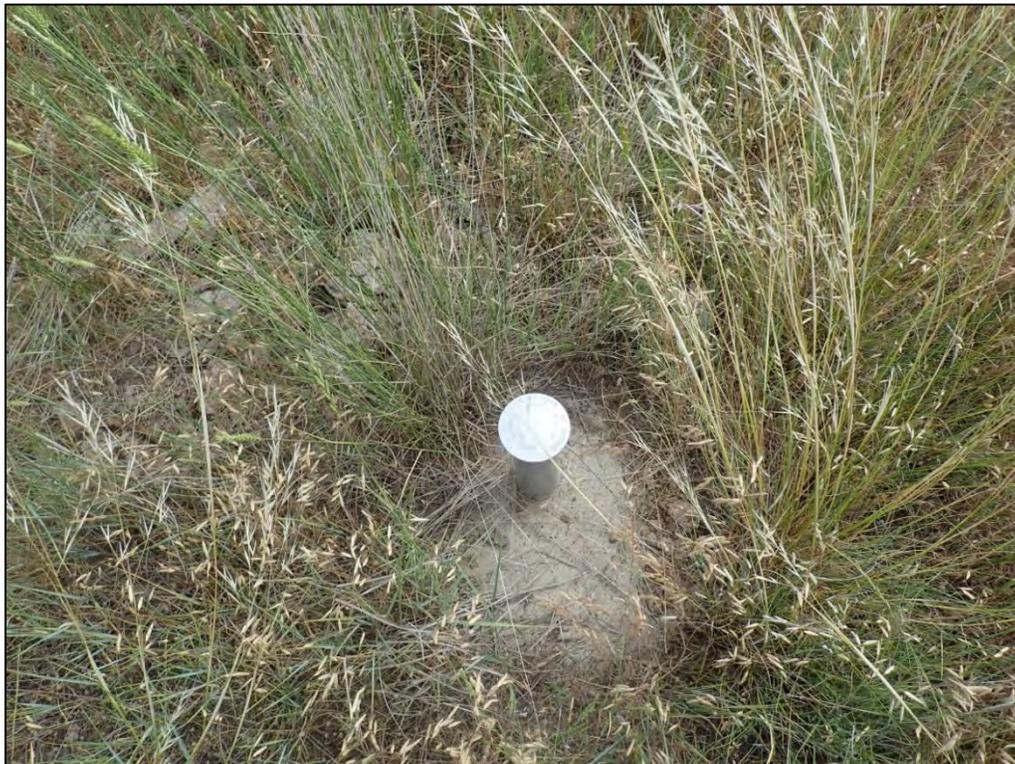
PL-4. Boundary Monument BM-8

The site has three survey monuments and eight boundary monuments (PL-4). Boundary monument BM-6 is bent but stable. The boundary monuments and a survey monument, as well as the perimeter signs, are outside the property boundary. The owner of the surrounding property (Hornbuckle ranch) is aware they are on his property but is not concerned. Therefore, the survey and boundary monuments and perimeter signs will remain at their current locations.

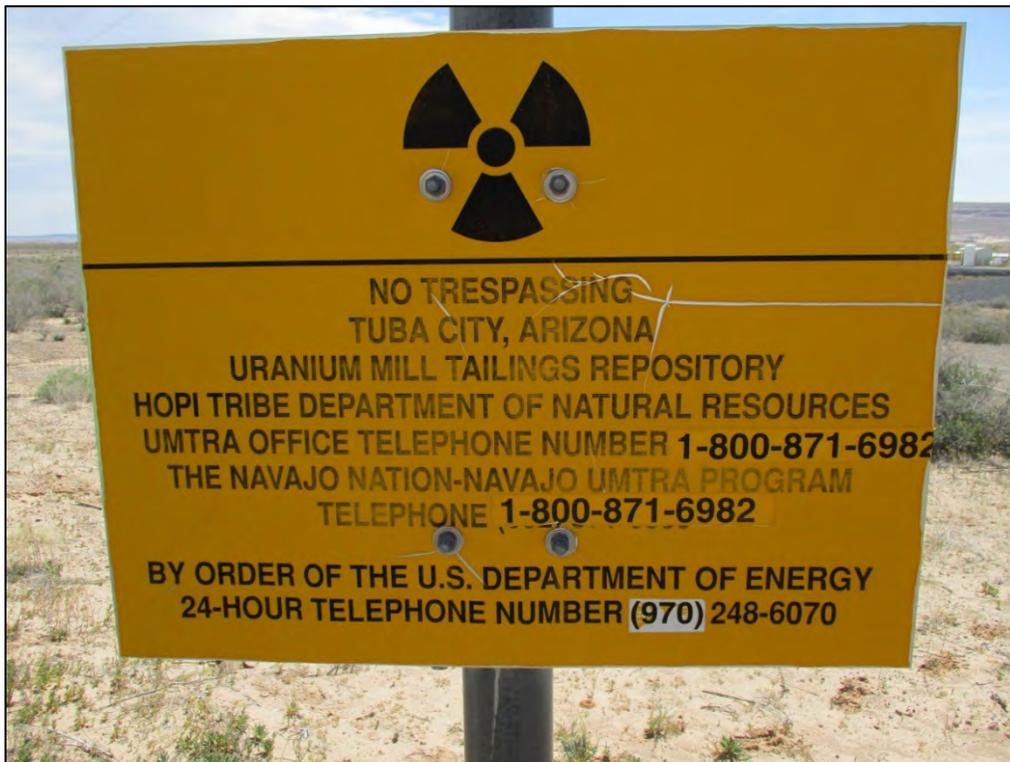
PL-2. Entrance Sign on Post at Entrance Gate (Replaced Following Inspection)

- Replacement of two textual and one pictorial sign on the entrance gate
- Updating phone numbers for the Hopi Tribe Department of Natural Resources on two textual signs
- Replacement of entrance signs on vehicle gate No. 1 and vehicle gate No. 2

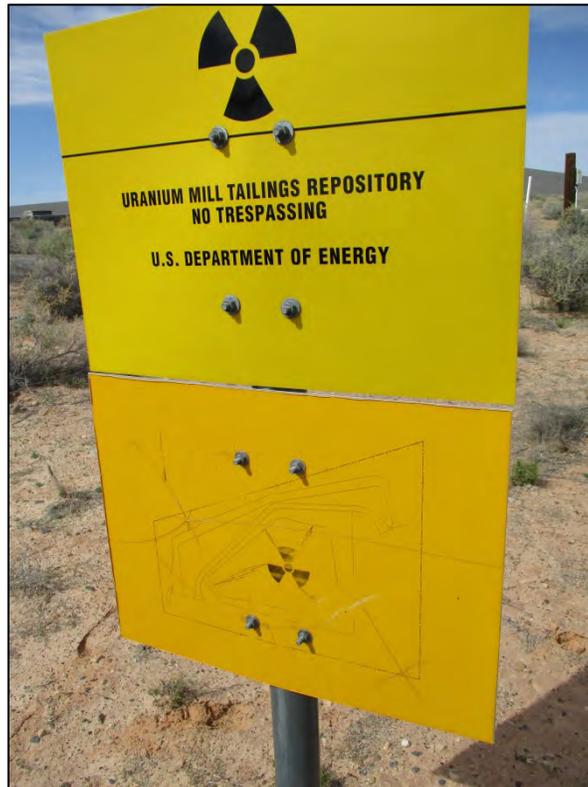
PL-9. Perimeter Sign P24; Pictorial Sign Faded (Replaced Following Inspection)

- Removal of accumulated sand from the western perimeter fence, perimeter road, and along the northern perimeter fence
- Repair of gaps beneath the fence created by animals and soil erosion
- Replacement of three pictorial perimeter signs at the P6, P9, and P24 locations
- Location of survey and boundary monument SM/BM-1, with installation of a steel T-post to permanently mark its location
- Replacement of the evaporation pond fabric safety rope with steel rope
- Installation of new caution signs surrounding the northwestern evaporation pond
- Repair of the surficial crack in the HDPE liner of the northwestern evaporation pond
- Removal and treatment of vegetation

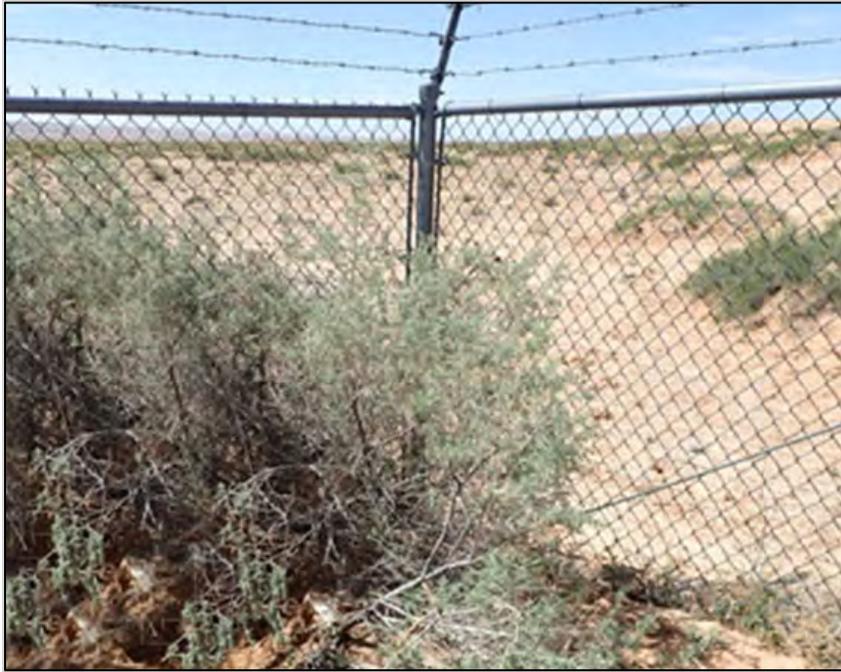
*PL-11. Survey and Boundary Monument SM/BM-1 Buried in Sand
(Found Following Inspection and Permanent T-Post Installed)*

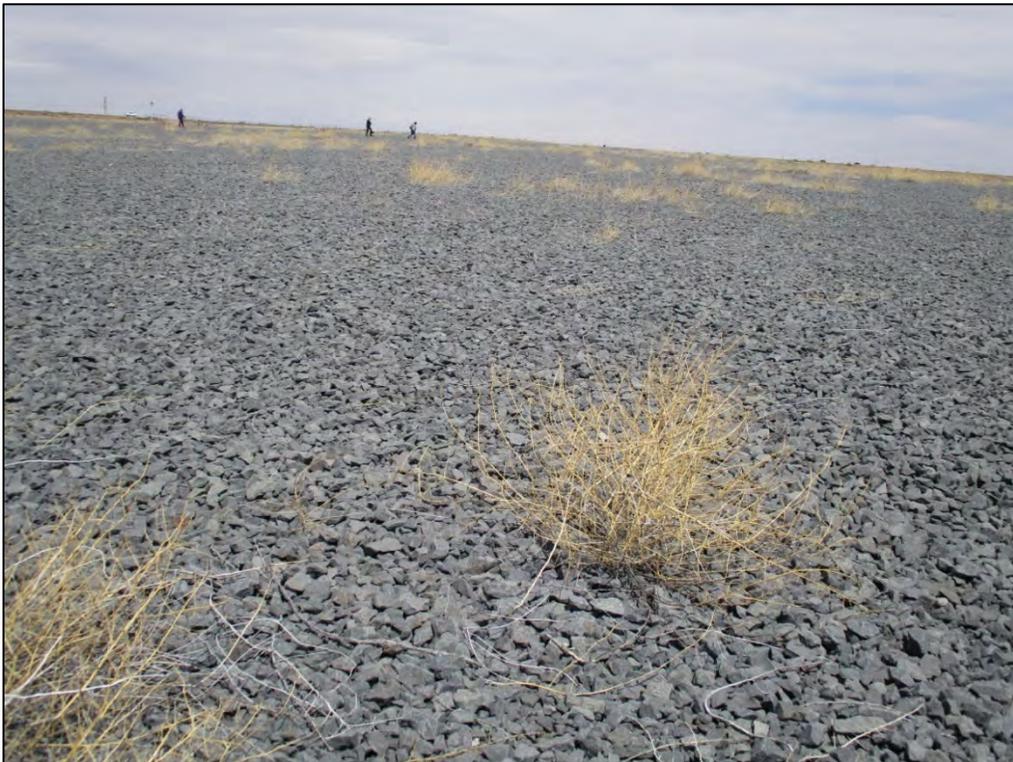
PL-14. Annual Weeds on Disposal Cell Cover

In accordance with the LTSP, deep-rooted vegetation is controlled to prevent potential penetration of the radon barrier. Periodic spot-application of herbicide has been effective in controlling deep-rooted vegetation growth on the disposal cell cover. No deep-rooted shrubs were observed on the cell top or side slopes during the inspection. Scattered patches of annual weeds grow on the disposal cell top and side slopes (PL-14), but these shallow-rooted plants are not a concern. Windblown sand and dirt continue to accumulate on the rock-covered surfaces, providing a favorable environment for plant growth. No maintenance needs were identified.

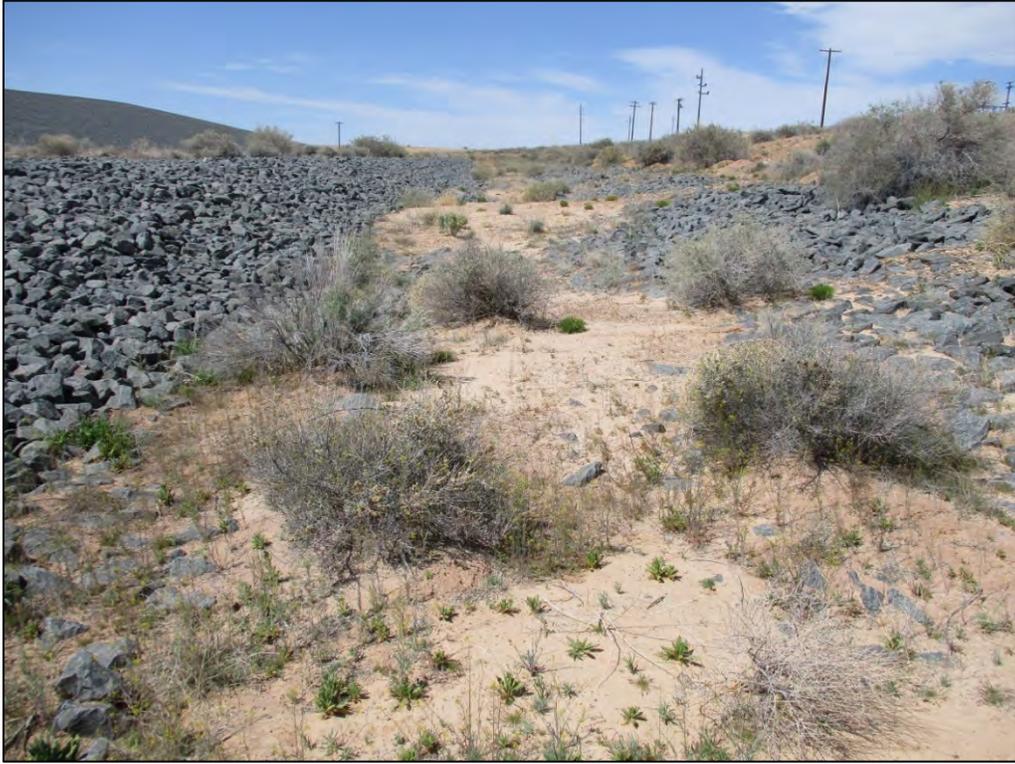
of these structures. No evidence of recent or past water flows was observed in the apron ditch or the diversion channel.

PL-15. Sediment Accumulation and Vegetation in Diversion Channel

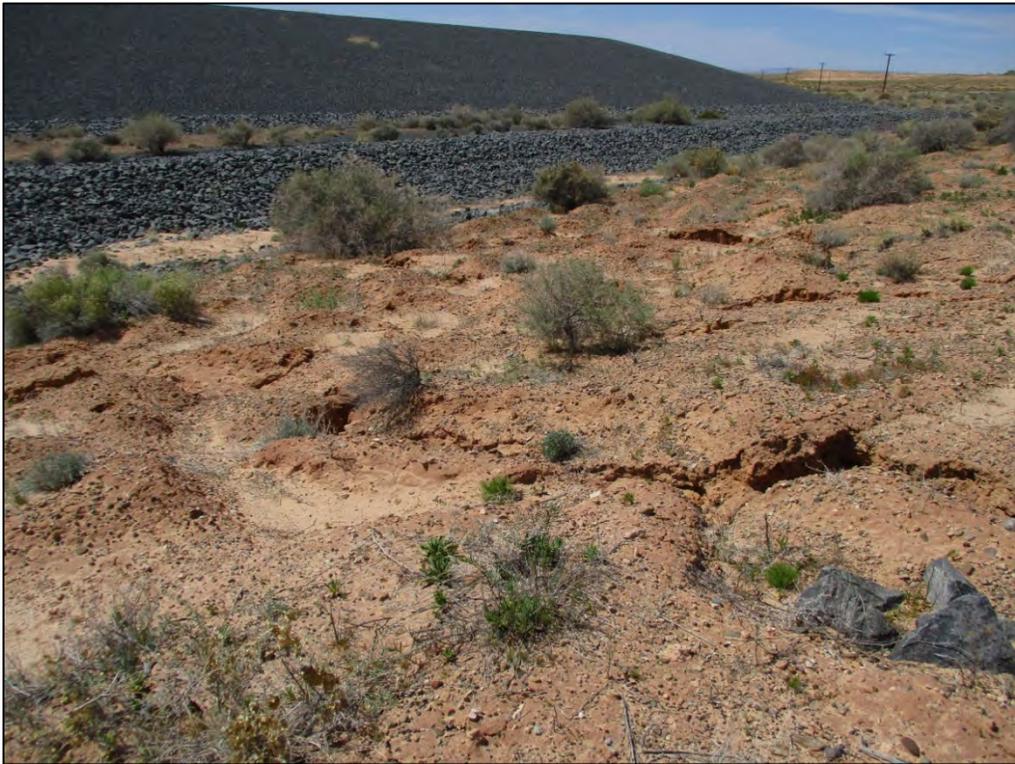
The north slope above the diversion channel, consisting of noncohesive sandy soil, is subject to erosion from storm runoff. Erosion repair conducted in this area in 2013 was successful in reducing the rate of erosion and subsequent soil deposition in the channel. Some erosion and deposition continue (PL-16), however, and erosion control repairs are performed as needed. No repairs are necessary at this time.

PL-16. Soil Erosion in Reclaimed Area

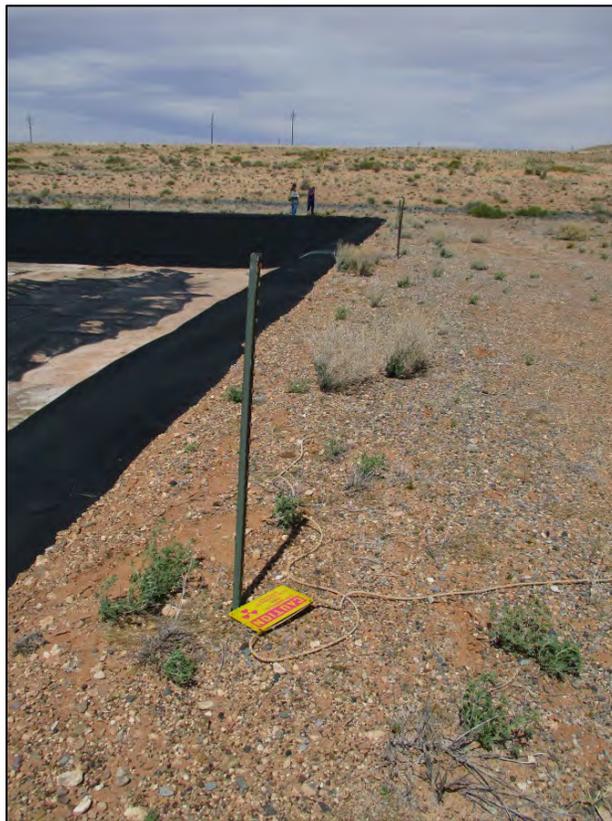
*PL-18. Downed Safety Rope and Caution Sign
(Replaced with Steel Rope and New Caution Sign Following Inspection)*
